**Re: Manutenzjoni, Restawr u Installazzjani ta' Dawl Ġdid tal-Koppla tas-
Santwarju**

A Case for the Restoration of the Żabbar Parish Dome

Żabbar Parish Church, Sanctuary Street,
Żabbar, Malta.

Report no.: 1

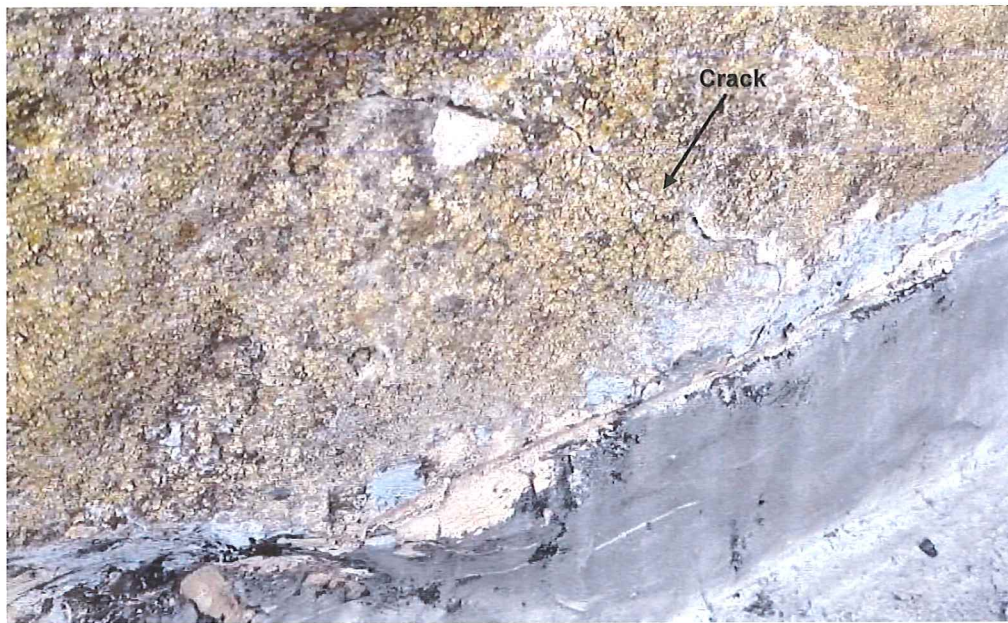
On the exterior, sparse cracks of limited width (<2mm) were observed above the extrados of the arch supporting the drum over the main aisle, where the vault ('troll') of the nave meets the pendentives supported by the four main pillars at the central crossing. Such thin cracks are normal and expected within a heavy masonry structure of this kind, typically formed as the main thrust line of force finds its way through the various stone components of the structure. Although not of concern from a structural point of view, these cracks present propitious entry points for rainwater, which is then led into the internal core and infill and possibly finding its way to the interior surfaces, damaging the decorative mouldings and frescoes in the vicinity of the annular base of the drum. Furthermore, cracks of this kind, and the associated thermally induced movement across the seasonal cycle, often compromise the applied waterproofing lining that in some places was seen to span across these same cracks.

Figure 4-1 – A crack observed beneath the north-east facing side of the drum, that is overlying the barrel vault of the main aisle.

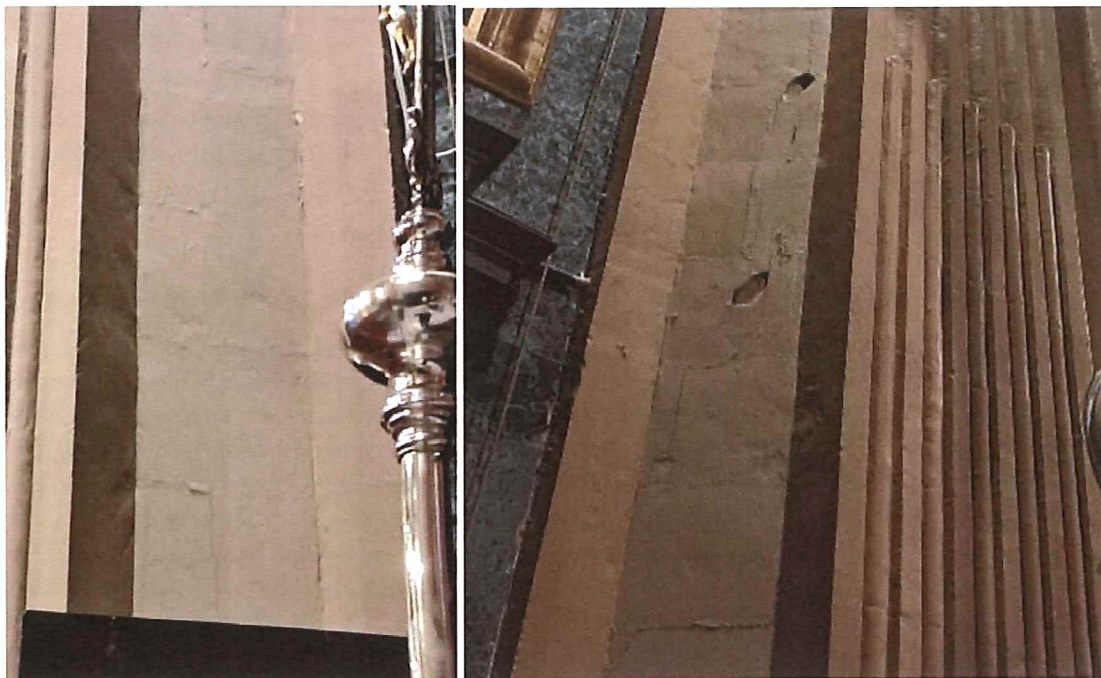
Minor cracks, of width not exceeding 2mm, were also observed within the internal pilasters supporting the dome, specifically at the junction between the corner pilasters and the walls of the choir, immediately behind the main altar. These cracks follow the vertical joints in the masonry and suggest redistribution of forces created by the sheer weight of the dome. Although the scale of these cracks do not indicate major problems, they inevitably compromise the interior finishes and the attached marble cladding in some places. It is therefore suggested that these cracks are monitored over time, before reparatory interventions are attempted.

Figure 4-2 – Fine cracks within the pilasters at the main crossing supporting the dome, behind the main altar

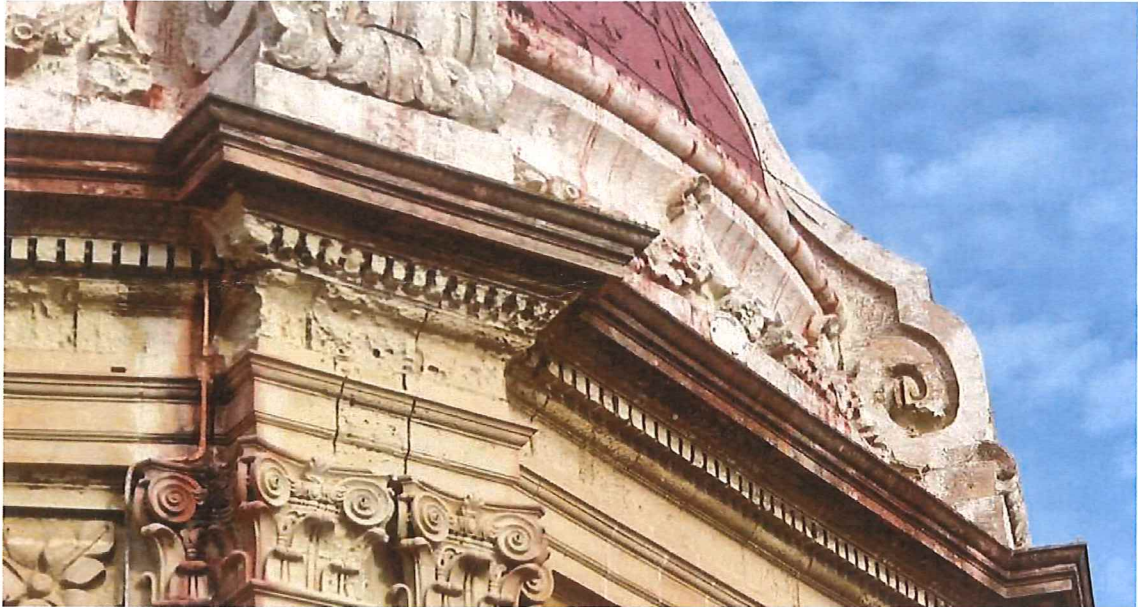
Within the external fabric of the drum, and specifically at the upper cornice, the stone masonry exhibits severe deterioration, such that sections of the stone mouldings forming the frieze have been severely weathered and disfigured (Figure 4-3). Signs of stone exfoliation are also visible within the lower sections of the drum pilasters, in some places leading to localized cracking and delamination. The masonry at the drum's level is noted to have a red patina, resulting from the natural weathering of the stone and possibly from washout of the paint applied on the lead lining above.

Figure 4-3 – Weathering and deterioration of the frieze below the main cornice of the drum.

Restoration work can then commence, including pointing of open joints, plastic repair and consolidation of deteriorated stonework, lime and/or epoxy injection interventions, pinning of delaminated stone, replacement of deteriorated stone blocks with new worked stone inclusive of all the necessary sculpture, and any other works necessary to address the existing problems outlined in the previous sections.

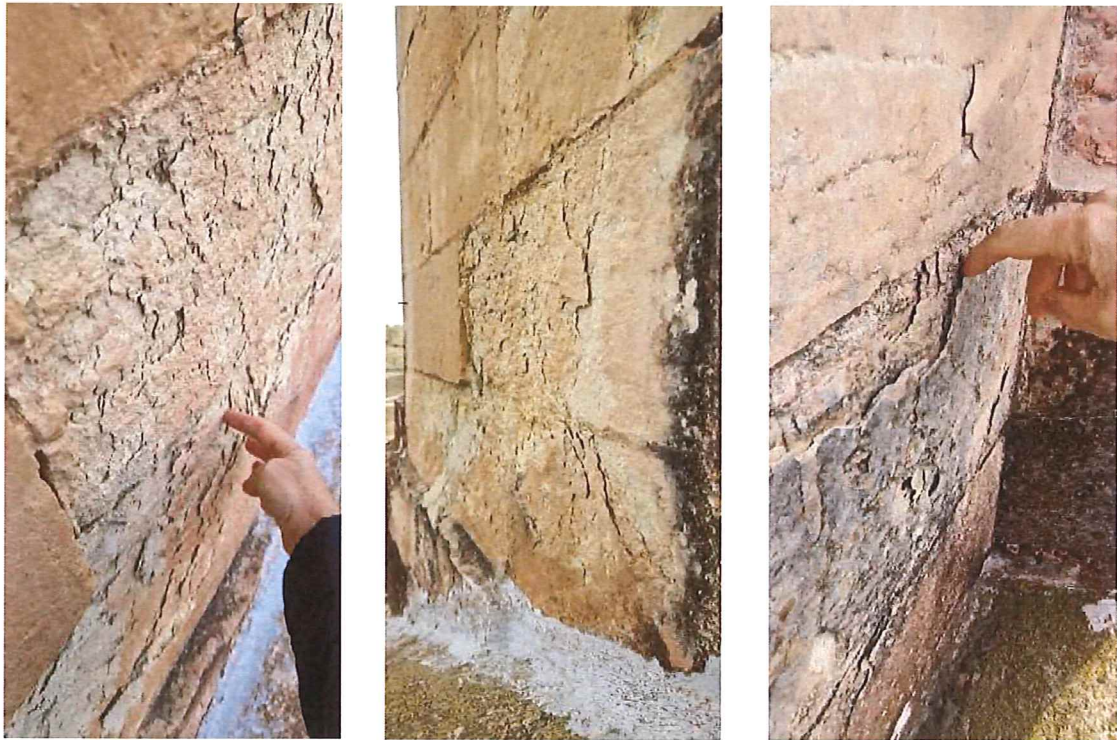
Figure 4-4 – Examples of exfoliation within the stonework at the base of the drum. The stone fabric is also noted to have a red patina.

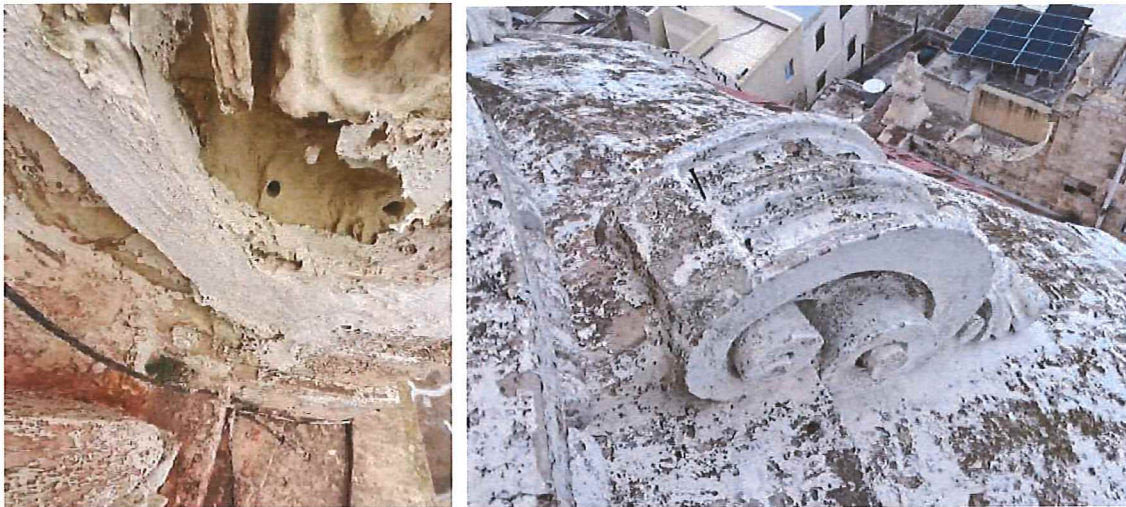
Delamination of the white paint that has been applied on the dome's and lantern's masonry is noted to be considerable. This paint was tested on the spot for inherent elasticity and was found to be relatively brittle, possibly because the type of paint used was not of the elastomeric type. There are also signs of weathering of this paint system, this being seen to be clearly flaking or outright missing in several exposed parts of the masonry, especially where around those areas subject to considerable wind turbulence. This implies that several zones of the underlying porous stonework may not be fully impermeable to intense stormwater downpours.

Figure 4-5 – weathering of the paint system, exposing the underlying masonry

The subsequent stages will address the waterproofing system, specifically the repair of the lead lining sheets, and the application of liquid membrane and/or specialist coatings to the exposed masonry.

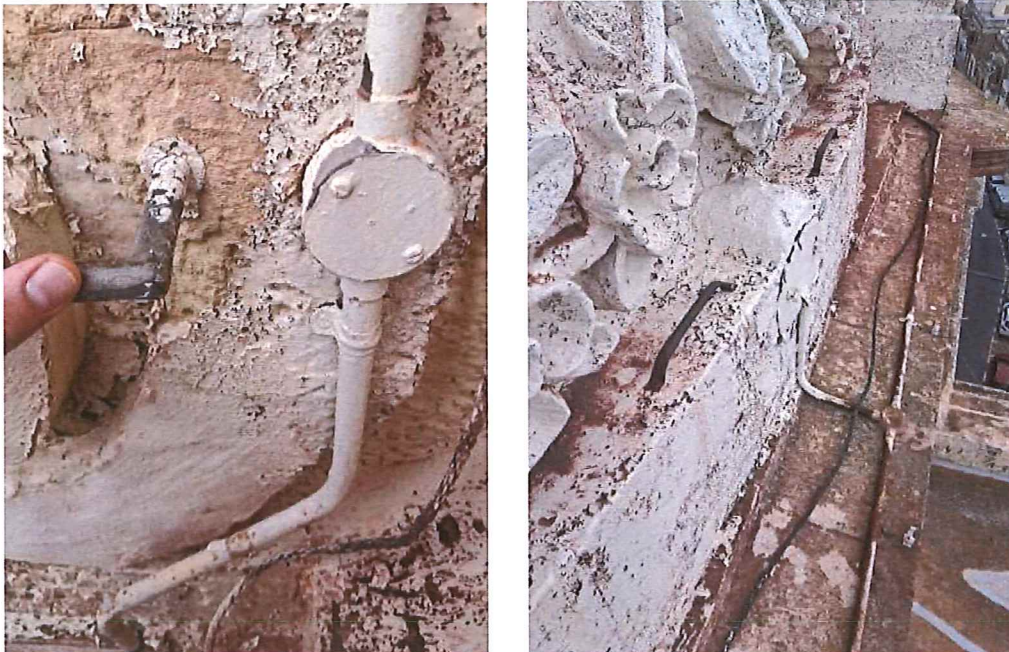
Figure 4-6 – Deteriorating paintwork and preferential storm water paths, compromising integrity of service perforations

Closer inspection of the mouldings and semi-horizontal surfaces at the lower levels of the dome also revealed preferential water paths and zones of more intense water-related deterioration of the finishes and underlying stonework. It is the opinion of the undersigned that stormwater management, over the dome surfaces, can be improved by judicious implementation of better falls across some of the horizontal surfaces and subsequent application of an elastomeric liquid membrane, possibly reinforced with a glass-fibre mesh in the more exposed locations. An exercise of this kind would need to be preceded by removal of all vegetal encrustations and treatment of deteriorated zones of the stonework. This would include treatment of several indents, channels and fixtures intended to provide a foothold or handhold or to enable the passage of service runs related to the dome lighting system, such that necessary interventions of this kind are detailed in the proper manner.

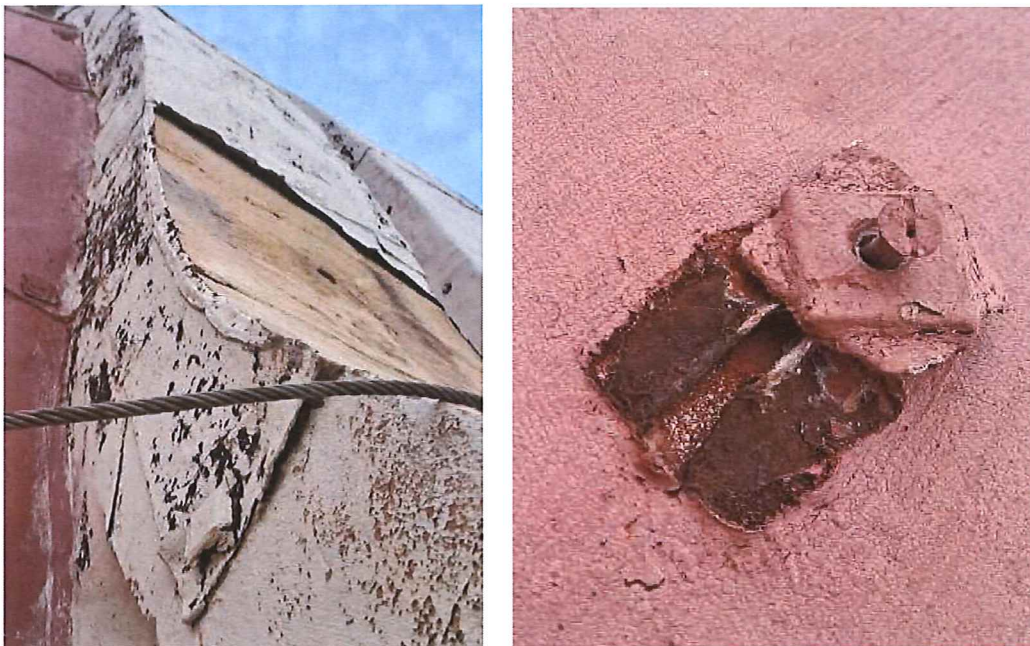
The lead sheet lining system is generally in good condition, but there are several locations where this has been compromised or where it is missing completely. The lining system is generally subject to intense peeling forces during windy days, and these forces have succeeded in removing parts of the lining system across the ribs, leaving the underlying stonework completely exposed. This is of concern since rainwater penetration will eventually damage the interior finishes, which are not only priceless but also extremely difficult to access. These zones of missing lead sheet therefore need to be replaced, and the correct seam joints with the existing lining implemented to ensure adequate shedding of water flow. This would need to be preceded by treatment of the underlying masonry with liquid membrane to create an additional layer of protection.

The same peeling forces have also resulted in cyclic in-plane movement of the lead sheets relative to the underlying masonry. Although most of the lining remains intact and firmly attached to the underlying masonry by point fixtures and square washers, this movement has resulted in widening of the holes at the fixing points, such that some of these are now slots rather than circular holes. In some instances, the accumulated movement has been large enough for the slots to develop well clear of the overlying washer, such that the resultant opening now creates an entry point for rainwater. It is therefore clear that the lining needs to be thoroughly inspected for such occurrences, and where these are identified, the fixture is removed, the lead sheet is patched up and a new fixture is introduced to secure the lining to the masonry once again.

Figure 4-7 – missing lead sheets and slotted hole created by cyclic movement of the lead sheet relative to the fixture and the masonry.

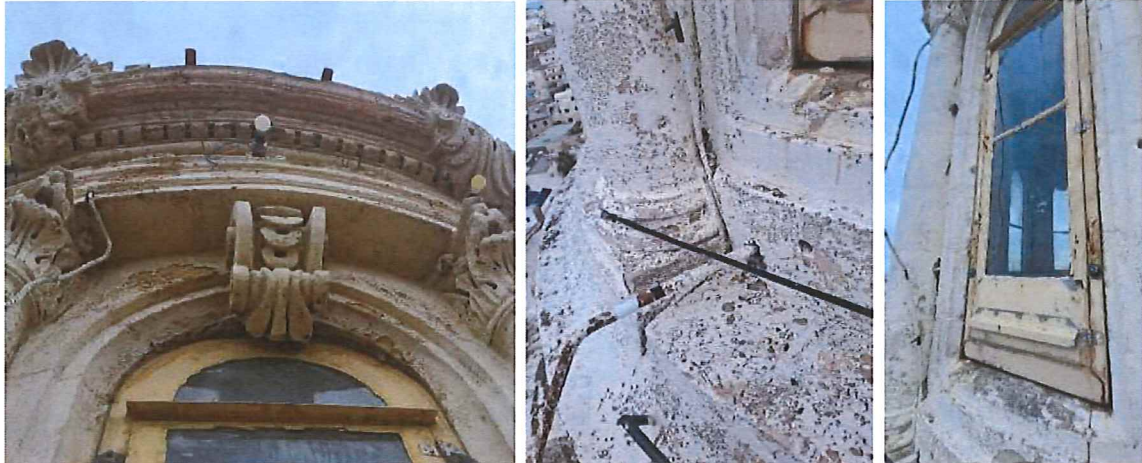
The lantern is generally in good condition from a structural point of view. There are however the same indications of deteriorating masonry mouldings and a compromised water proofing system. Signs of water penetration in the form of flaking paint are observable within the interior of the lantern, calling for a timely intervention to prevent the situation from deteriorating further. In a similar manner to the interior of the dome, the interior of the lantern is very difficult to access, making reparative interventions very costly and disruptive.

Figure 4-8 – closeups of masonry mouldings at lantern level showing deterioration and flaking protective paintwork

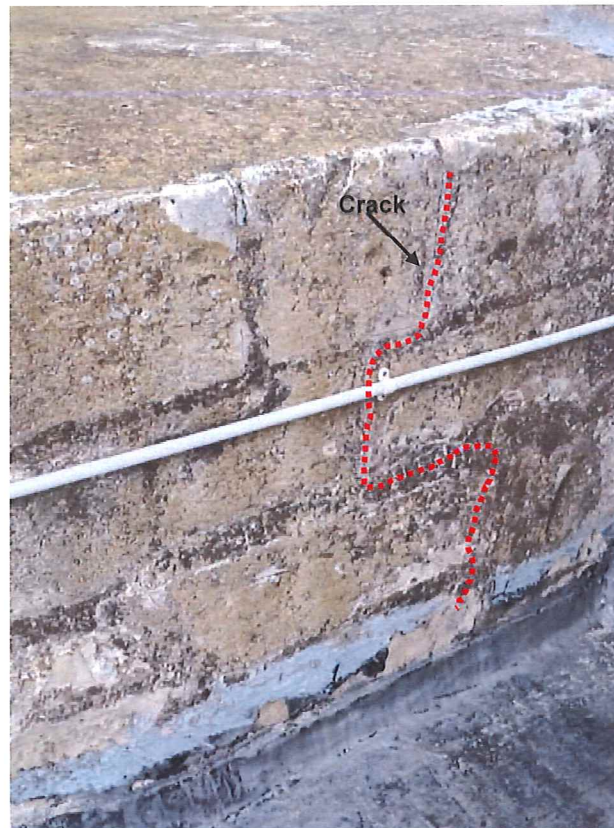
Figure 0-1 – A crack observed beneath the north-east facing side of the drum, that is overlying the barrel vault of the main aisle.

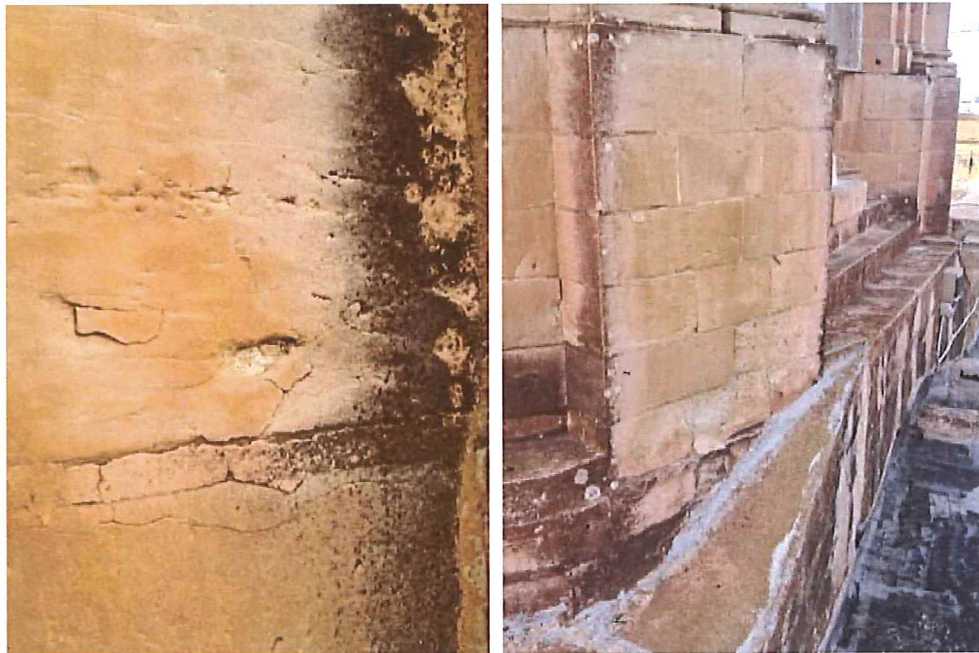
Figure 0-2 – Exfoliating stone and cracked stone especially towards the drum's base. The stone fabric is also noted to have a red patina.

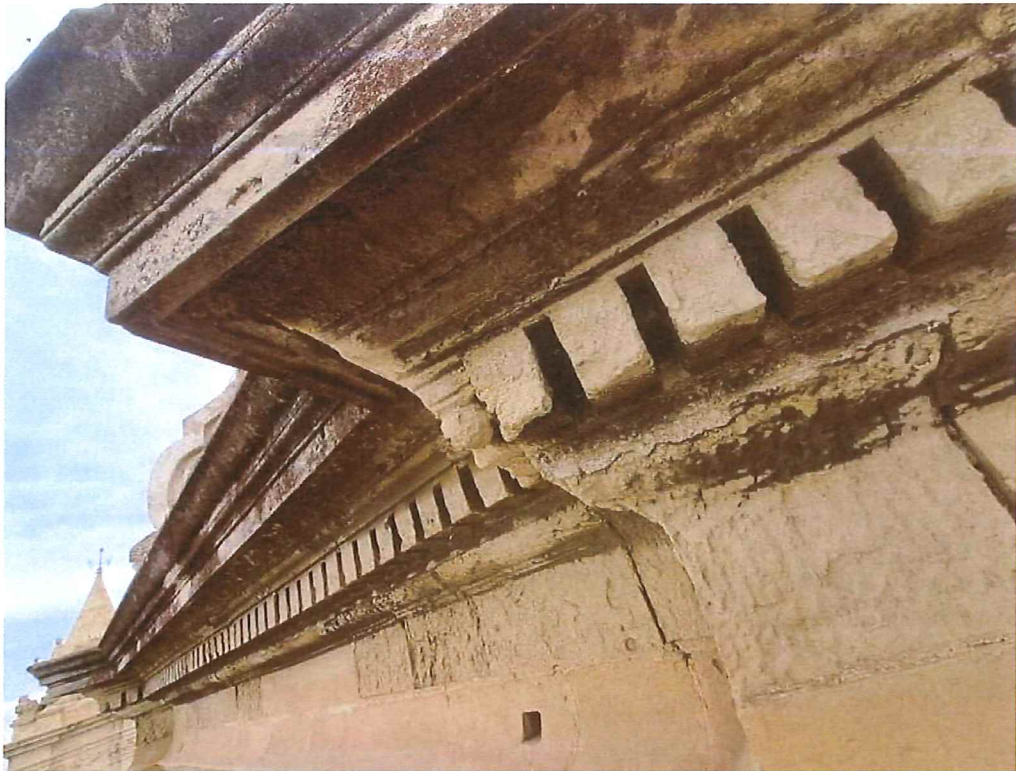
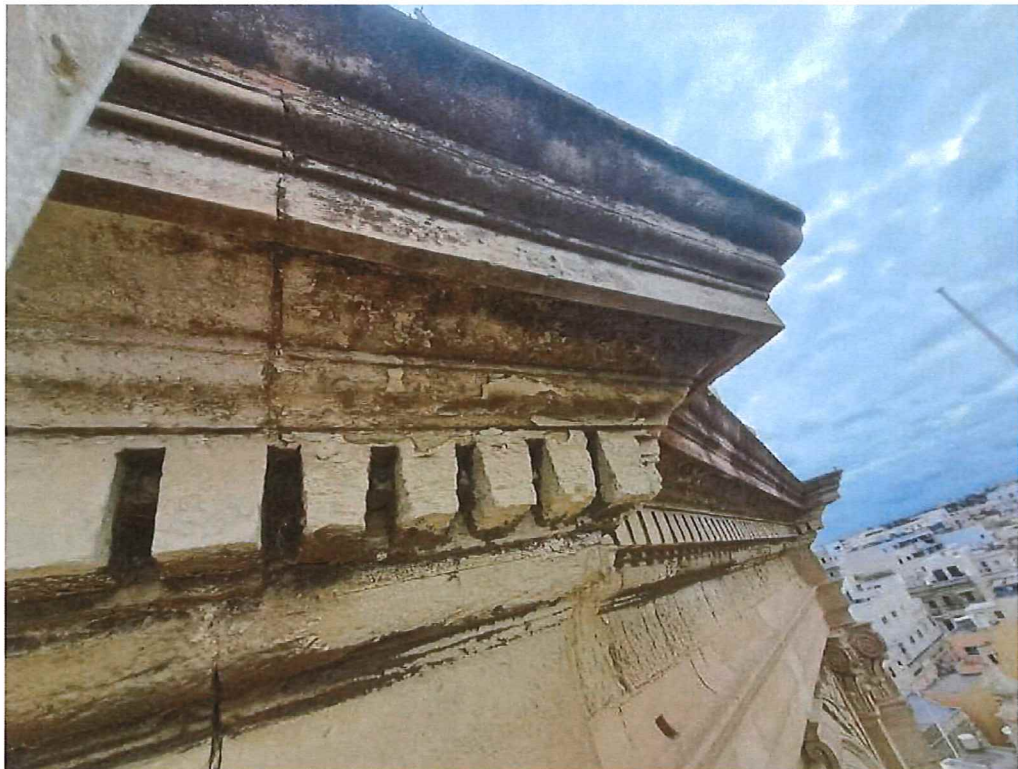
Figure 0-3 – Weathered stone at several locations of the cornice at the top of the drum

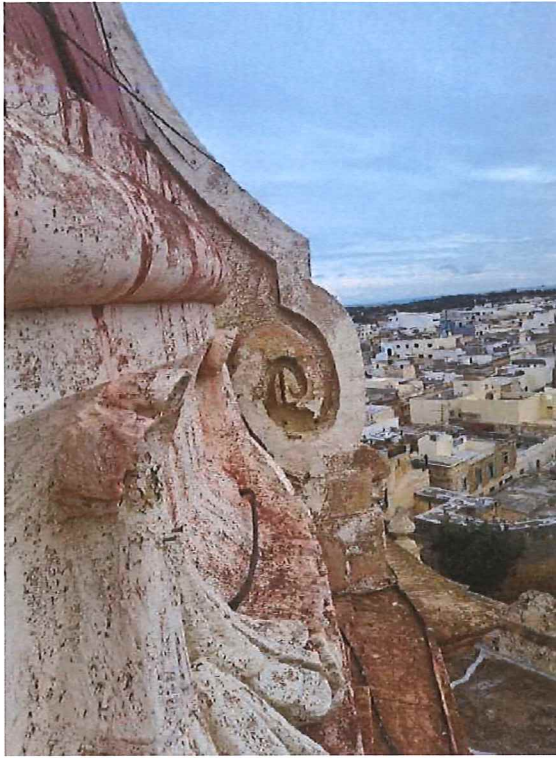
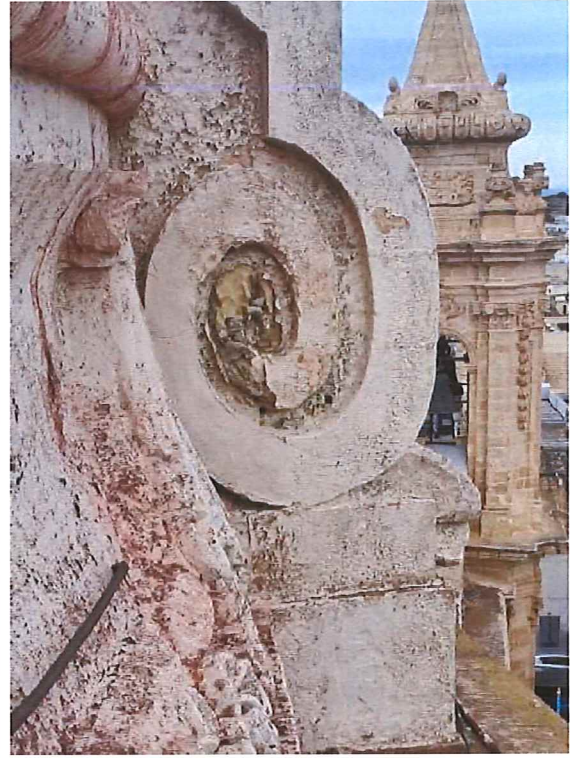
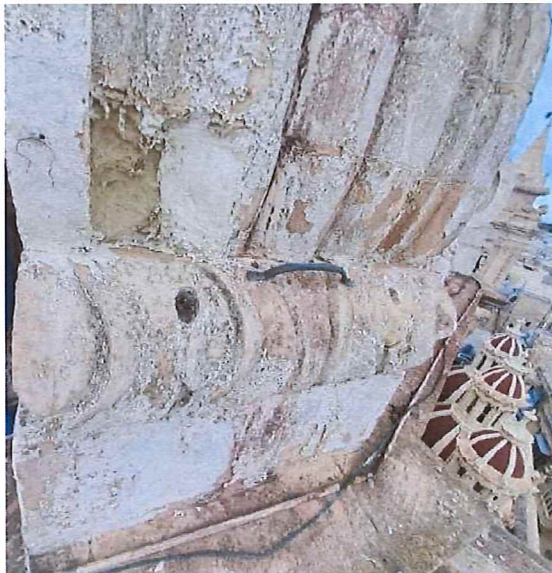
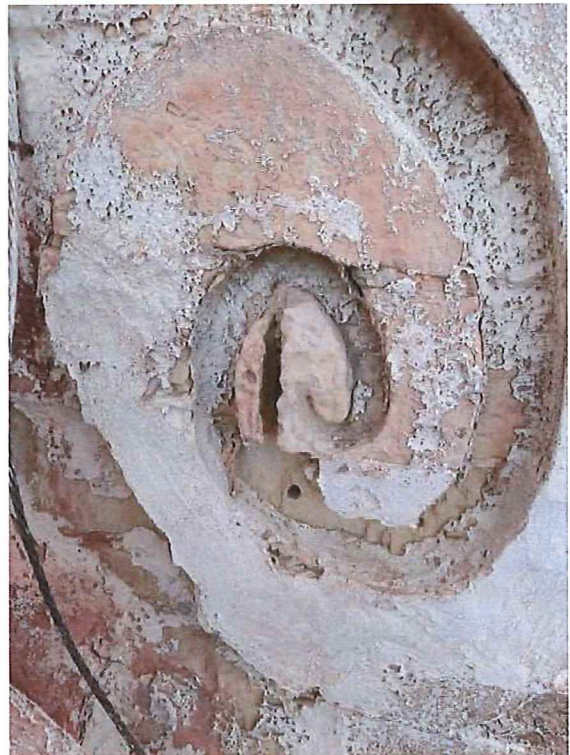
Figure 0-1 – Stone weathering

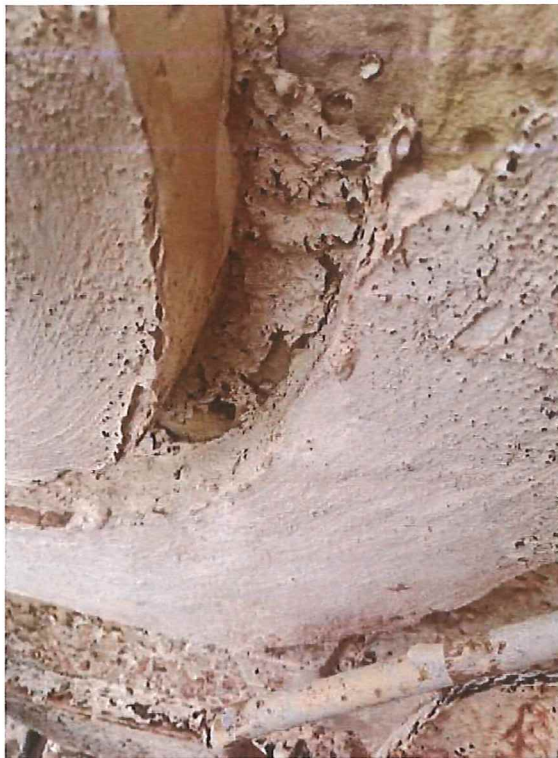
Figure 0-2 – Exfoliating white paint, vegetal deposits, paint deposits at preferential zones showing possible water entrapment.

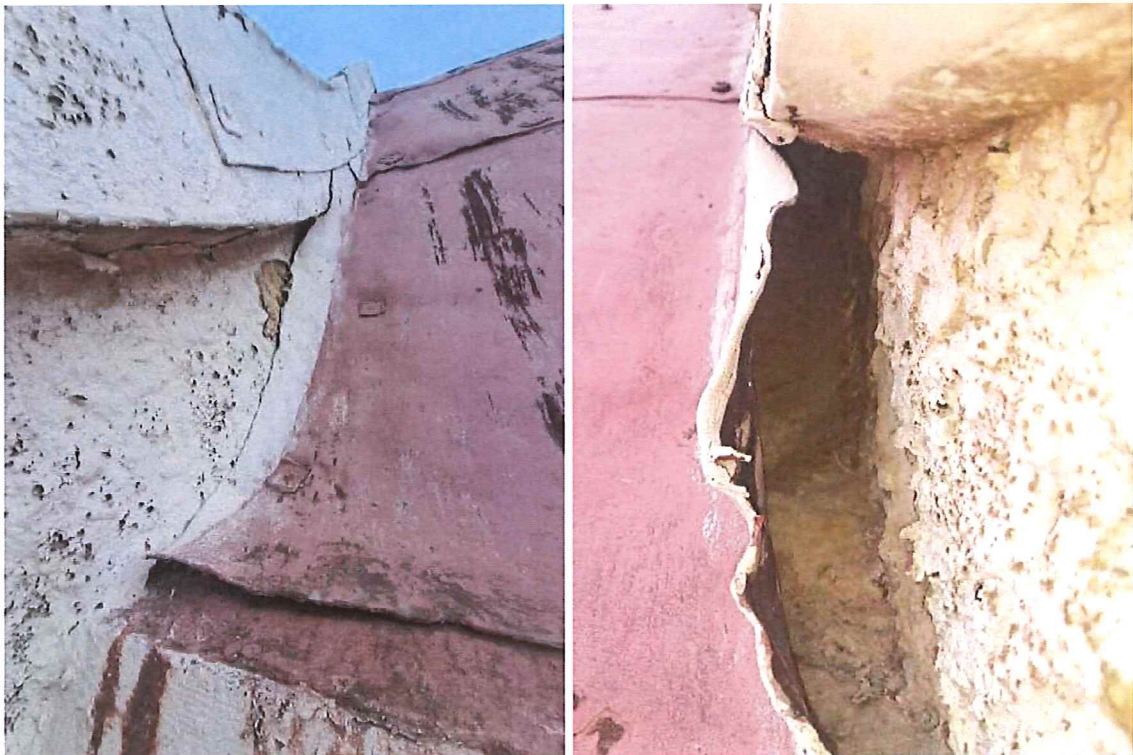
Figure 0-3 – Delaminating and detachable lead sheets used as waterproofing.

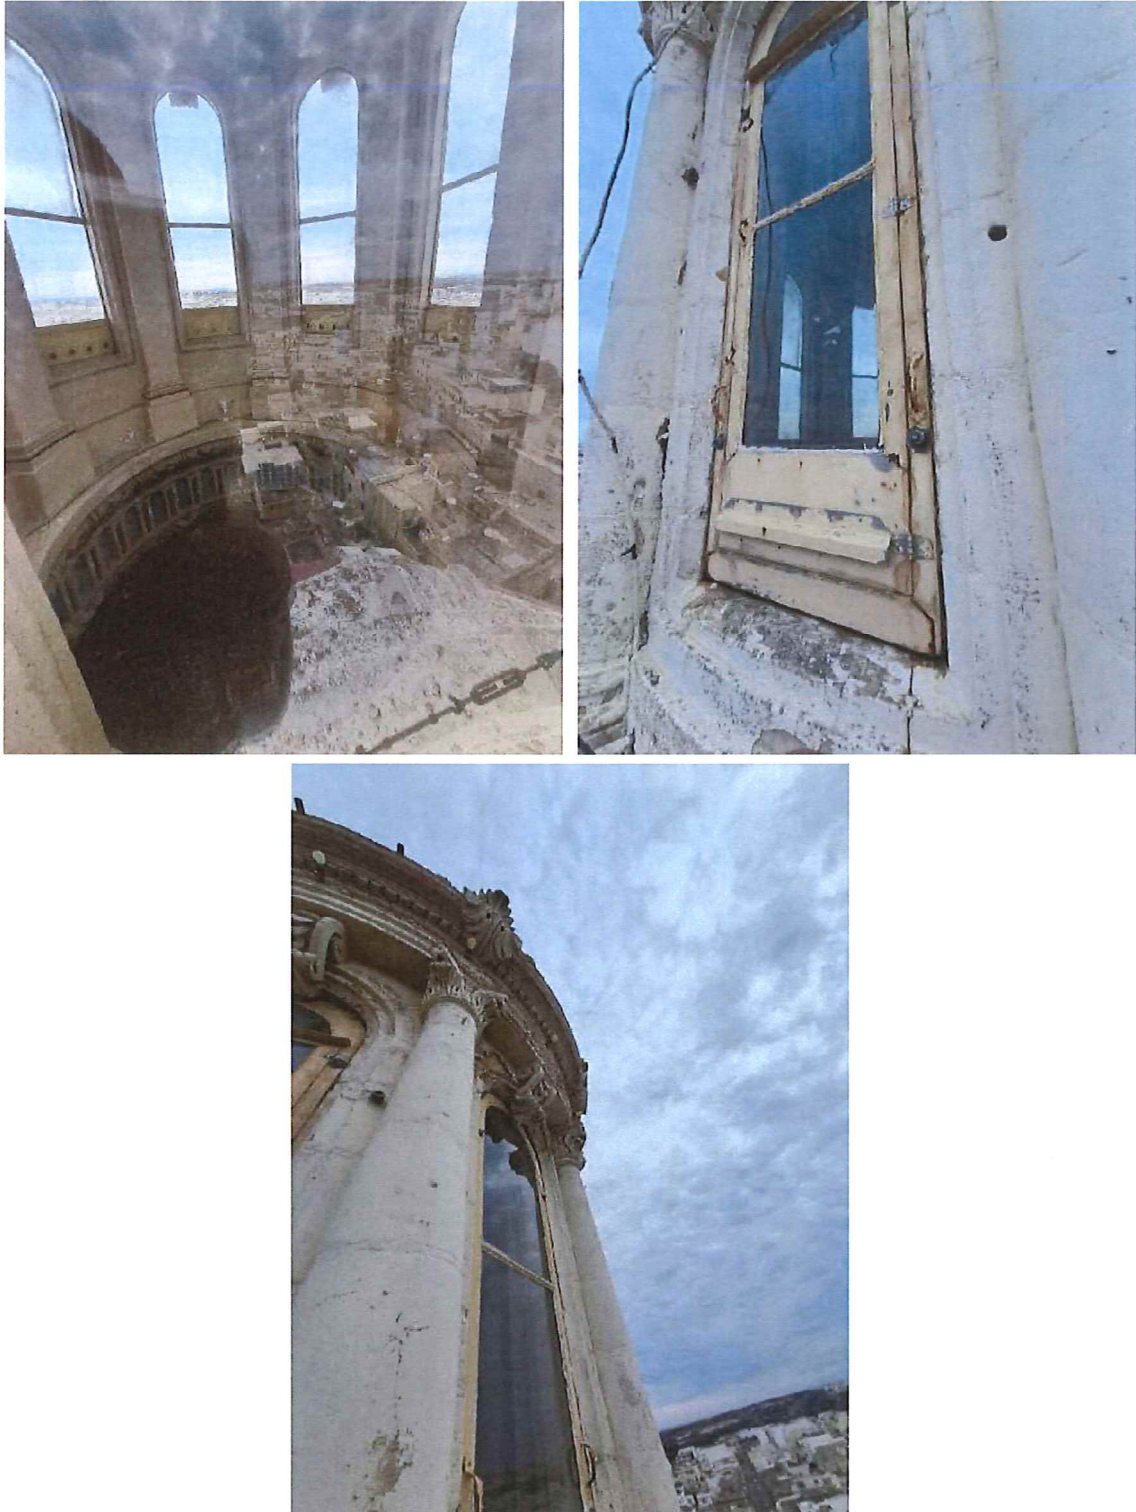
During the inspection it was also noted that the wooden apertures at lantern level require routine maintenance work, in the form of treatment to the joints in the timberwork and periodic paintwork. On the same note, the apertures and protective screens of the stained-glass windows of the drum require similar maintenance work and in some cases, replacement of some isolated shattered panels.

Figure 0-1 – Exfoliating paint and apertures requiring maintenance.

The final stages will involve restoration and painting of the timber apertures and replacement of the damaged protective screens to the stained-glass windows, and the installation of the architectural lighting system.

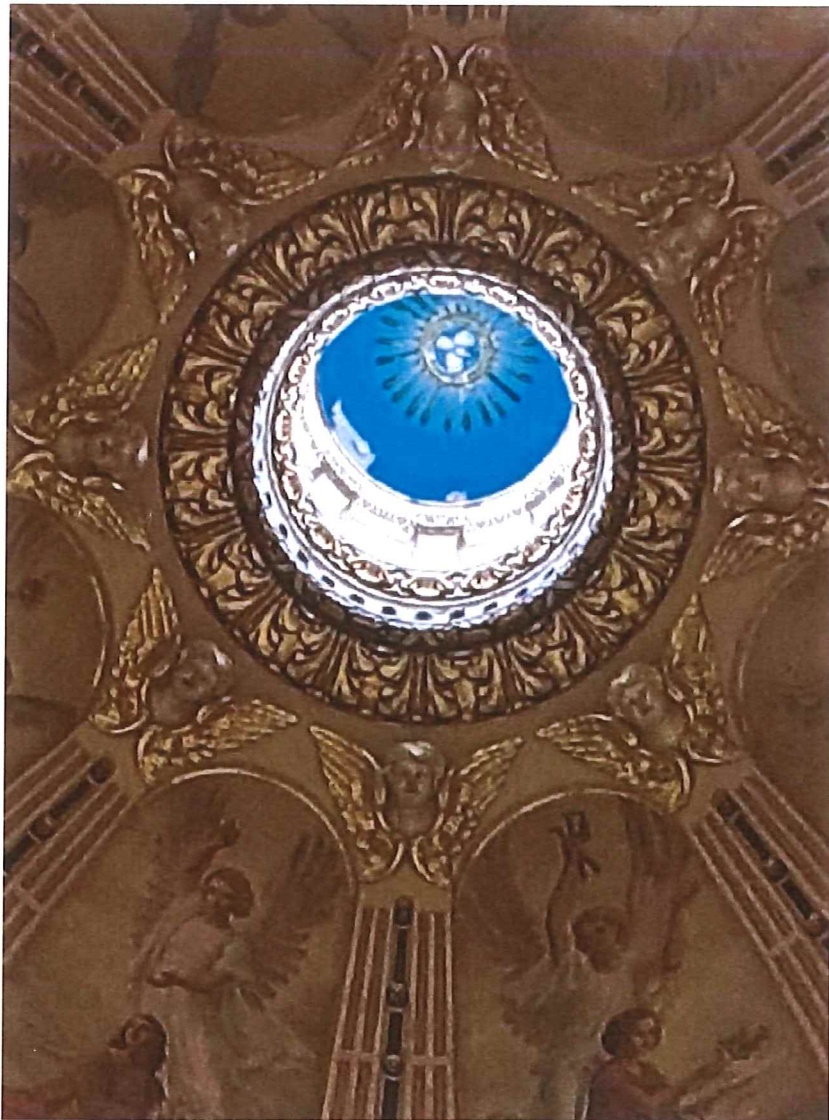
Figure 0-2 – Signs of water penetration in the form of flaking paint within the lantern.
