APS CSR 2024 Restawr - Ikona ta San Nikola

Conservation and Restoration –St. Nicholas, tempera on panel,
15th Century

St Nicholas Icon,
Tempera and gilding on panel, 15th Century
Naxxar Parish Museum

Restoration Method Statement

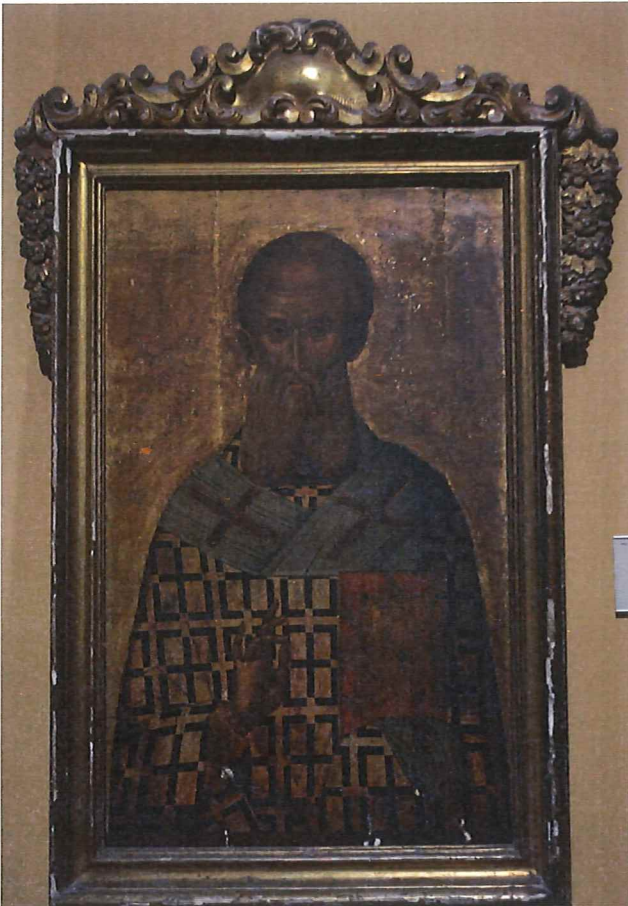
Figure 1. The icon of St. Nicholas, 15th Century, and Baroque style decorative frame, at Naxxar Parish Museum. Image, Restawr Arti, 2024.

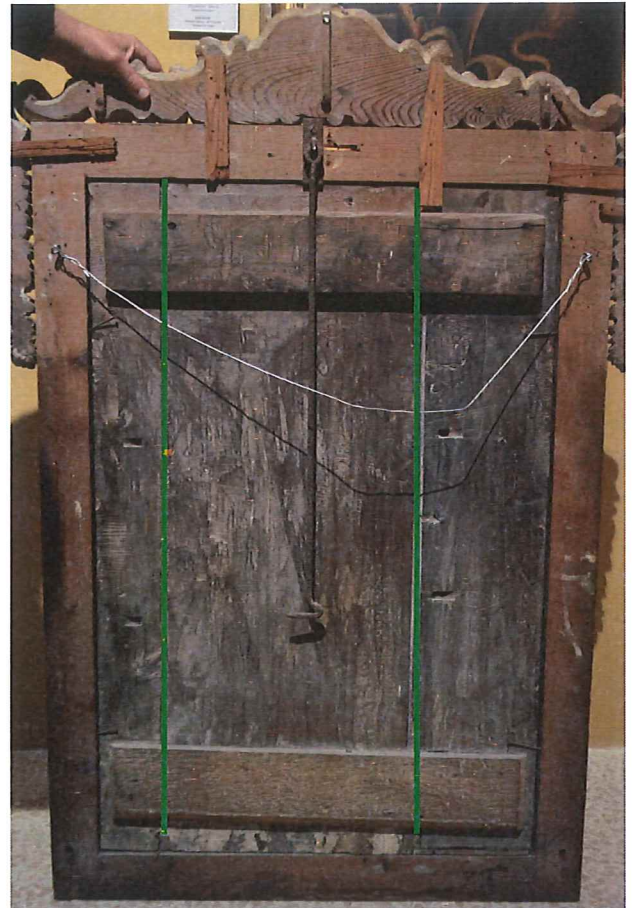
Figure 2. The backside of the panel painting, showing 3 separate panels (green lines mark the joints) and 2 horizontal cross bars to support the structure. Image, Restawr Arti, 2024.

Initiating from the panel support, the wood is in a very good condition. No severe losses or expansions were noted. Additionally, no insect damage was identified. The gypsum preparatory layer shows cracks and losses, mostly around the joints of the different panels (Figure 3.). Although, the canvas underneath serves as a support for the climatic movements and changes in the wood support, the different panels react differently to the climatic conditions, and hence these cracks and losses.

The focus will move to the lengthy and important treatments including the structural support. A temporary facing using Japanese paper will be applied to the pictorial layer to protect it from the handling that is required in the coming stages. Unstable gypsum layers and detachments will be adhered using a micro- emulsion adhesive diluted in alcohol. The adhesive will be injected under the layers, and eventually re-activated with a heat weave in order to have similar properties as the original. The painting will be re- stretched and tensioned to the original stretcher frame.

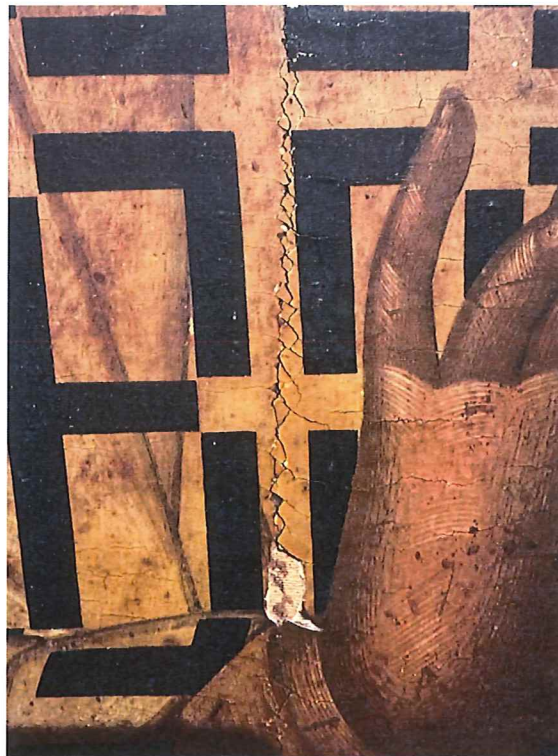
Figure 3. Detail showing the cracked and damaged gypsum and paint layers over the different panels. Image, Restawr Arti, 2024.

Lacunae and losses in the paint layer, and preparation layer will be infilled with fine quality *gesso di Bologna* and rabbit glue, and eventually levelled to match the rest of the painting's surface. Lacunae in the gilded areas will be prepared with red bolo and gilded with authentic gold leaf 23.75Kt. The new applied gold leaf will be aged in order to match the appearance of the original gold using glazes and stable retouching colours.

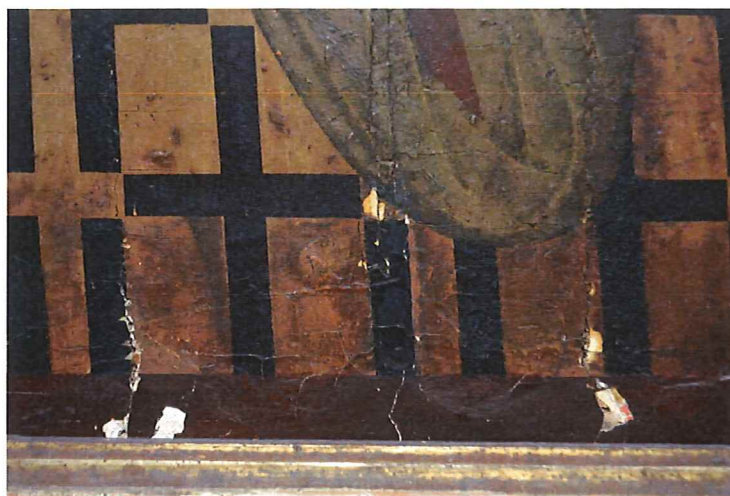
Most of the bottom part seems to be previously restored. Some areas are deformed and the retouching and overpaint has discoloured by time (Figure 4.).

Figure 4. Detail showing previous restoration material. Cracked gypsum and discoloured retouching and overpaint. Image, Restawr Arti, 2024.

The next stage will be to determine the best possible cleaning methodology or methodologies to remove the oxidised varnish, and altered restoration colours without affecting or touching the original paint and gilt surfaces. Various cleaning tests will be carried out to determine the mixture of solvents in liquid or gel state, and the methodology of cleaning. Dirt, grime, and gypsum infills from the previous restoration will be softened and removed by fine scalpel blades. This process will be carried out to expose the artist's original colours once again.

Prior to re- integration of the pictorial layer, a low molecular weight retouching varnish will be applied to separate the original colours from the retouching restoration colours while saturating the original colours. Then, the pictorial re- integration of losses of the pictorial layer will be carried out using stable varnish based colours purposely designed for restoration. This phase will unify the appearance of the painting. As a final step, the surface will be given a synthetic coating with a satin finish. A synthetic varnish will be chosen over a natural varnish since it is proven to be more stable to high temperatures and humidity levels, does not discolour by time, and also has an ultraviolet filter

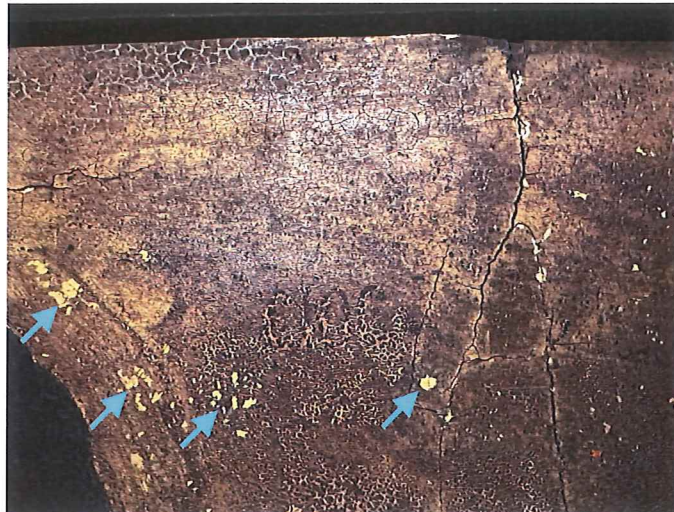
Overall, the painting has a dull appearance due to the oxidised coatings, dirt and grime that is present on the painted surface and gilt areas (Figure 5.). This is reducing dimensionality and certain details of the portrait and background.

Figure 5. Bright gold spots under the thick layers of oxidised coating. (Image, Restawr Arti, 2024).

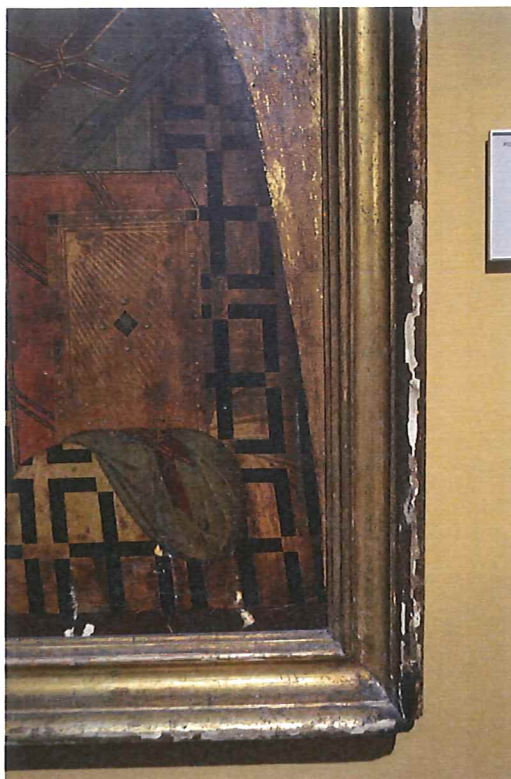
Overall, structurally, the frame is in a good condition. No major cracks or missing parts were observed. However, it was noted that some areas are missing the gypsum layer, and hence also the bole and gilding (Figure 6.). Around these lacunae, the edges are detached from the wooden support and unstable.

Figure 6. Detached, and lost gypsum layers. (Image, Restawr Arti, 2024).

Primarily, the unstable cracked, detached gypsum and gilded surfaces, will be re. adhered back to their support with an acrylic micro emulsion, fine brushes, and needles. Once the structure is in a good state of conservation, the process will move to the cleaning of the gilded surfaces. Various cleaning tests will be carried out to determine the mixture of solvents in liquid or gel state, and the methodology of cleaning the oxidised shellac coating, dirt and grime without affecting the gilt surface.

Any minor lacunae or cracks in the wood support will be reconstructed using a two component resin, purposely designed for art restoration as a substitute for wood and timber. Lacunae in the gypsum layer are to be infilled with a mix of *gesso di Bologna* and animal glue, and levelled to the adjacent surface.

Black and red bole, according to the original, will be applied over the new infilled areas, and other areas of missing original bole. Authentic silver leaf will be used to cover only the areas of missing original silver, and eventually burnished using agate stone. In order to integrate the appearance of the new silver with that of the original silver, layers of shellac will be applied until the same level is reached. Finally, a layer of final protective varnish (UV filtered) will be applied all over the frame to reduce the risk of future abrasions.

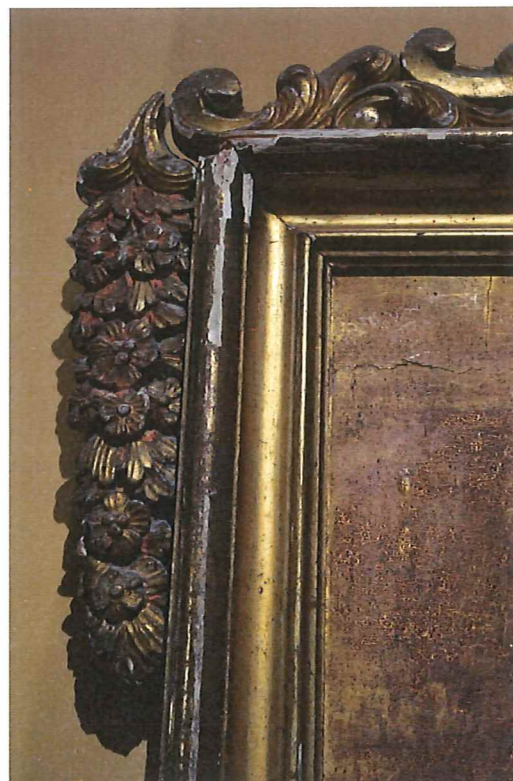
By time, or due to inappropriate handling or dusting, some areas of the gilt surface are abraded. Most of the intricate details of the sculptural motifs and the luminosity is hindered by the dirt deposit attached to the surface (Figure 7.).

Figure 7. Dull and abraded sculptural motifs. (Image, Restawr Arti, 2024).
