**Five marble ledger slabs
at the Old Parish Church Lija
Condition Assessment Report
and Proposed Maintenance Works**

Report drawn up by
Mr. Frank Chetcuti (Conservator-Restorer)

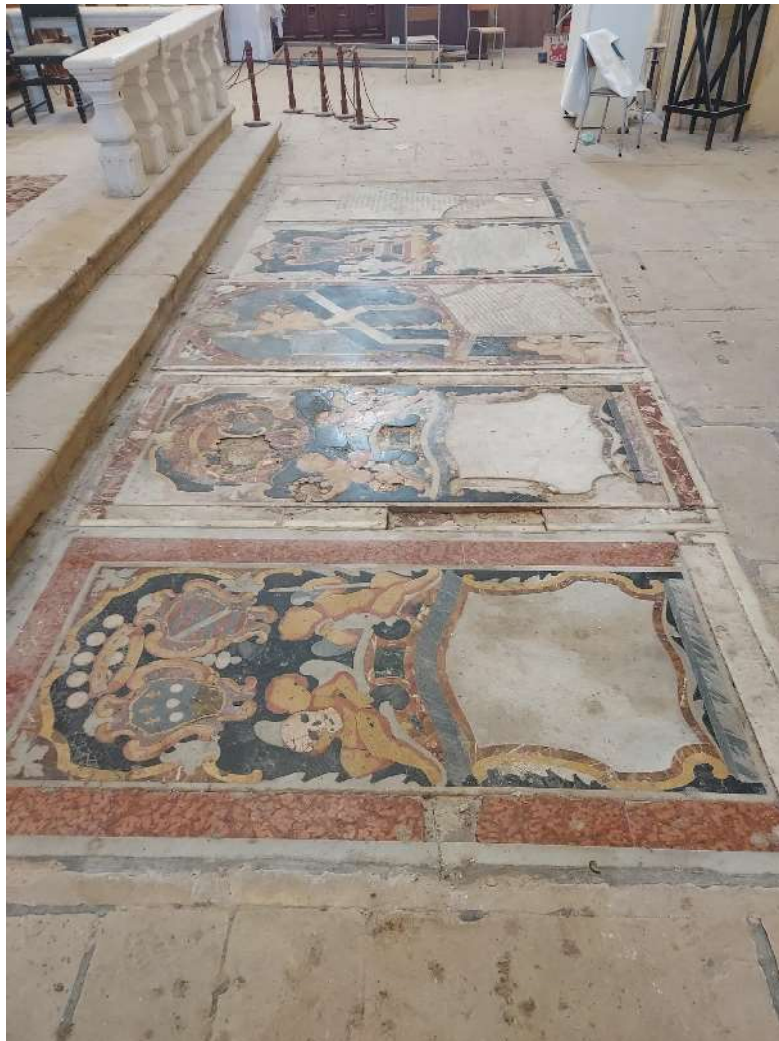
The marble ledger slabs are situated in the old parish church in Lija. They are laid together in front of the main altar. Some slabs are in a good state while others are heavily deteriorated. They all show signs of superficial soiling due to being stepped on. Colours seem to be faded out which could be the result of the superficial soiling and abrasions. Other slabs have marble integrations missing, cracked, or are depressed due to weight or uneven settlement beneath.

Photograph 1: General view of the five marble slabs.

It is being proposed that the ledger slabs are first documented both photographically and using a laser scanner. It is then proposed that the following interventions are carried out:

- i. The marble plaques will be cleaned from the superficial soiling.
- ii. Any crack in the marble will be injected with a fluid hydraulic grout.
- iii. Missing coloured marble pieces will be filled in using a lime-based mortar.
- iv. Any mortar integrations to be coloured.
- v. A protective layer will be given also to saturate natural colours.

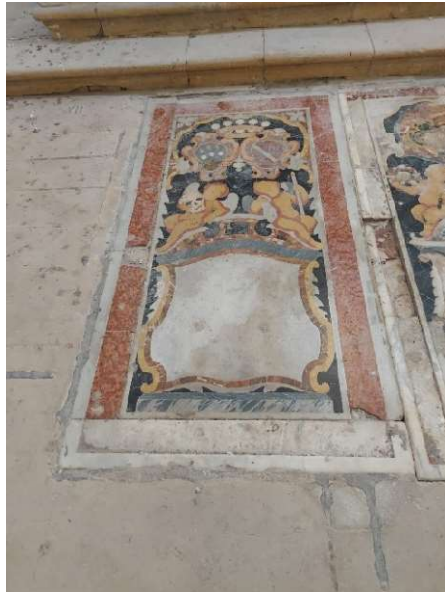
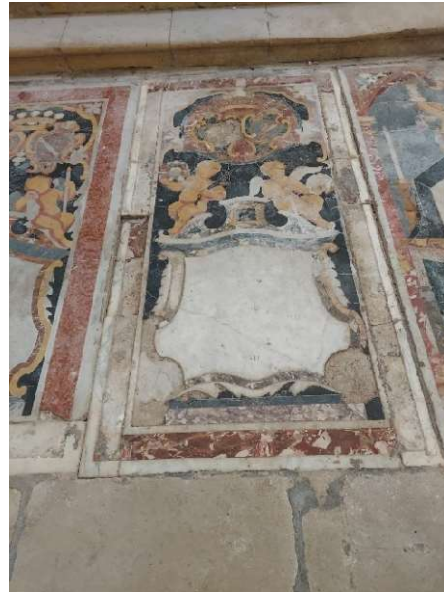
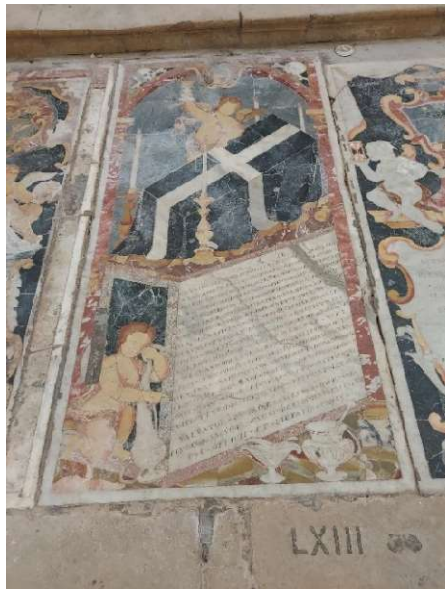
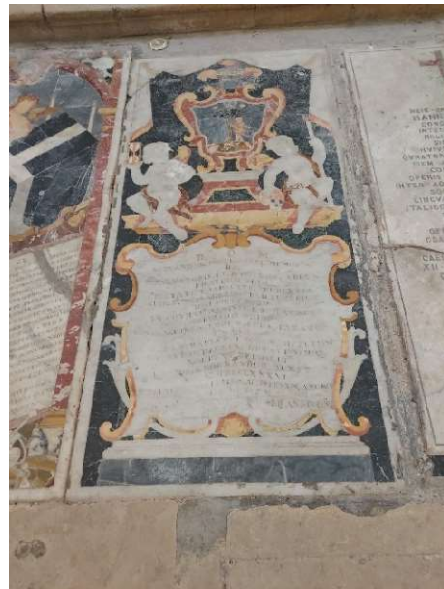
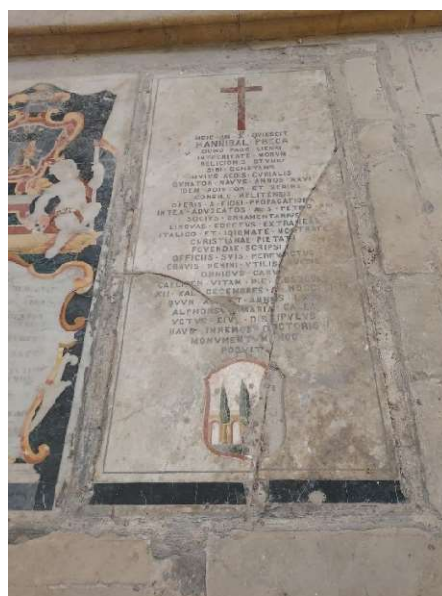
Photograph 2-6: General view of each marble slab.
