St Peter,
Oil and gilding on panel, 16th Century
Naxxar Parish Museum

Restoration Method Statement

Semira Gayle Bugeja (M.Sc., B.A. (Hons) (Melit.))

January 2025

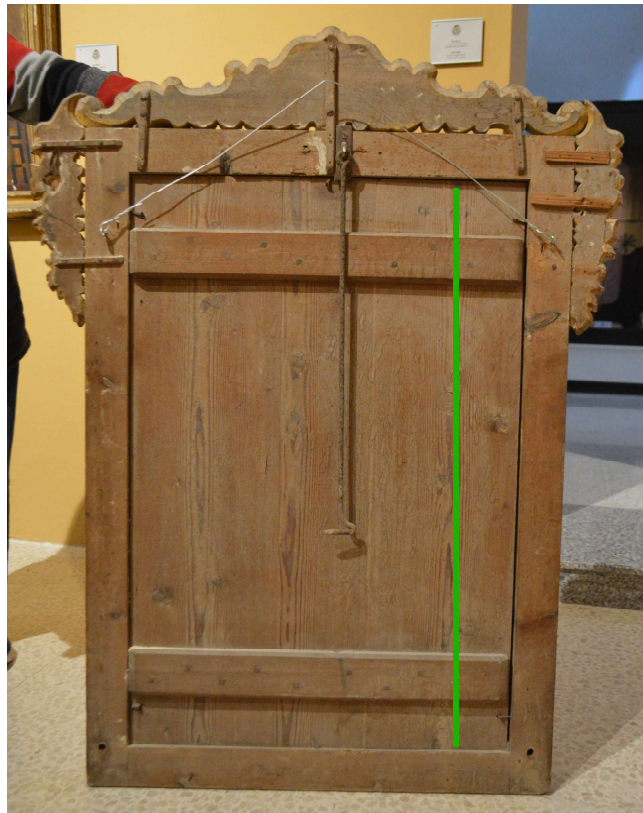
Figure 2. The backside of the panel painting, showing 2 separate panels (green line marks the joint) and 2 horizontal cross bars to support the structure. Image, Restawr Arti, 2025.

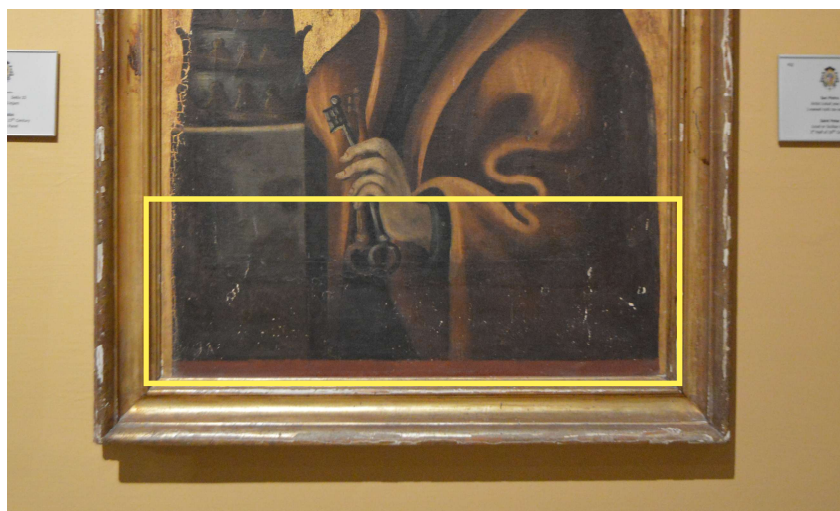
Initiating from the panel support, the wood is in a very good condition. No severe losses or expansions were noted. Additionally, no insect damage was identified. Although most of the gypsum preparatory layer seems to be in a good condition, minimal areas at the bottom right corner is suffering from gypsum detachments and losses. Most of the bottom part seems to be previously restored. The retouching and overpaint has discoloured by time (Figure 3.).

Figure 3. Detail showing the bottom area with patches of discoloured paint. Image, Restawr Arti, 2025.

The next stage will be to determine the best possible cleaning methodology or methodologies to remove the oxidised varnish, and altered restoration colours without affecting or touching the original paint and gilt surface. Various cleaning tests will be carried out to determine the mixture of solvents in liquid or gel state, and the methodology of cleaning. Dirt, grime, and gypsum infills from the previous restoration will be softened and removed by fine scalpel blades. This process will be carried out to expose the artist's original colours once again.

Prior to re- integration of the pictorial layer, a low molecular weight retouching varnish will be applied to separate the original colours from the retouching restoration colours while saturating the original colours. Then, the pictorial re- integration of losses of the pictorial layer will be carried out using stable varnish based colours purposely designed for restoration. This phase will unify the appearance of the painting. As a final step, the surface will be given a synthetic coating with a satin finish. A synthetic varnish will be chosen over a natural varnish since it is proven to be more stable to high temperatures and humidity levels, does not discolour by time, and also has an ultraviolet filter

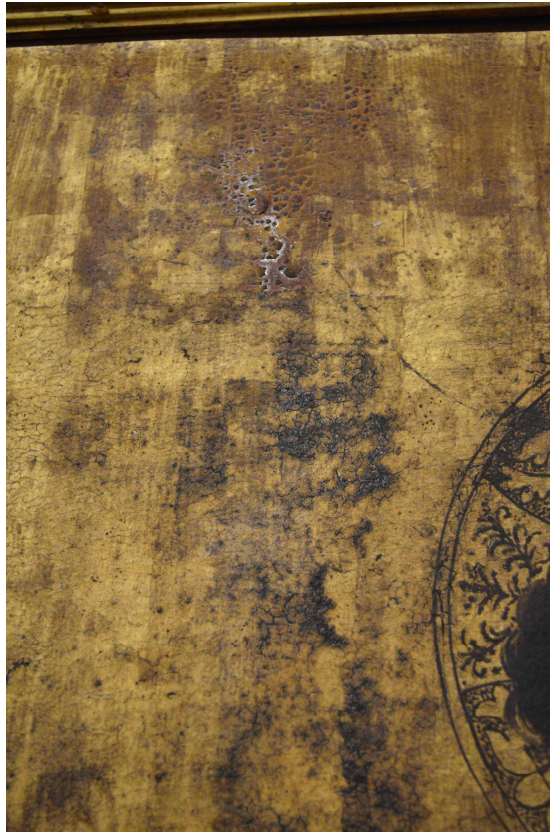
Different coatings or mixtures of coatings were applied by time, and can now be seen as dark orange and dark brown patches. Due to the thickness of the coatings and possibly fast drying, the thick layer shrunk and in some areas also affected the underlying paint and gold (Figure 4.). Overall, the painting has a dull appearance due to the thick oxidised coatings, dirt and grime that is present on the painted surface and gilt areas. This is reducing dimensionality and certain details of the portrait and background.

Figure 4. Detail of the gilt background showing very thick and oxidised coatings. Image, Restawr Arti, 2025.

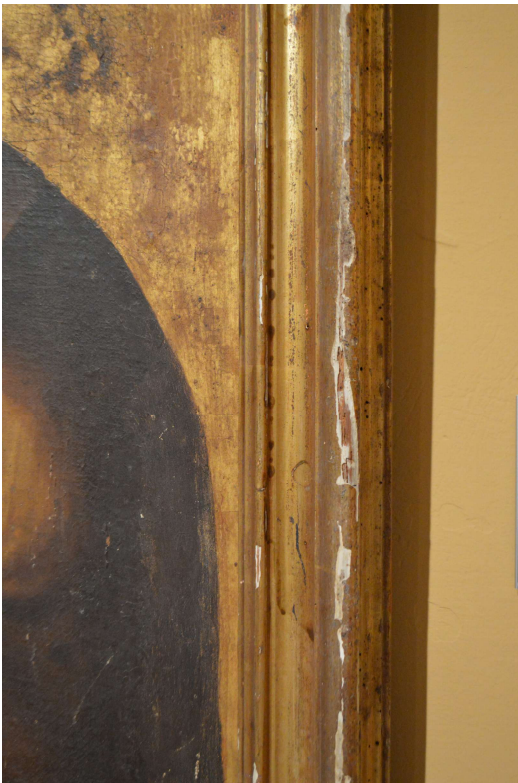
Overall, structurally, the frame is in a good condition. No major cracks or missing parts were observed. However, it was noted that some areas are missing the gypsum layer, and hence also the bole and gilding (Figure 5.). Around these lacunae, the edges are detached from the wooden support and unstable.

Figure 5. Detached, and lost gypsum layers. Image, Restawr Arti, 2025.

Primarily, the unstable cracked, detached gypsum and gilded surfaces, will be re adhered back to their support with an acrylic micro emulsion, fine brushes, and needles. Once the structure is in a good state of conservation, the process will move to the cleaning of the gilded surfaces. Various cleaning tests will be carried out to determine the mixture of solvents in liquid or gel state, and the methodology of cleaning the oxidised shellac coating, dirt and grime without affecting the gilt surface.

Any minor lacunae or cracks in the wood support will be reconstructed using a two component resin, purposely designed for art restoration as a substitute for wood and timber. Lacunae in the gypsum layer are to be infilled with a mix of *gesso di Bologna* and animal glue, and levelled to the adjacent surface.

Black and red bole, according to the original, will be applied over the new infilled areas, and other areas of missing original bole. Authentic silver leaf will be used to cover only the areas of missing original silver, and eventually burnished using agate stone. In order to integrate the appearance of the new silver with that of the original silver, layers of shellac will be applied until the same level is reached. Finally, a layer of final protective varnish (UV filtered) will be applied all over the frame to reduce the risk of future abrasions.

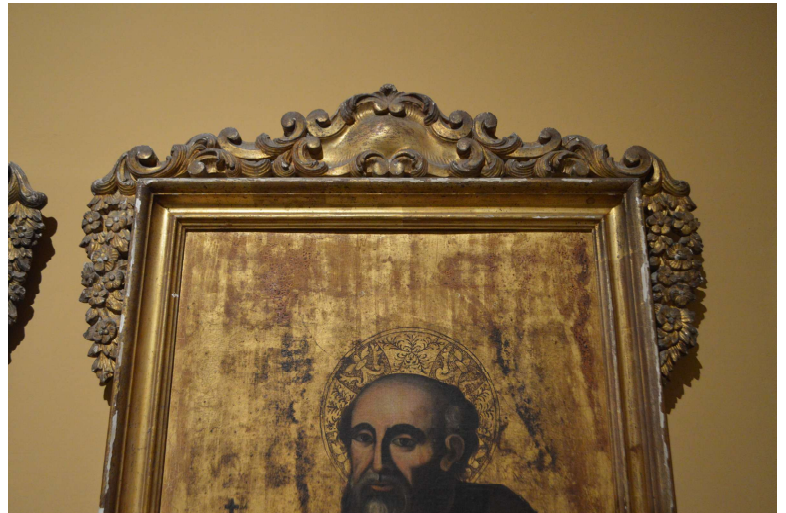
By time, or due to inappropriate handling or dusting, some areas of the gilt surface is abraded. Most of the intricate details of the sculptural motifs and the luminosity is hindered by the dirt deposit attached to the surface (Figure 6.).

Figure 6. Dull and abraded sculptural motifs. Image, Restawr Arti, 2025.
