**THE MAIN DOME
OF ST PUBLIUS
PARISH CHURCH
IN FLORIANA**

**METHOD STATEMENT FOR THE
EXTERNAL REPAINTING OF THE DOME
AND ITS LANTERN**

AUGUST 2020

**Perit Mark Azzopardi
B.E.&A., M.Sc.**

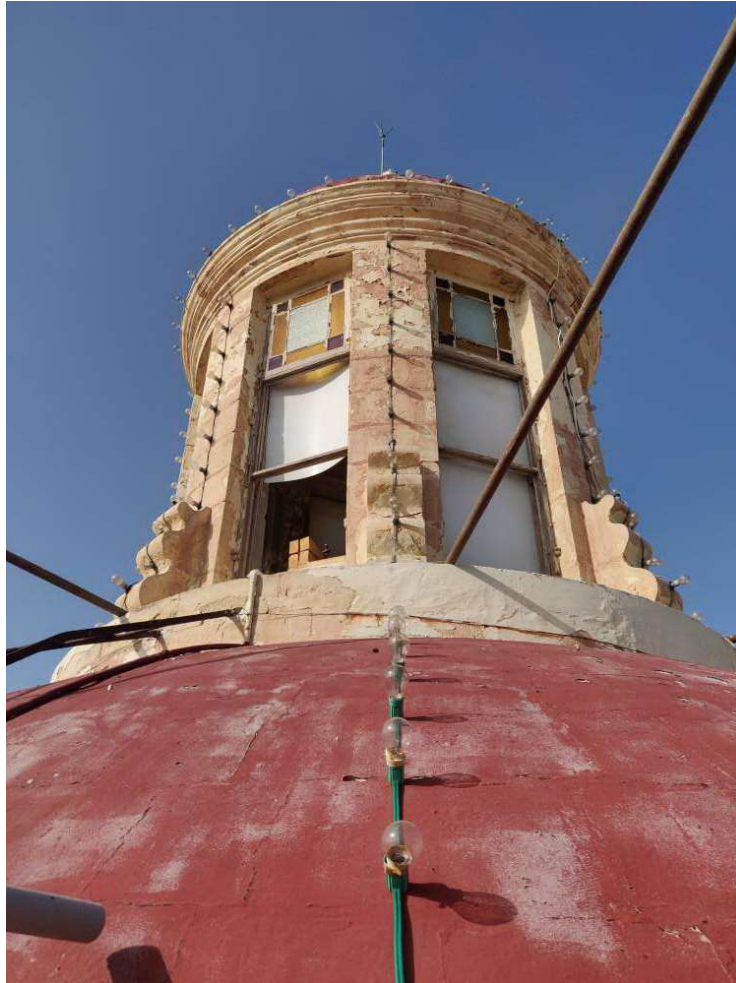
A visual and photographic inspection of the dome has ascertained numerous areas where the paint layers have cracked and where they have become detached.

Plate 4: The dome showing the numerous cracks in the paint layers.

- i) All paint layers be stripped off using manual means, in particular hand held tools. No orbital sanders are to be used. The stone surface be cleaned from any residual paint flakes where possible.
- ii) Any open joints or defects to the surface of the masonry be addressed using a lime-based mortar.
- iii) Copertinas and fillets (sgoxx) be laid areas where rain water ingress is liable to occur.
- iv) The surface of the dome and lantern as well as any horizontal surface at the base of the dome be painted with an impervious paint.
- v) All windows will be sanded down and repainted.

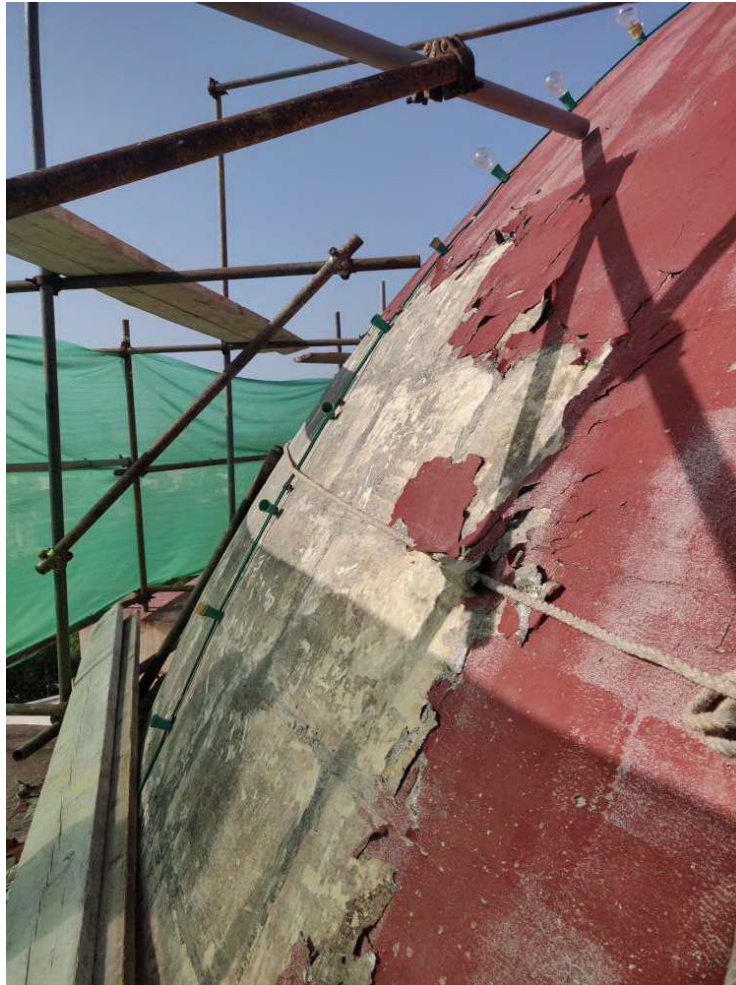
Plate 5: The peeling paint layers exposing the masonry dome underneath.

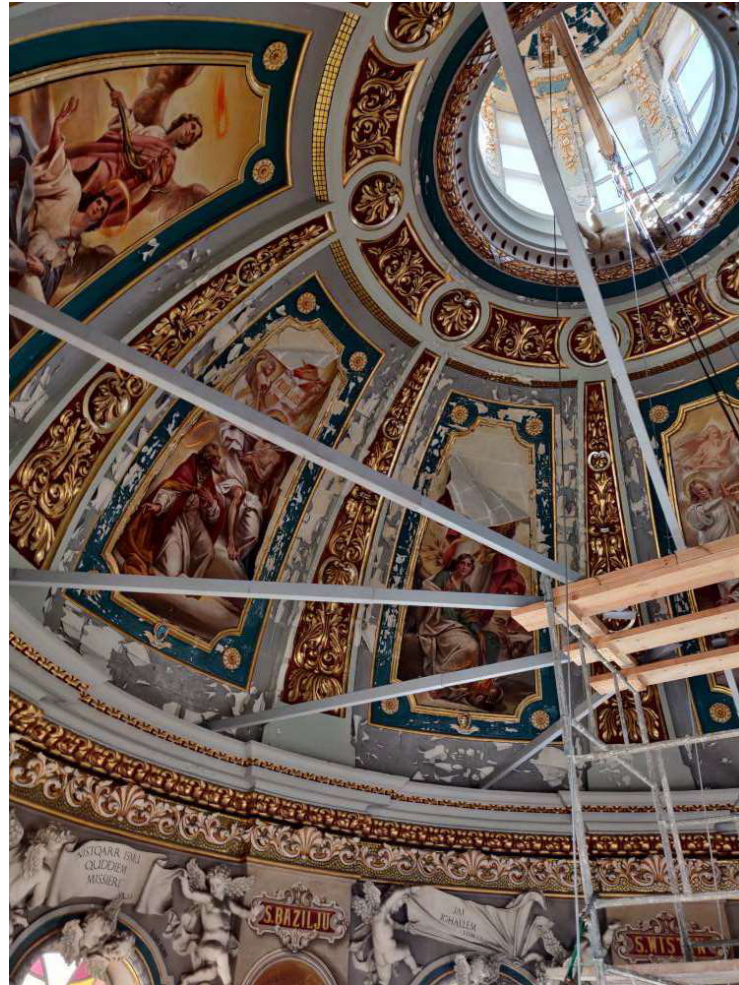
This has resulted in extensive damages to the painting on the inside of the dome seen as the detachment of interior paint layer, flaking and peeling as well as the detachment of the actual painted canvases.

Plate 6: Extensive damages on the inside of the dome.
