Parrocchia Santa Marija  
Qrendi

# KENNETH CAUCHI

06th March, 2025

## *Parish Church of the Assumption QRENDI*

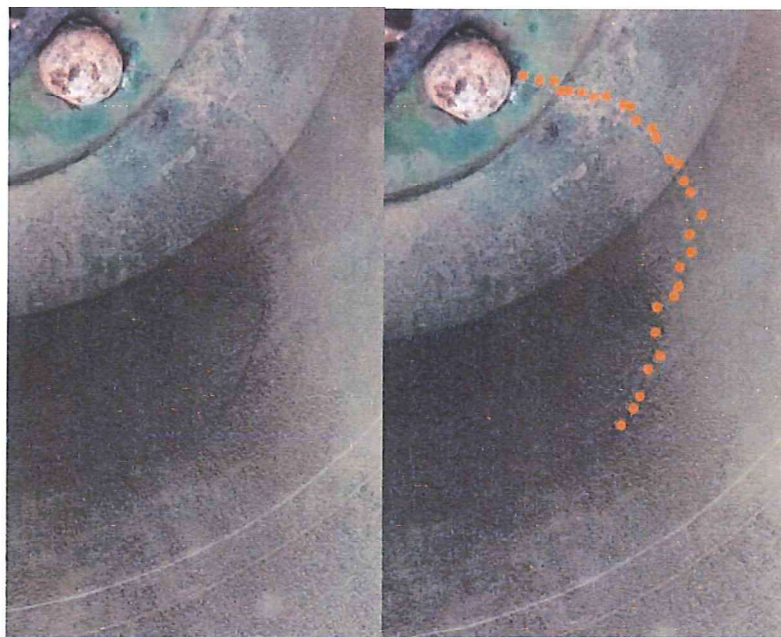
The bell is only adorned by a crucifix and is a typical bell cast by the Trigances. It seems to have a problem in its suspending crown however this could not be examined at close range. The bell has been drilled throughout its lifetime and suspended by what appears to be four ferrous bolts. These have rusted in due course and two of these appear to have cracked the bell – at this moment in time without significant loss of sound. It is not known whether the other two bolts have done the same. Images hereunder referred.

Images above indicate the crack coming from the first bolt, spanning over the shoulder of the bell and down the waist and right, the same crack highlighted for the scope of this report.

It is here being proposed that bell is underpinned on a sturdy timber pallet and extending beams (travetti) to shift the weight of the bell from the suspending fittings onto its soundbow. The bell is to be released from its ferrous fittings cautiously to ensure that the cracks are not propagated further during handling. The bell is to be lifted and lowered by crane from the belfry. Shipping of the bell to an appropriate and specialized bell welding company to be diagnosed further for any further cracks through non-invasive dye penetrating techniques. This will either confirm what we know already or worse, establish that the cracking is deeper and more extensive. Assuming that the cracks are those detected and exhibited above, a crack arresting bore is drilled ahead of the end of each crack as a precaution against further crack propagation (see image hereunder).

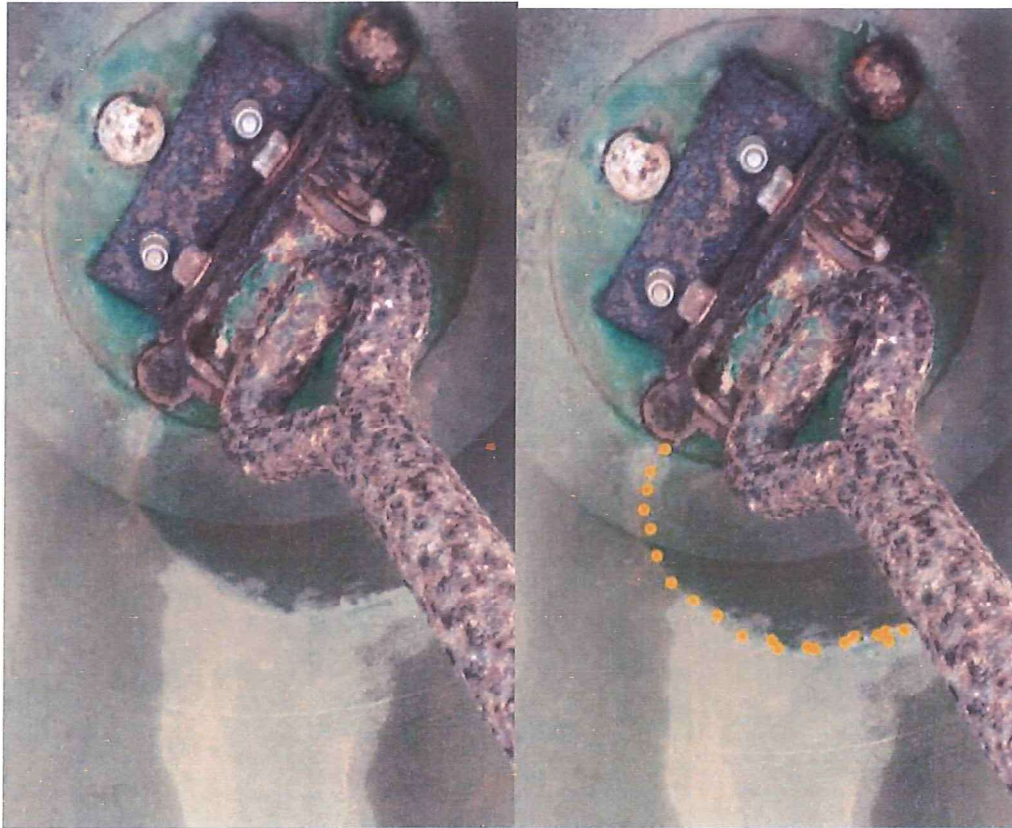
Images above indicate the crack coming from the second bolt, spanning over the shoulder of the bell and across the waist and right, the same crack highlighted for the scope of this report. Note the whitened area below the crack indicating surface change due to what is presumably a change in the surface deposits due to moisture penetrating through the crack.

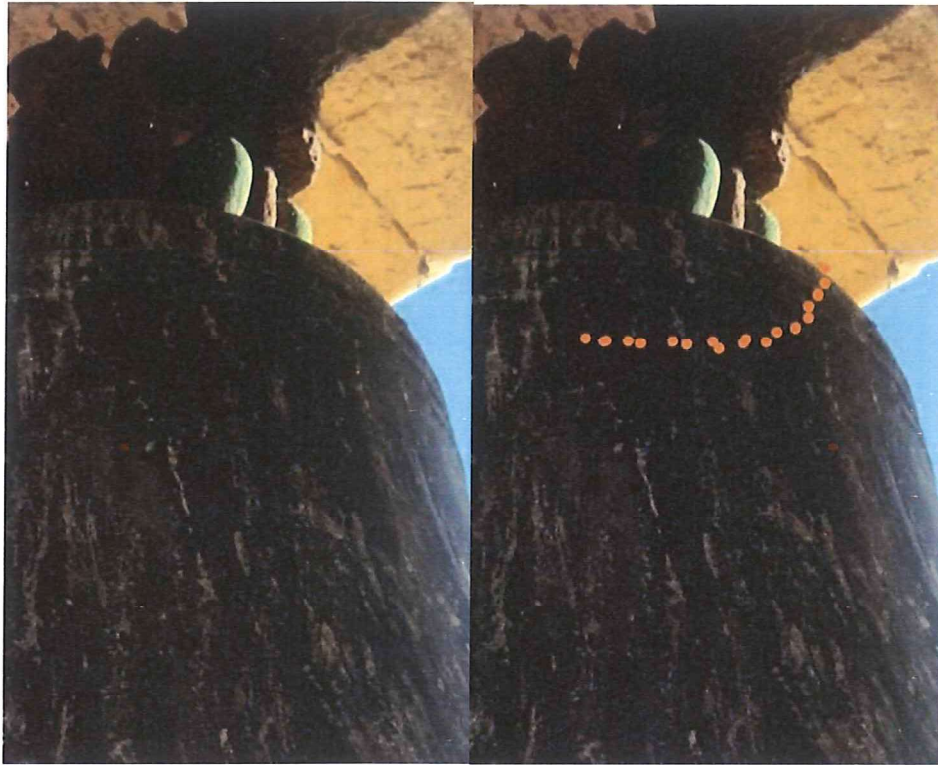
Images above indicate the crack coming from the second bolt, spanning over the shoulder of the bell and across the waist and right, the same crack highlighted for the scope of this report. Note that these images show the same crack in the two images before these however this time from the outside of the bell.
