Method Statement & Quotation

*Institution of the Eucharist. Oratory of the Blessed Sacrament,
Zejtun Parish Church*

Object: Oil on Canvas

Subject: Jesus Giving his Body in the Last Supper

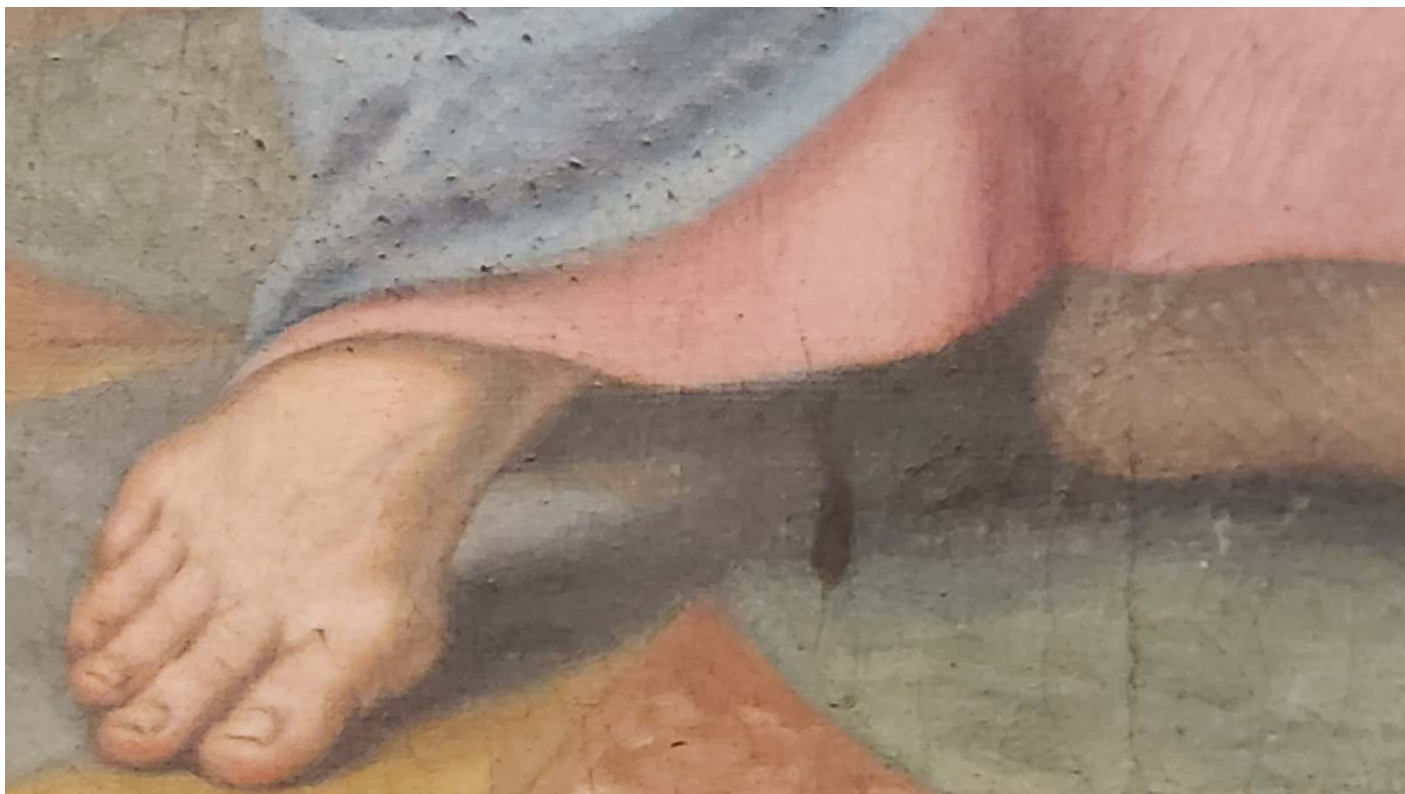
- The paint layer exhibits several cracks and cupping.
- A thick layer of surface dust and dirt can also be found on the surface of the painting.
- A thin layer of varnish was applied to the painting in the past. The varnish has altered slightly the colours used by the artist.

Details of flaking paint layer and cracking.

- Removal of the canvas from its auxiliary frame., so that the former can be placed face-down and cleaned from the back.
- Any deformations will be treated on the heated low-pressure table where a uniform and controlled pressure is applied on the canvas to bring down these deformations. At the same time, the areas where the paint layer is flaking and cupping will be consolidated from the front.

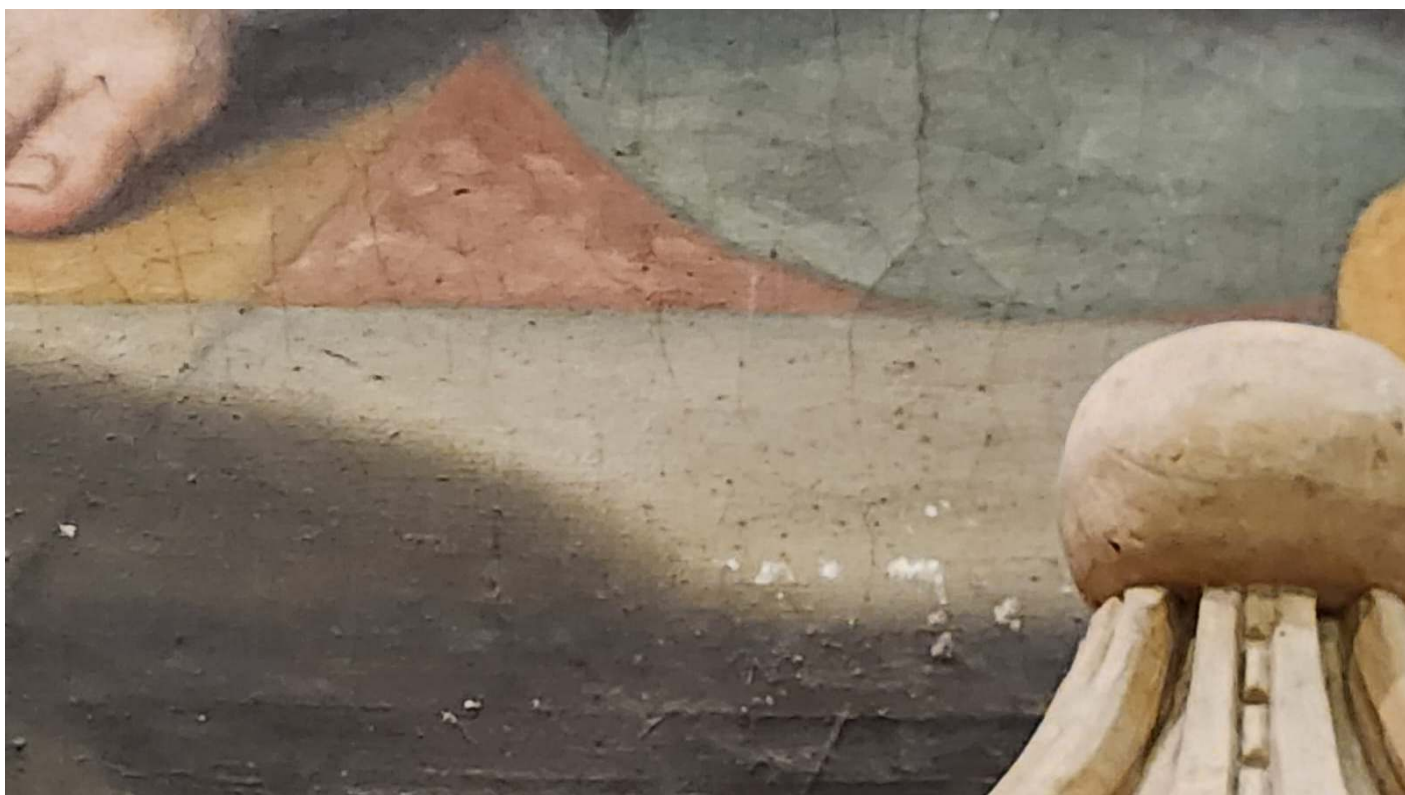
- There are some minor interventions of restoration that have occurred in the past, which can be seen more clearly under UV light.
- In the bottom section of the painting one can observe a number of losses and abrasions in the paint layer.
- There is the presence of blooming especially in the central section of the painting. This looks like a cloud laying on top of the paint layer. This blooming is usually the result of lack of ventilation which causes an accumulation of humidity in the interested areas.
- The decorative frame is gilded and in some areas one can notice losses in the gilding, abrasions and cracks. The frame has been drilled in place causing it to be perforated in a number of areas.

More details of losses in paint layer, and possible presence of mould.

- Removal of surface dirt and dust.
- Removal of any applied varnish and any other surface residues.
- Removal of any traces of mould from the bottom section.

- Removal of the facing that was applied to protect the paint layer during restoration.
- Infilling of any losses followed by levelling.
- Retouching and application of protective varnish.
- The decorative frame will need to first undergo structural repairs in the wood, followed by a reconstruction of the missing pieces. The missing gesso will need to be applied, levelled and textured on top of the original. The areas where the gilding has been lost will need to be regilded.

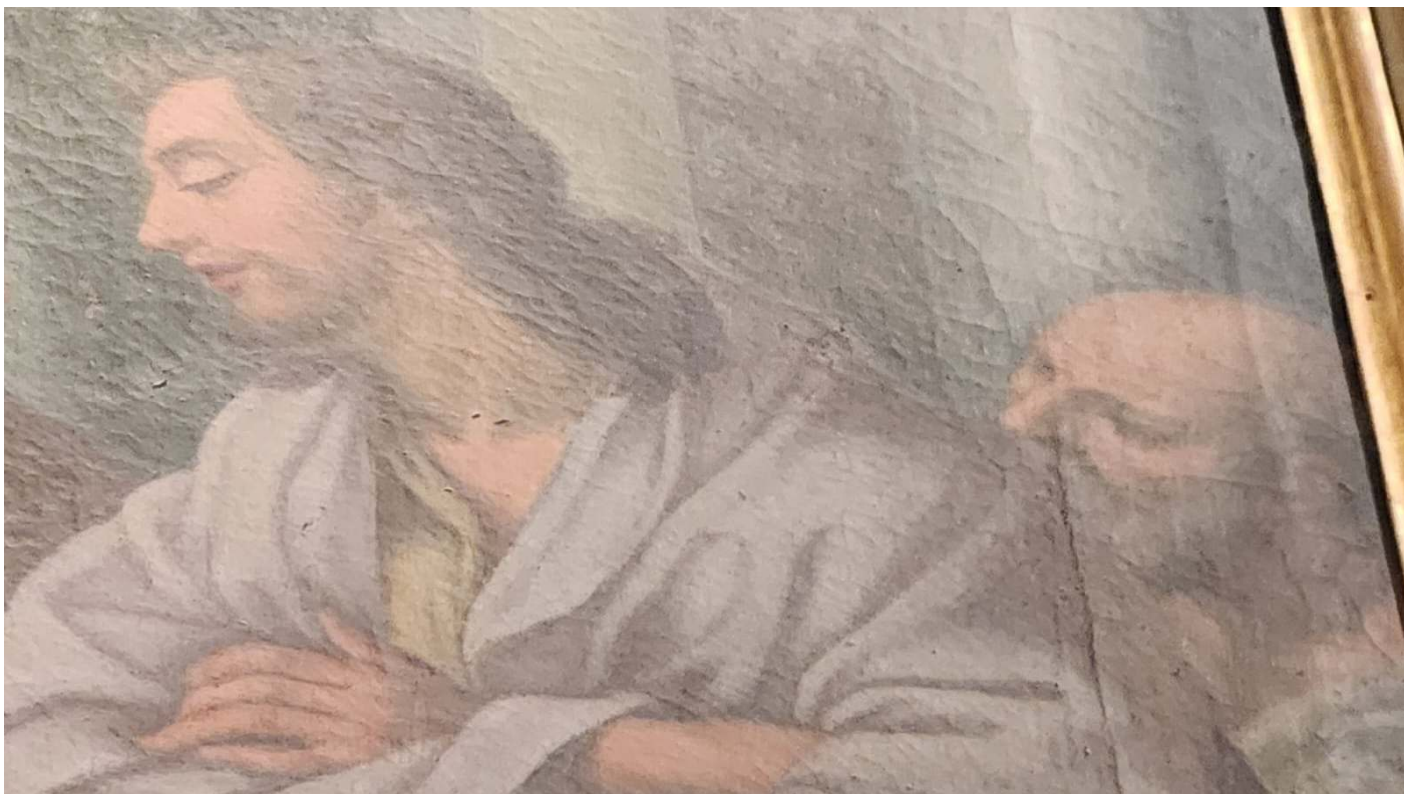
- The painting exhibits an original canvas which has never been relined. It has several deformations and manifests sagging in the bottom section. The canvas is also loosely stretched around its auxiliary frame, which is made evident under raking light.

- Around the perimeter of the painting one can notice also a number of stretcher marks. This is also evident in the middle section of the painting due to a horizontal wooden member of the auxiliary frame making contact with the canvas from the back.

Deformations and stretcher marks in the canvas seen under raking light.

- Following this intervention, it will be clearer whether the canvas needs strip-lining or relining.
- It will have to be considered whether the auxiliary frame can reused or has to be remanufactured. If it can be re-used it might require a disinfection treatment followed by any structural interventions. Some of the interventions would be to make it bevelled to avoid the recurring problem of the stretcher marks on the canvas, and to make it expandable to allow for proper stretching as necessary.

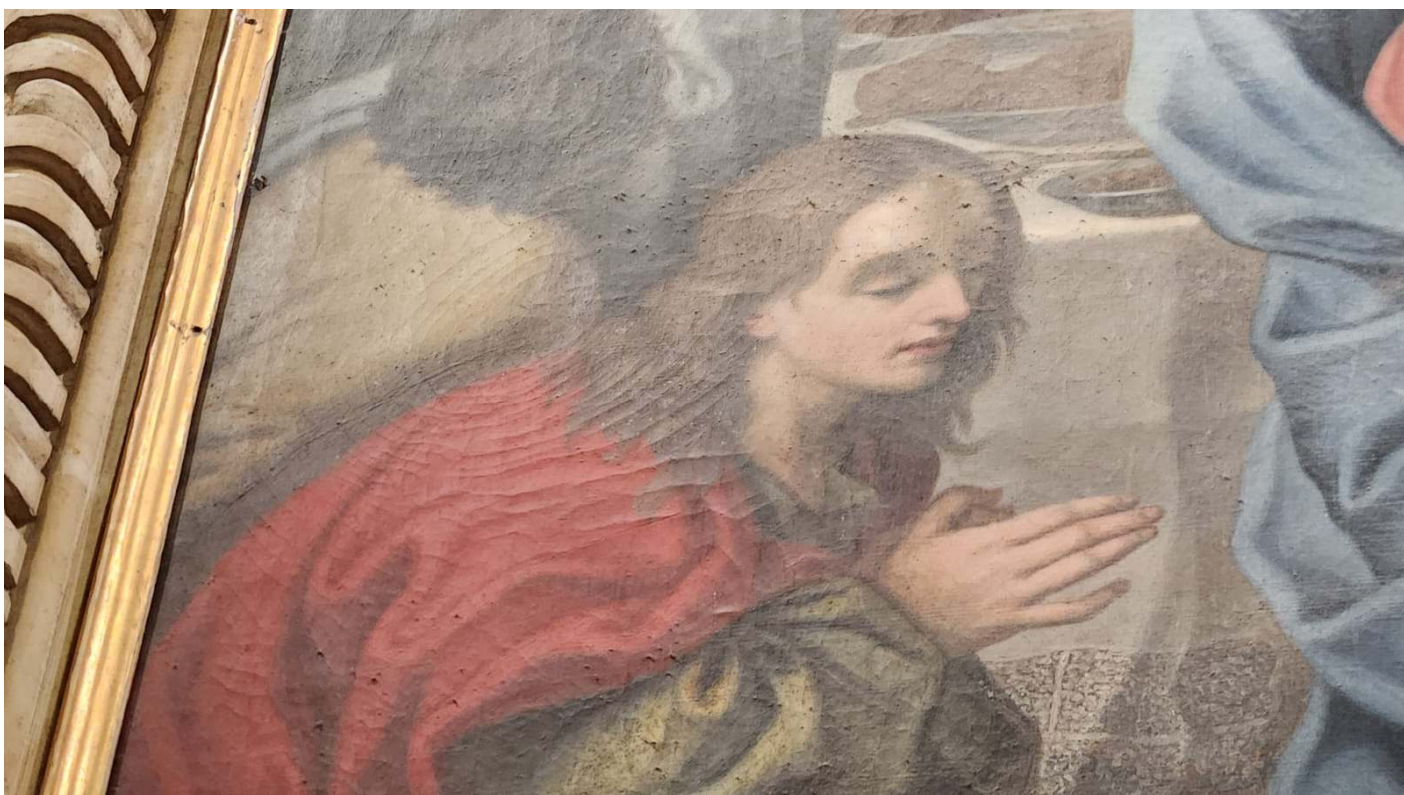
Detail of craquelure in the paint layer and deformations.

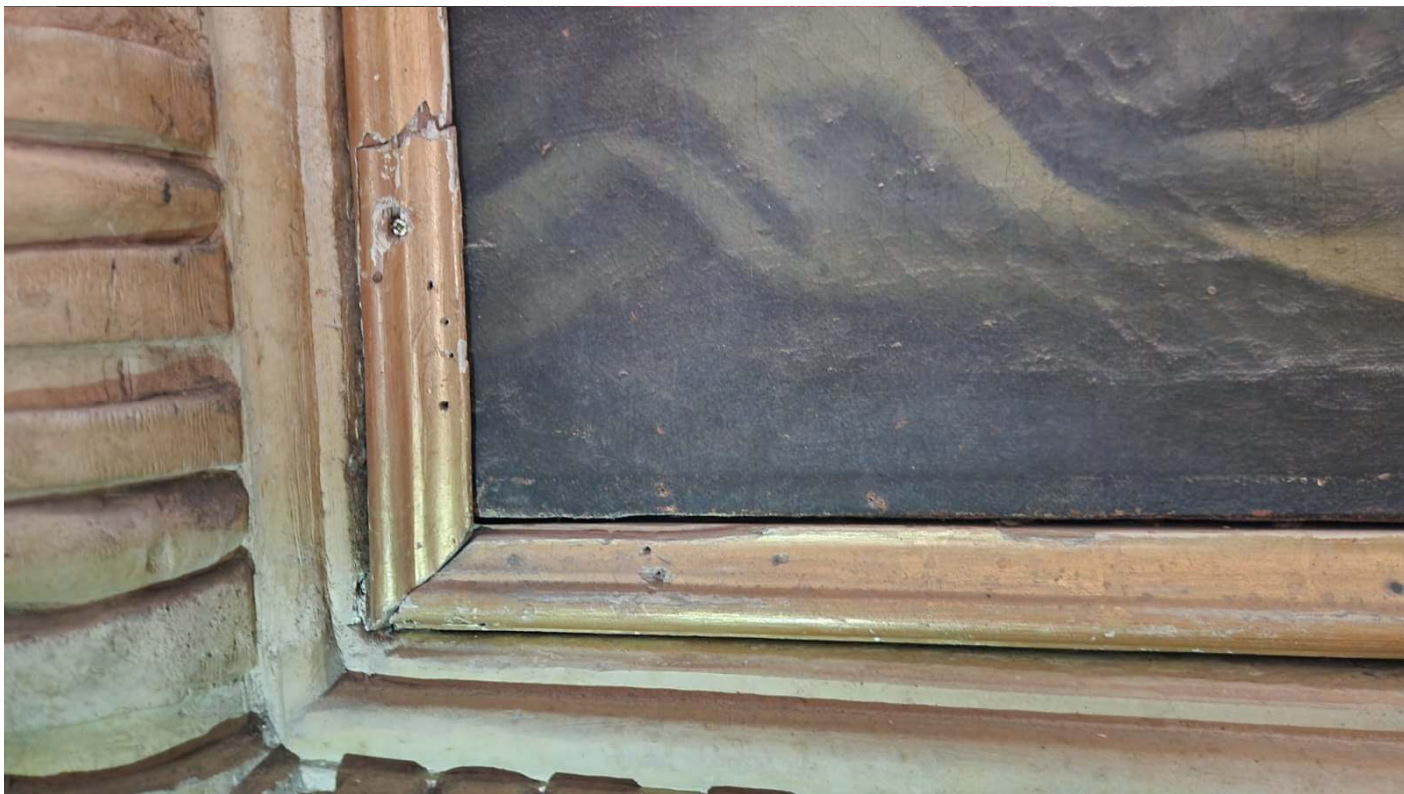
Detail of structural damage and loss in gilding in the decorative frame.

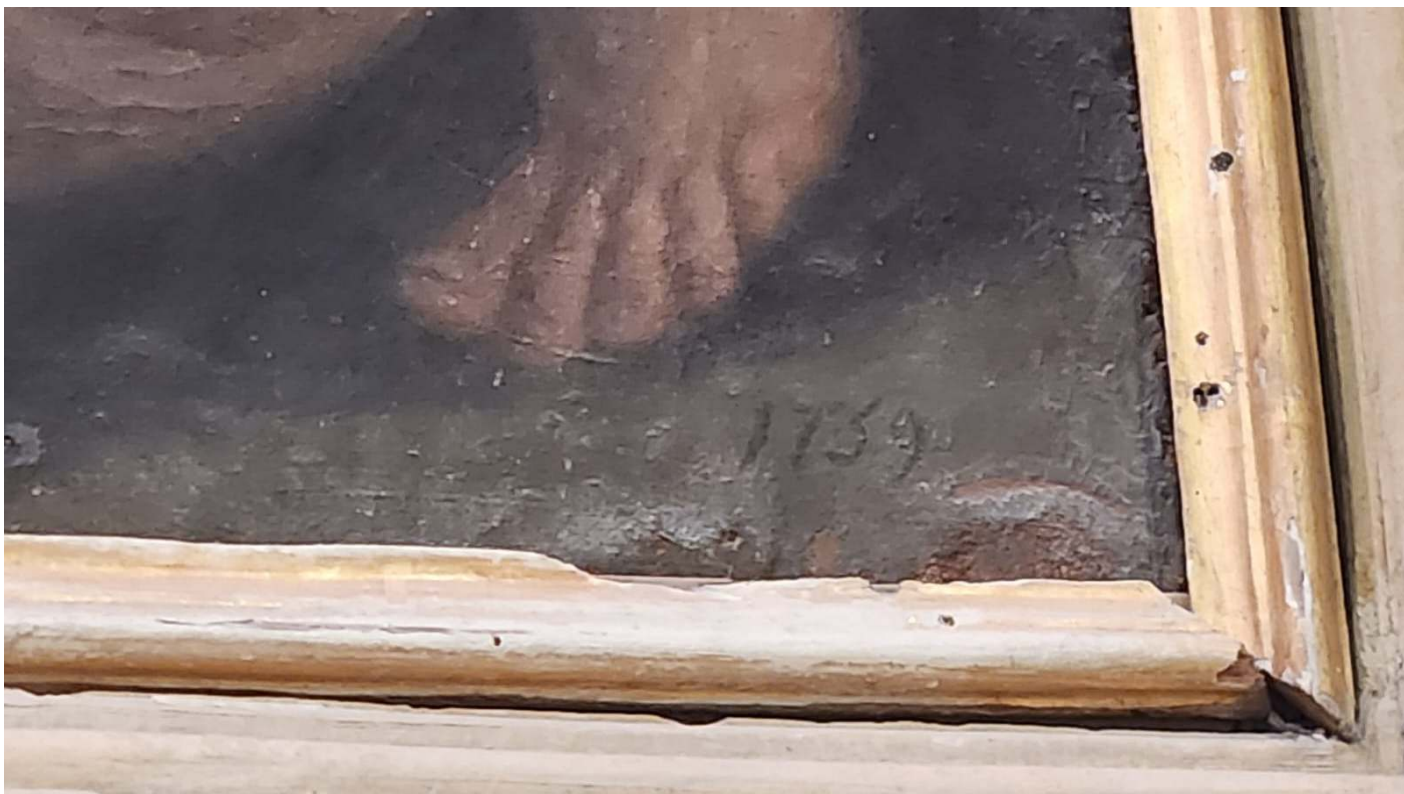
Detail of the dating of the painting, an area which is damaged by paint losses.

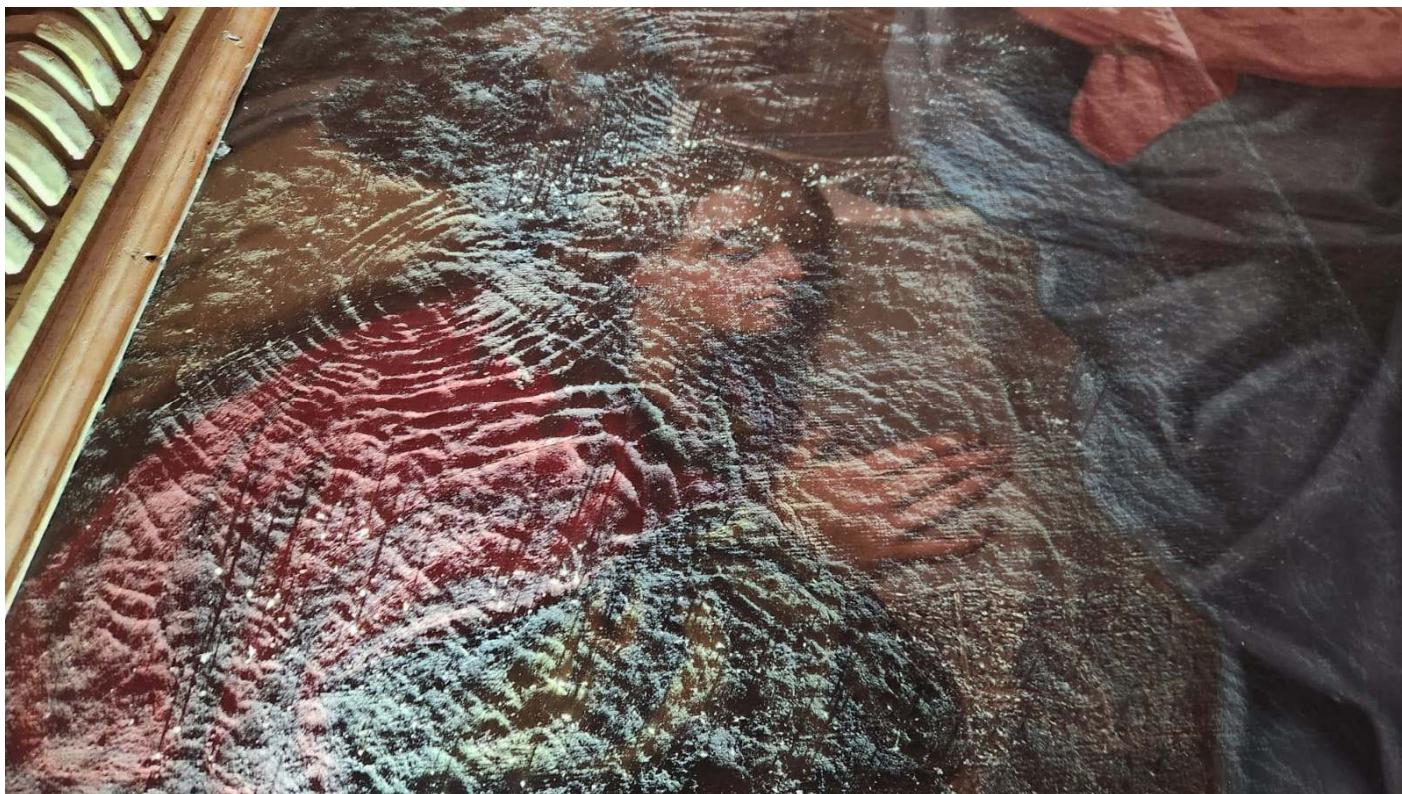
Detail of the deformations present in the canvas under raking light.

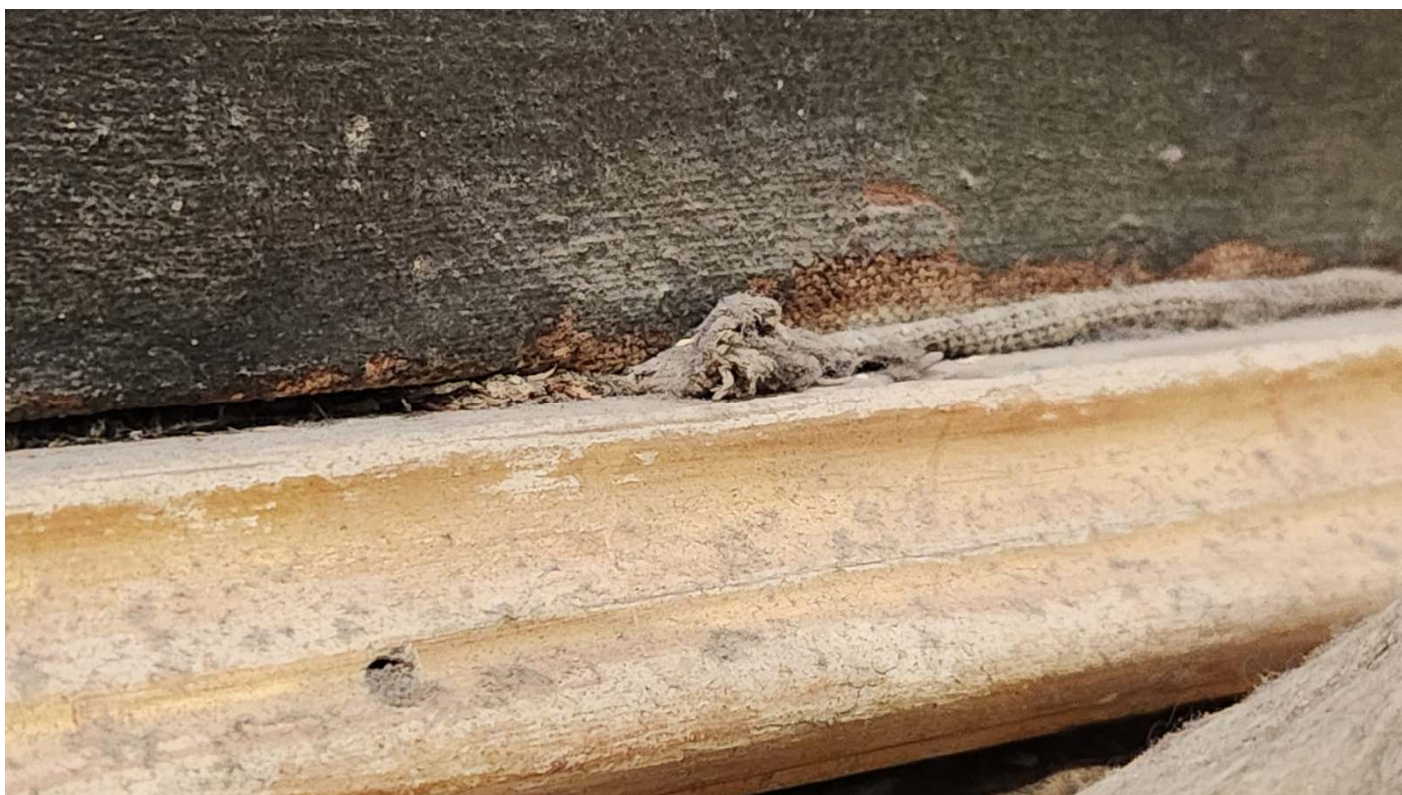
Detail of accumulation of dust and losses in the bottom section of the painting.

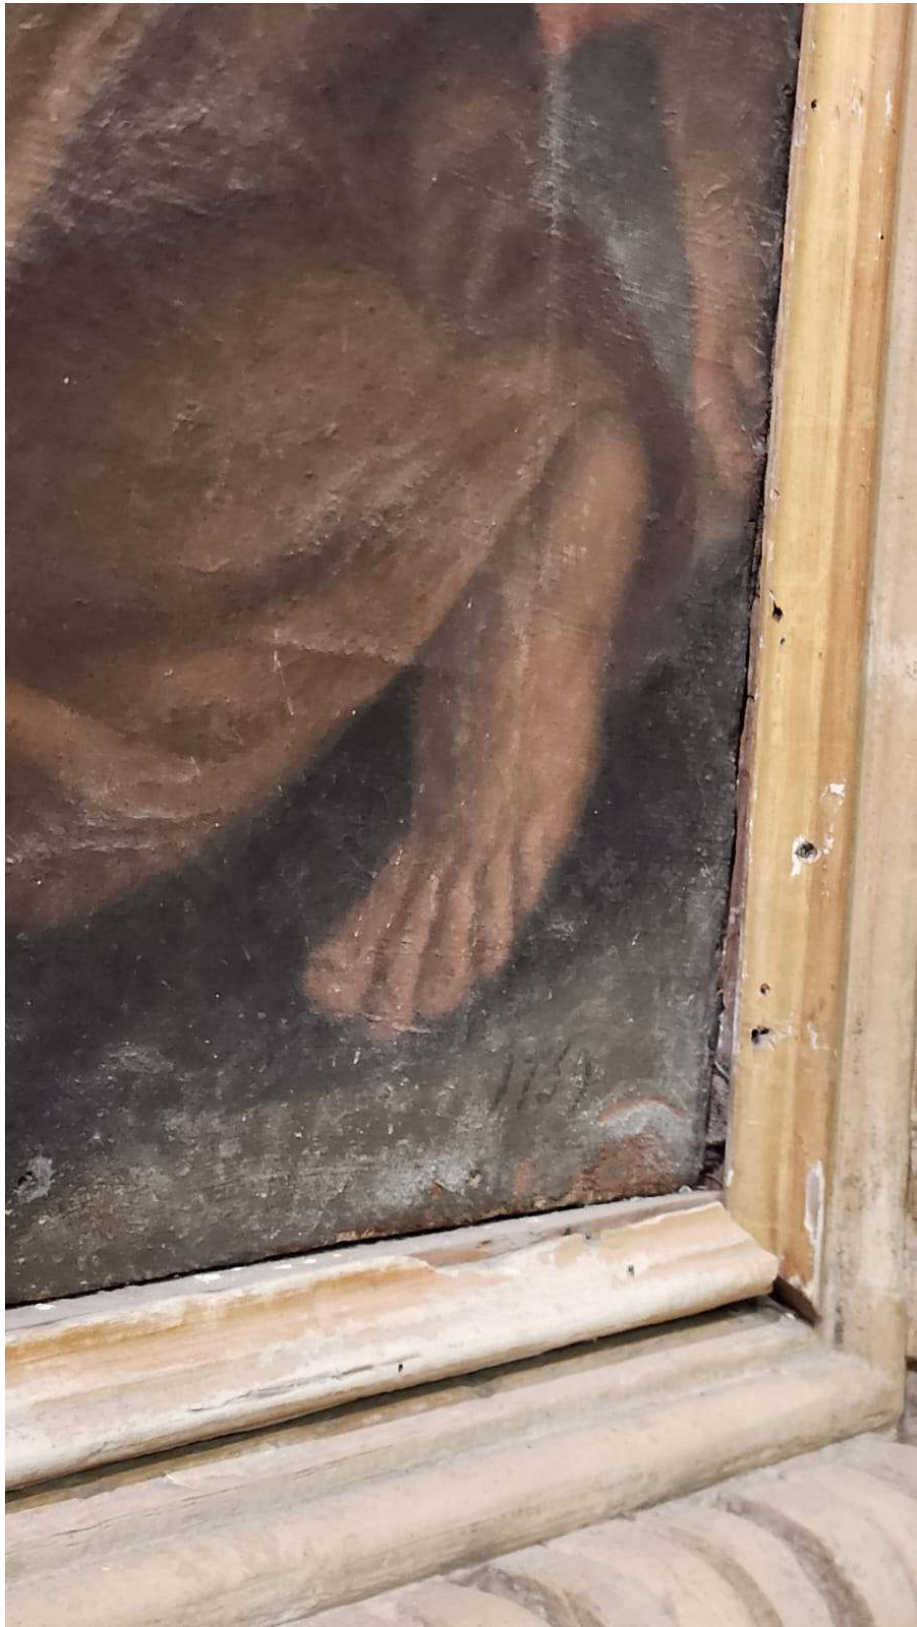
Detail of holes that have been drilled inside the decorative frame, and also traces of what might be mould on the surface of the canvas.

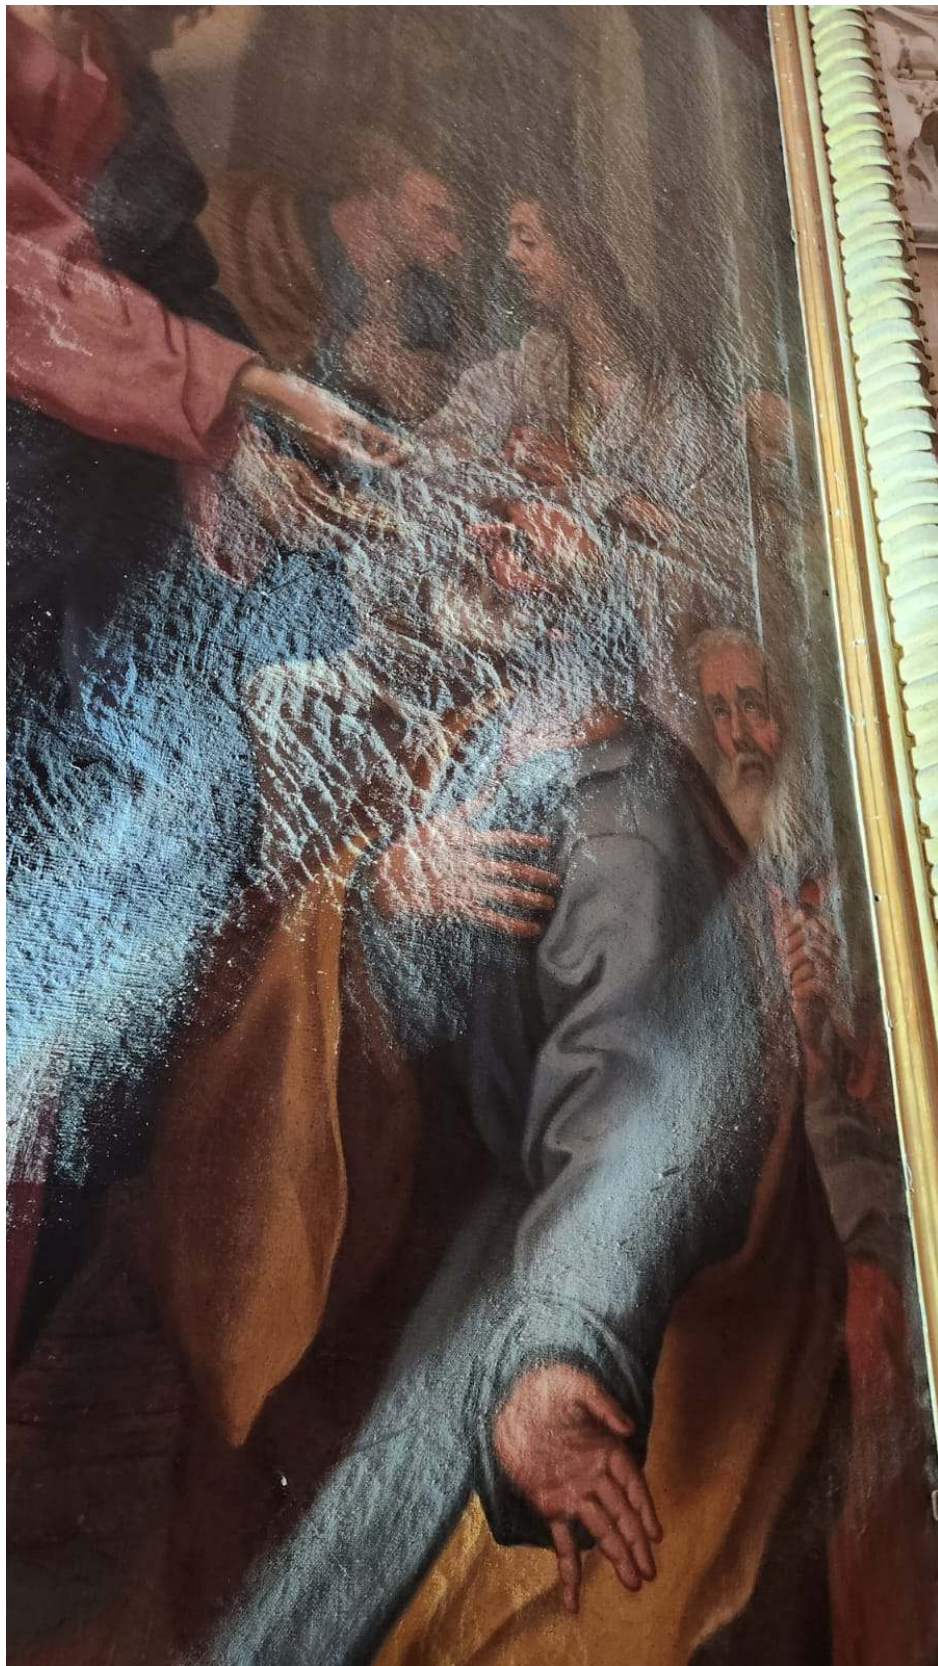
More details of the deformations in canvas and cupping of the paint layer.
