STATE OF CONSERVATION AND TREATMENT PROPOSAL
FOR THE IMPORTANT PAINTINGS AND FRAMES DEPICTING
THE VIA SAGRA LOCATED INSIDE THE BASILICA OF MOSTA
DEDICATED TO THE ASSUMPTION OF THE VIRGIN MARY

10th January 2025

ATELIER DEL RESTAURO
CONSERVATION & SCIENTIFIC ANALYSIS OF WORKS OF ART

QUOTATION

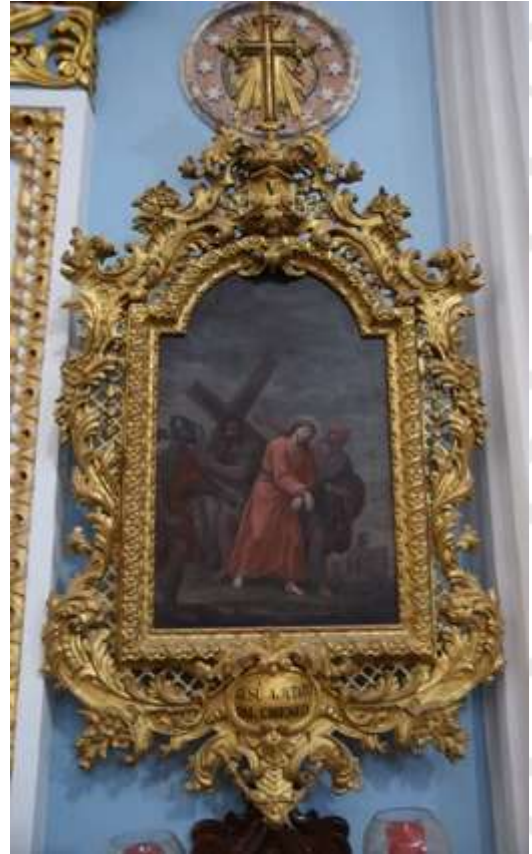
The ornate gilded and sculptured wooden frames have been decorated using the water gilding technique. During preliminary investigations the state of conservation of all the frames was assessed. In general the surface decoration of the frames was found in a bad state of conservation with the surfaces covered in dust and grime along with detachments, abrasions and losses of the gilding. Furthermore dust and grime are accumulated on the surface. The gold turned dark especially because in the past these were lit by oil lamps and therefore the soot has covered the gold gilded surface.

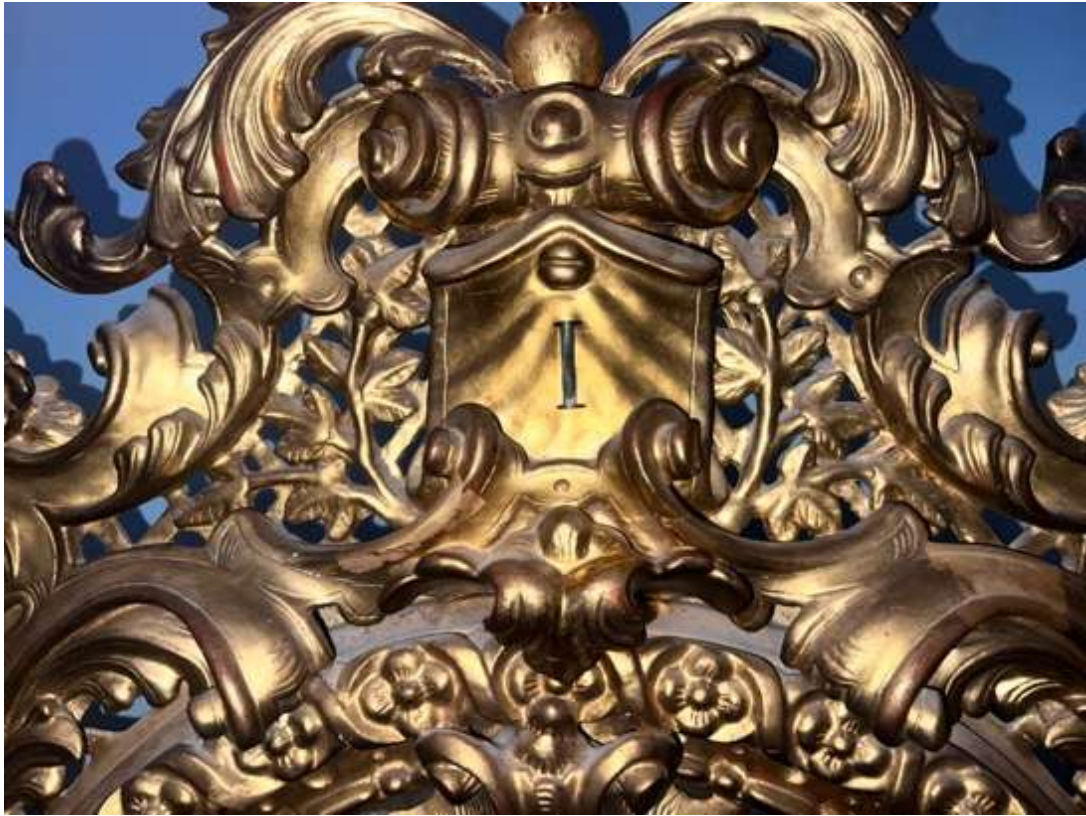
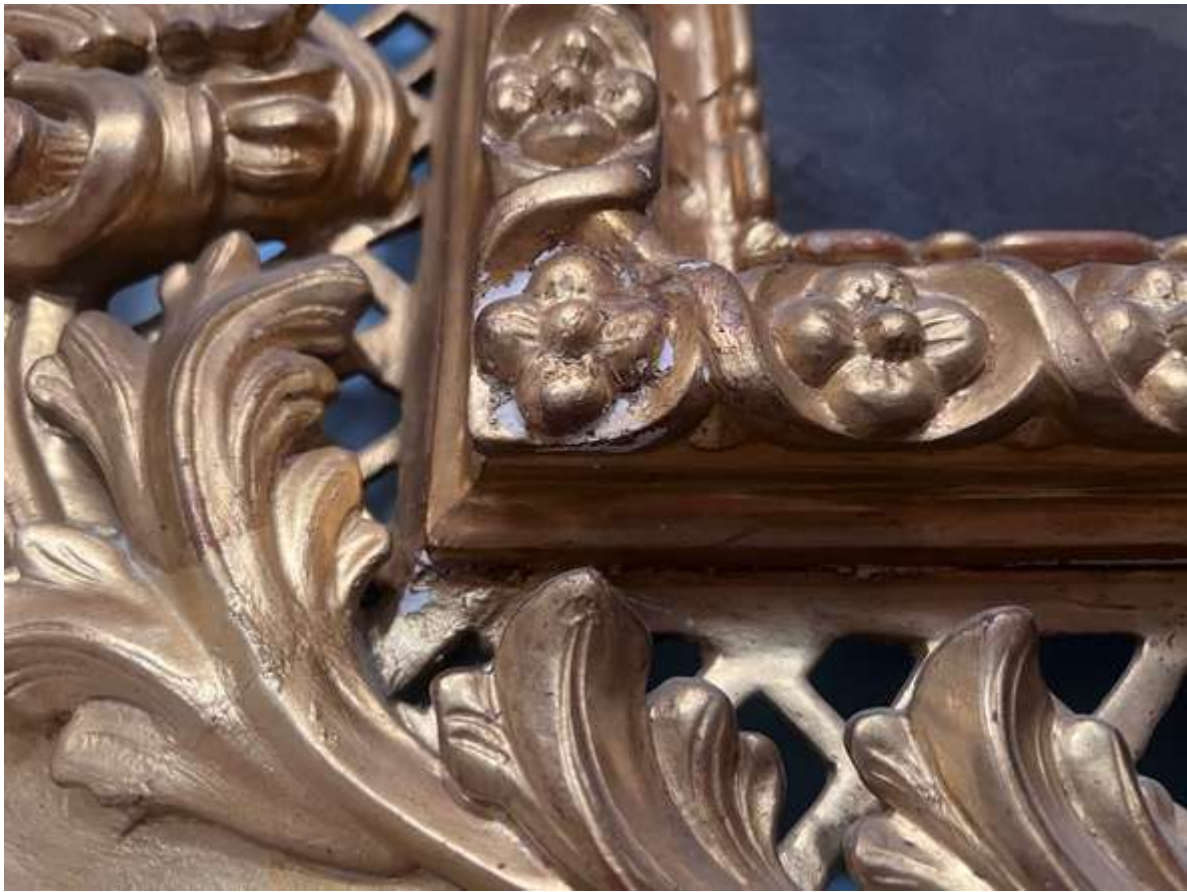
Some restoration interventions on different areas were done where the areas were regilded using the oil gilding technique.

Figure 5 – Details showing a dirty gilded surface, with losses of the paint layer and restoration interventions done by the oil gilding technique.

9. Mechanical cleaning of wax droppings
10. Removal of purpurin
11. Removal of oil gilding
12. Cleaning of oxidised varnishes to reveal the original brilliance of the gilded goldleaf

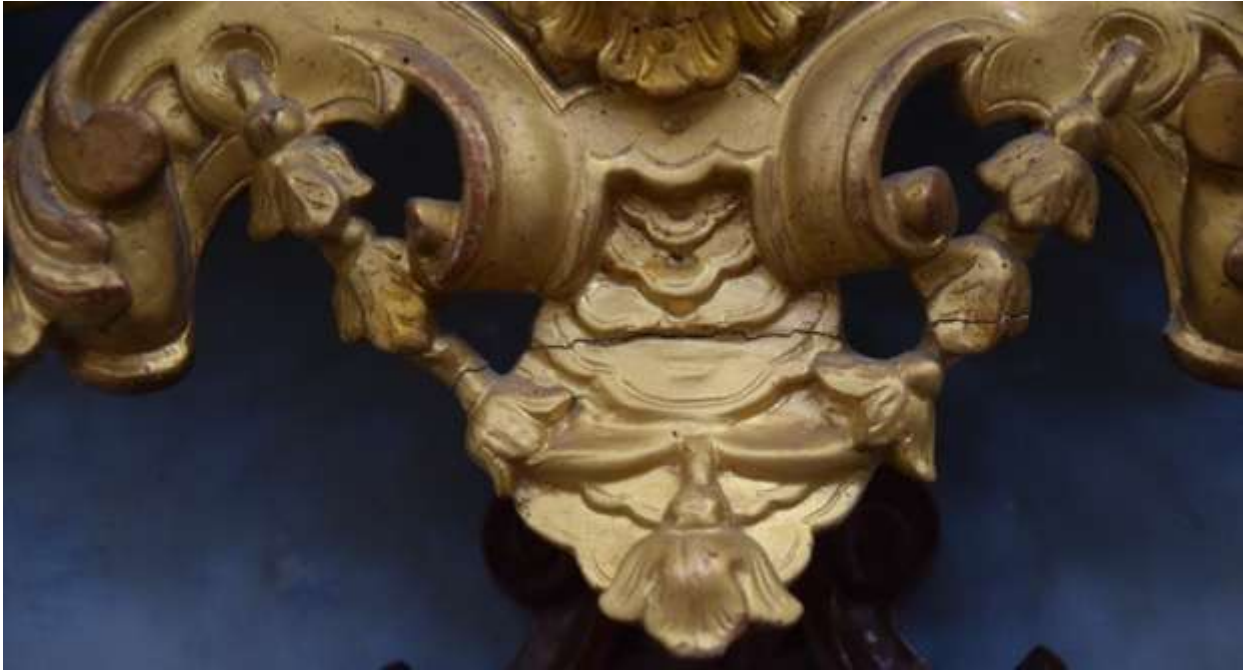
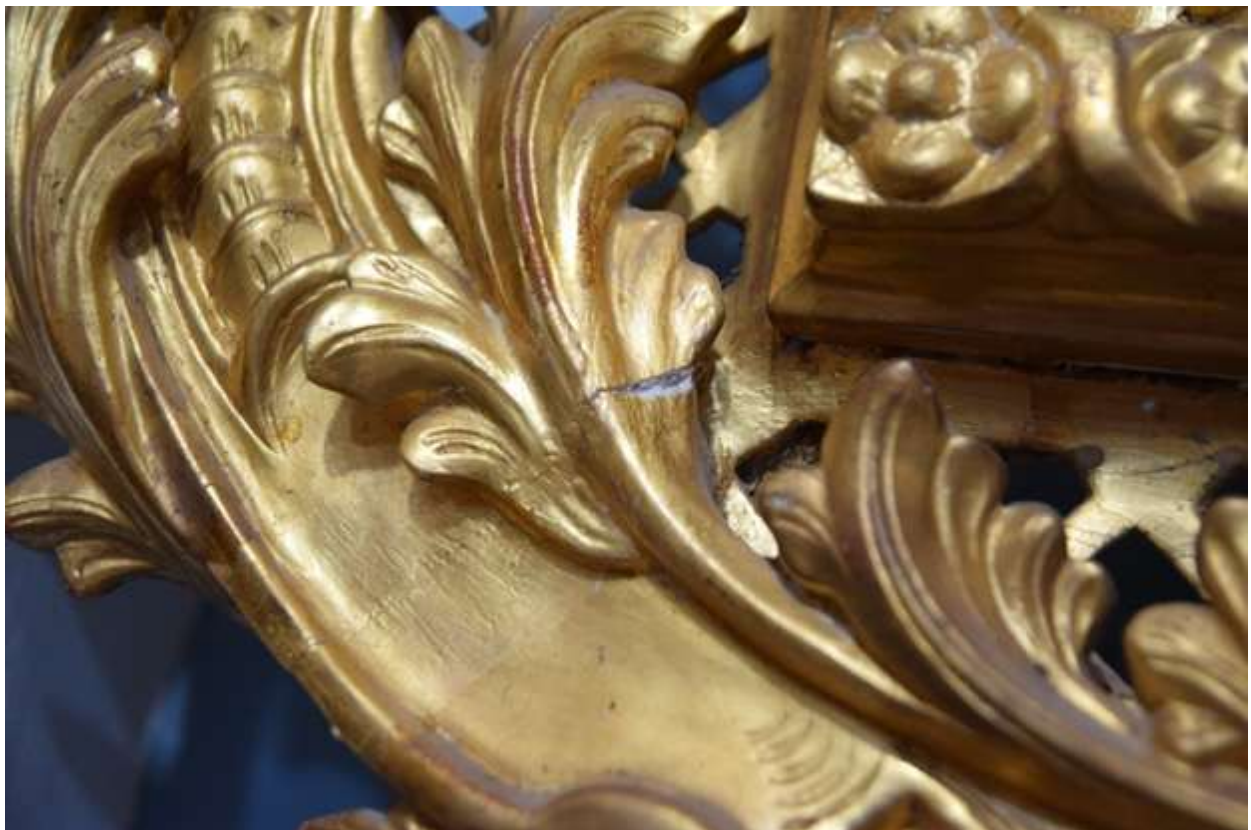
Fissures and breaks in the wooden support were observed in various areas of the wooden elements, especially in vulnerable areas of the carved decorations. Cracks and detachments of the gilding and its preparatory layers were also observed in these areas as well as in other parts of the gilding.

Figure 6 – Details showing cracks and an oil gilding intervention on the water gilded layer

5. Treatment of cracks using a special flexible material for the consolidation of wood
6. Treatment of mould
7. Cleaning Tests
8. Cleaning Dust, Grime and Altered Coating

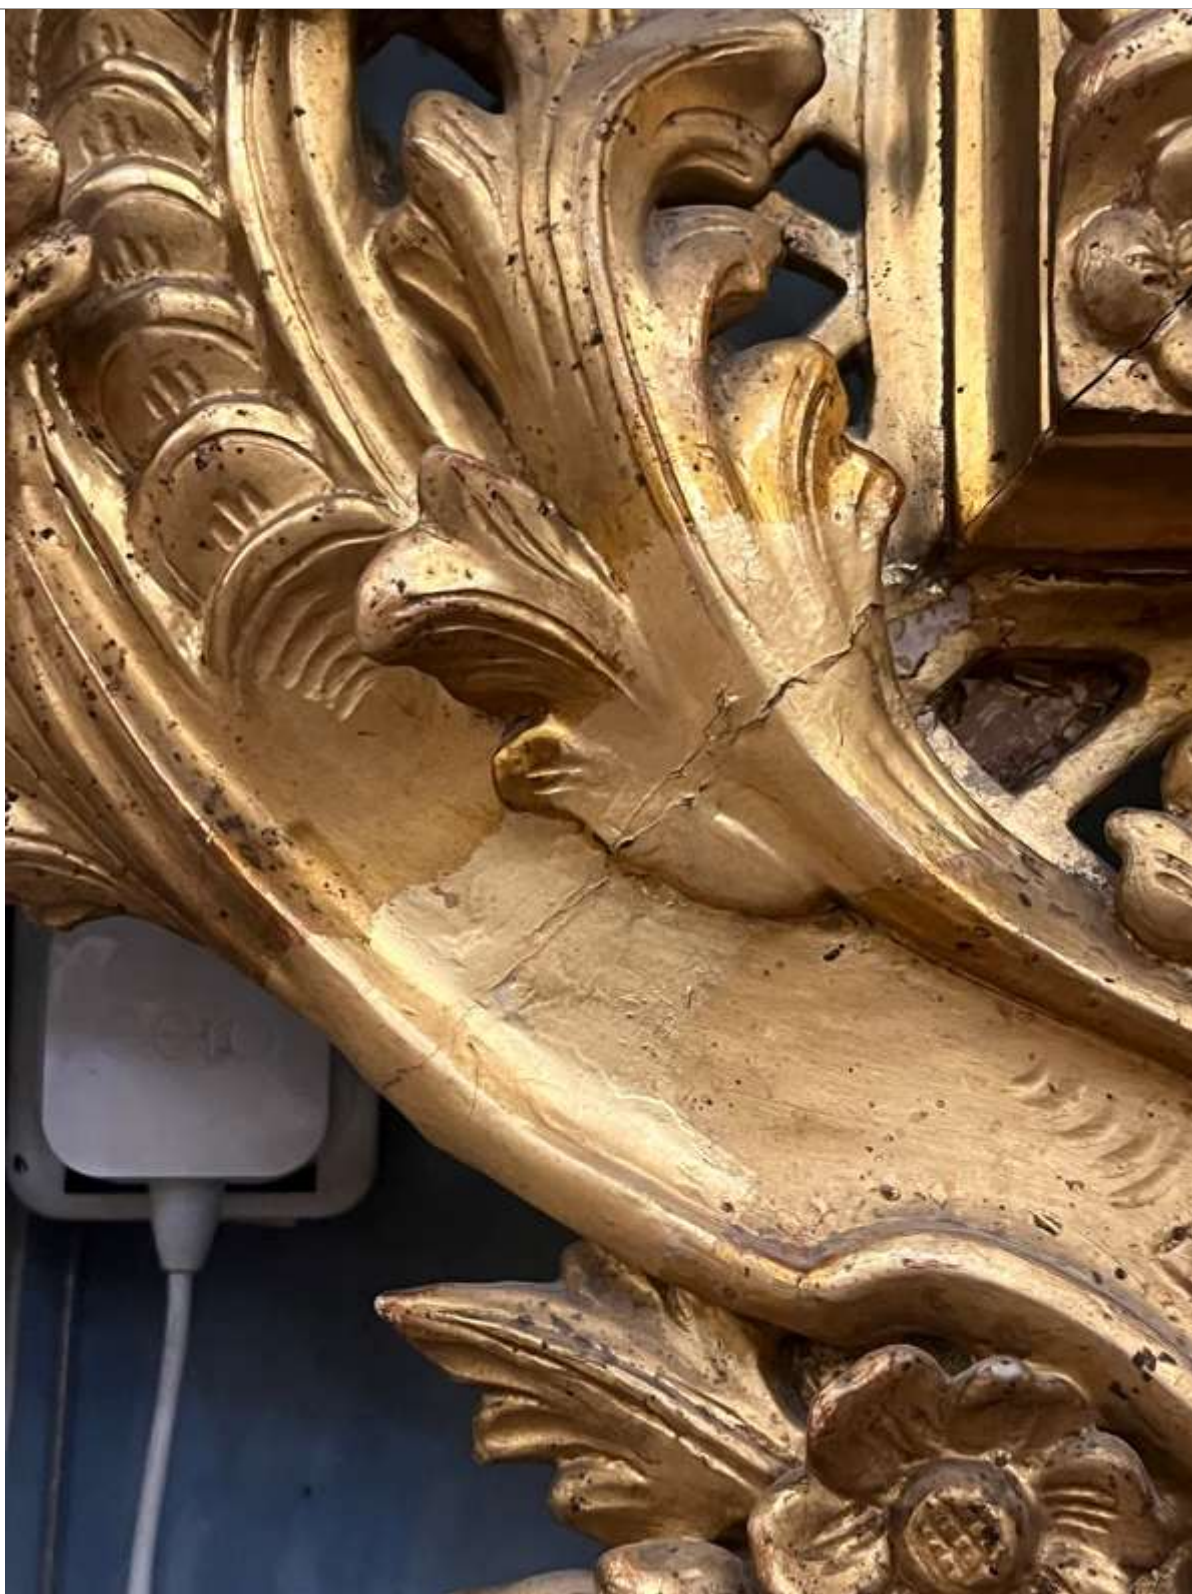
Figure 7 – other cracks and oil gilding interventions.

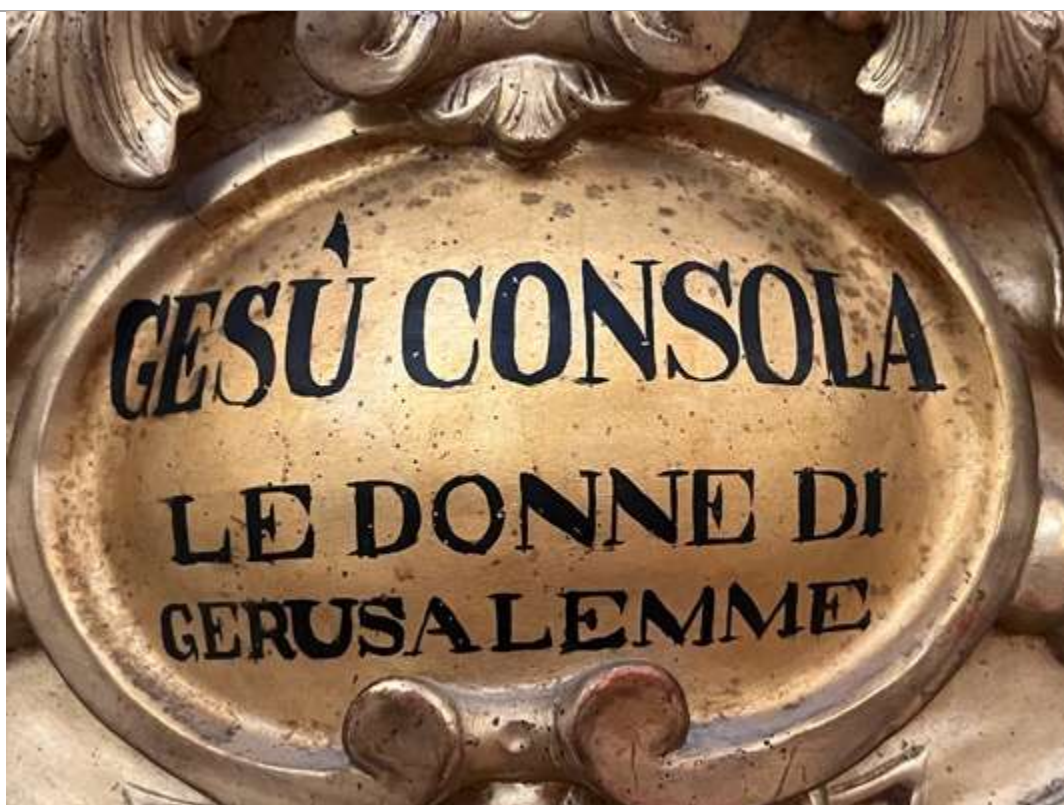
Additionally cracks and detachments were also present at different levels of the decorative stratigraphy. The frames which are hung closer to the doors at the back have several flyspecks (small black dots) which cover the gilded surface. Where flyspecks accumulations are present due to their acidity the gold underneath is usually found abraded. Some of the frames have also evidence of a bio-film indicating the presence of mould.

Figure 8 – Large black circular dots are a bio-film indicating the presence of mould on the top part of the inscription smaller dots are acidic flyspecks.

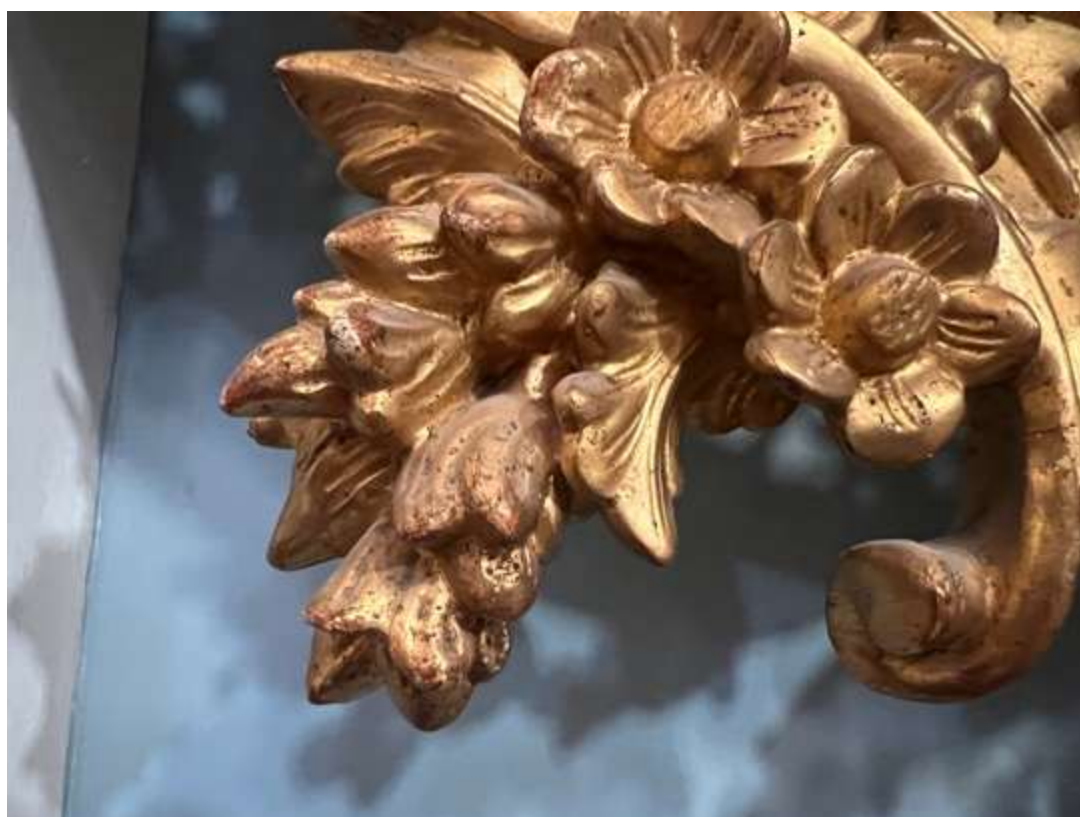
Figure 9 – Abrasions of the gilded layer show the exposed red bole

16. Application of bolo layers on lacunae and abrasions were the reddish layer of bolo shows
17. Water gilding with 23.75ct gold leaf* on lacunae and abrasions were the reddish layer of bolo shows

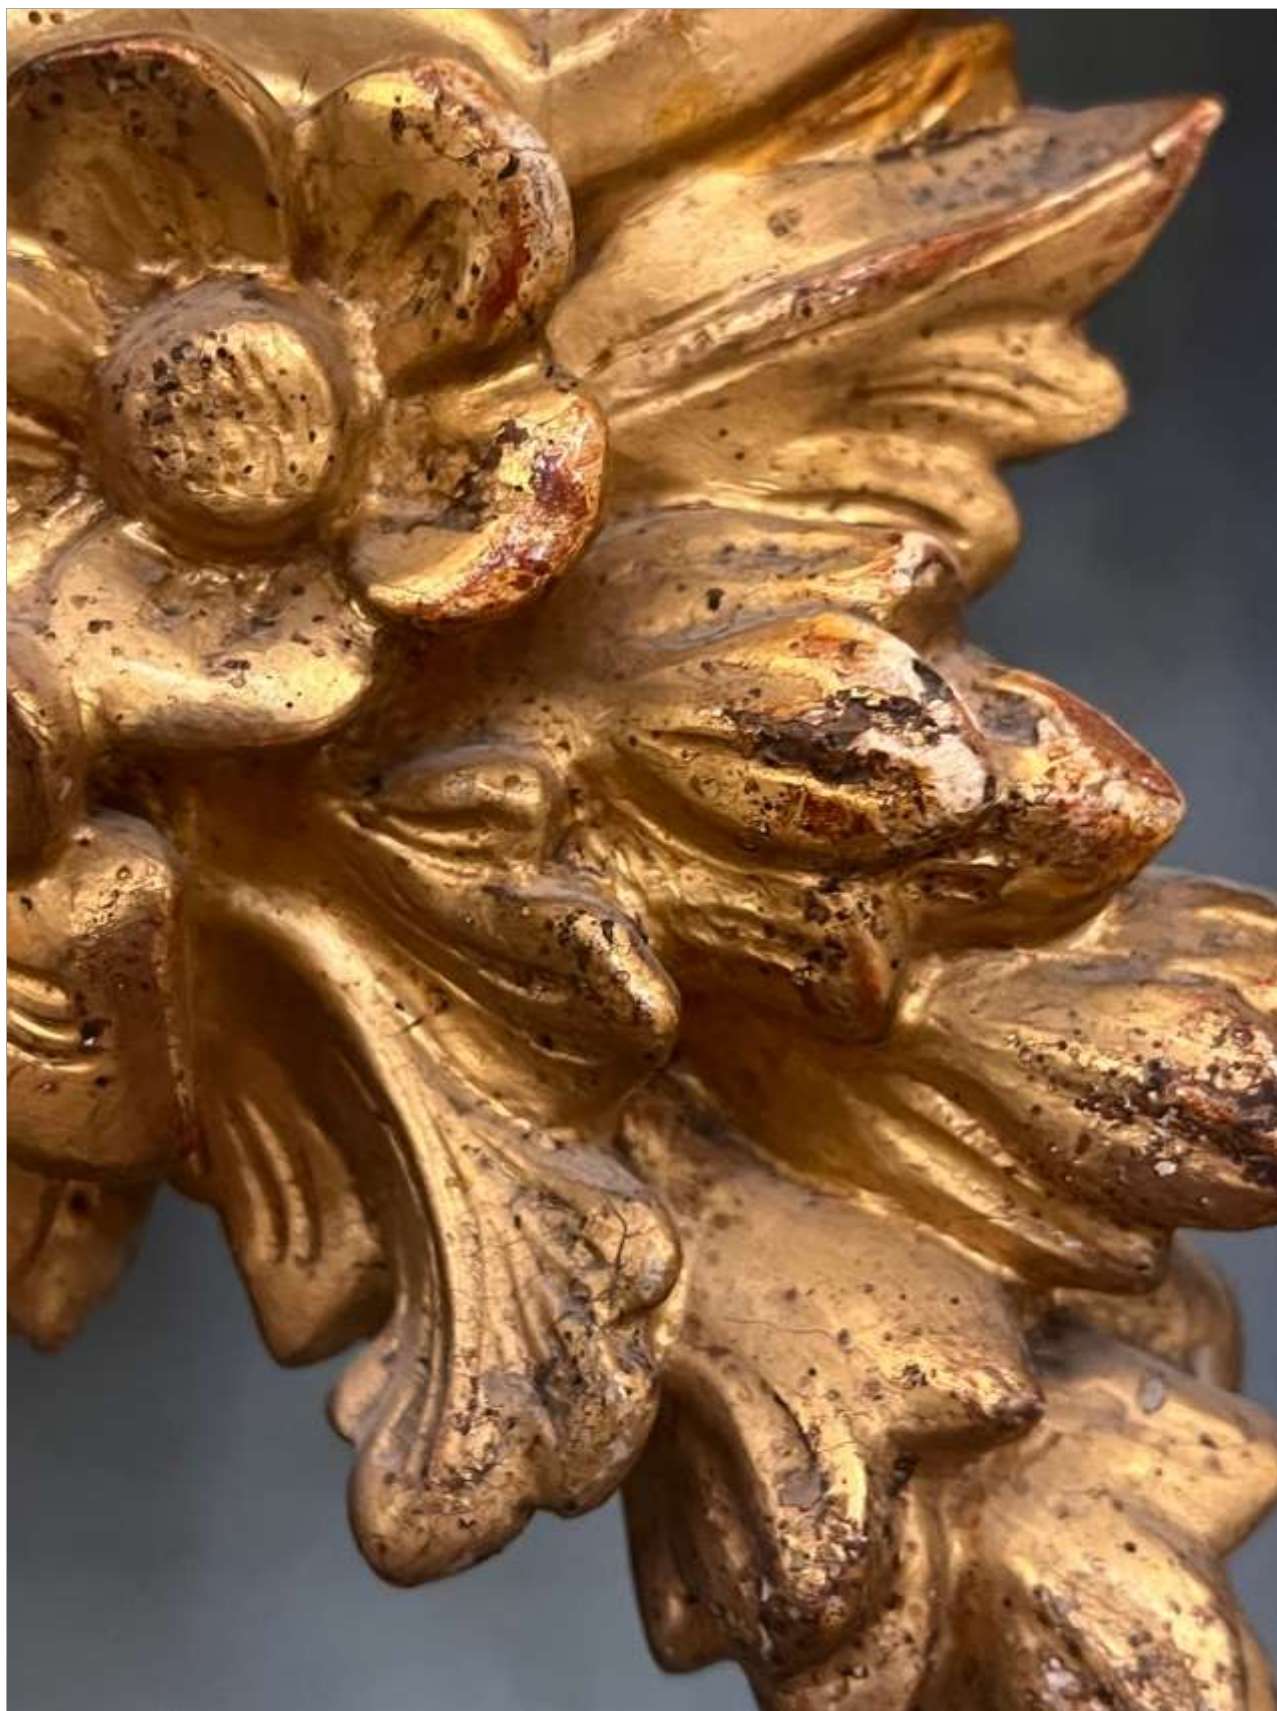
Figure 10 - Abrasions of the gilded layer show the exposed red bole

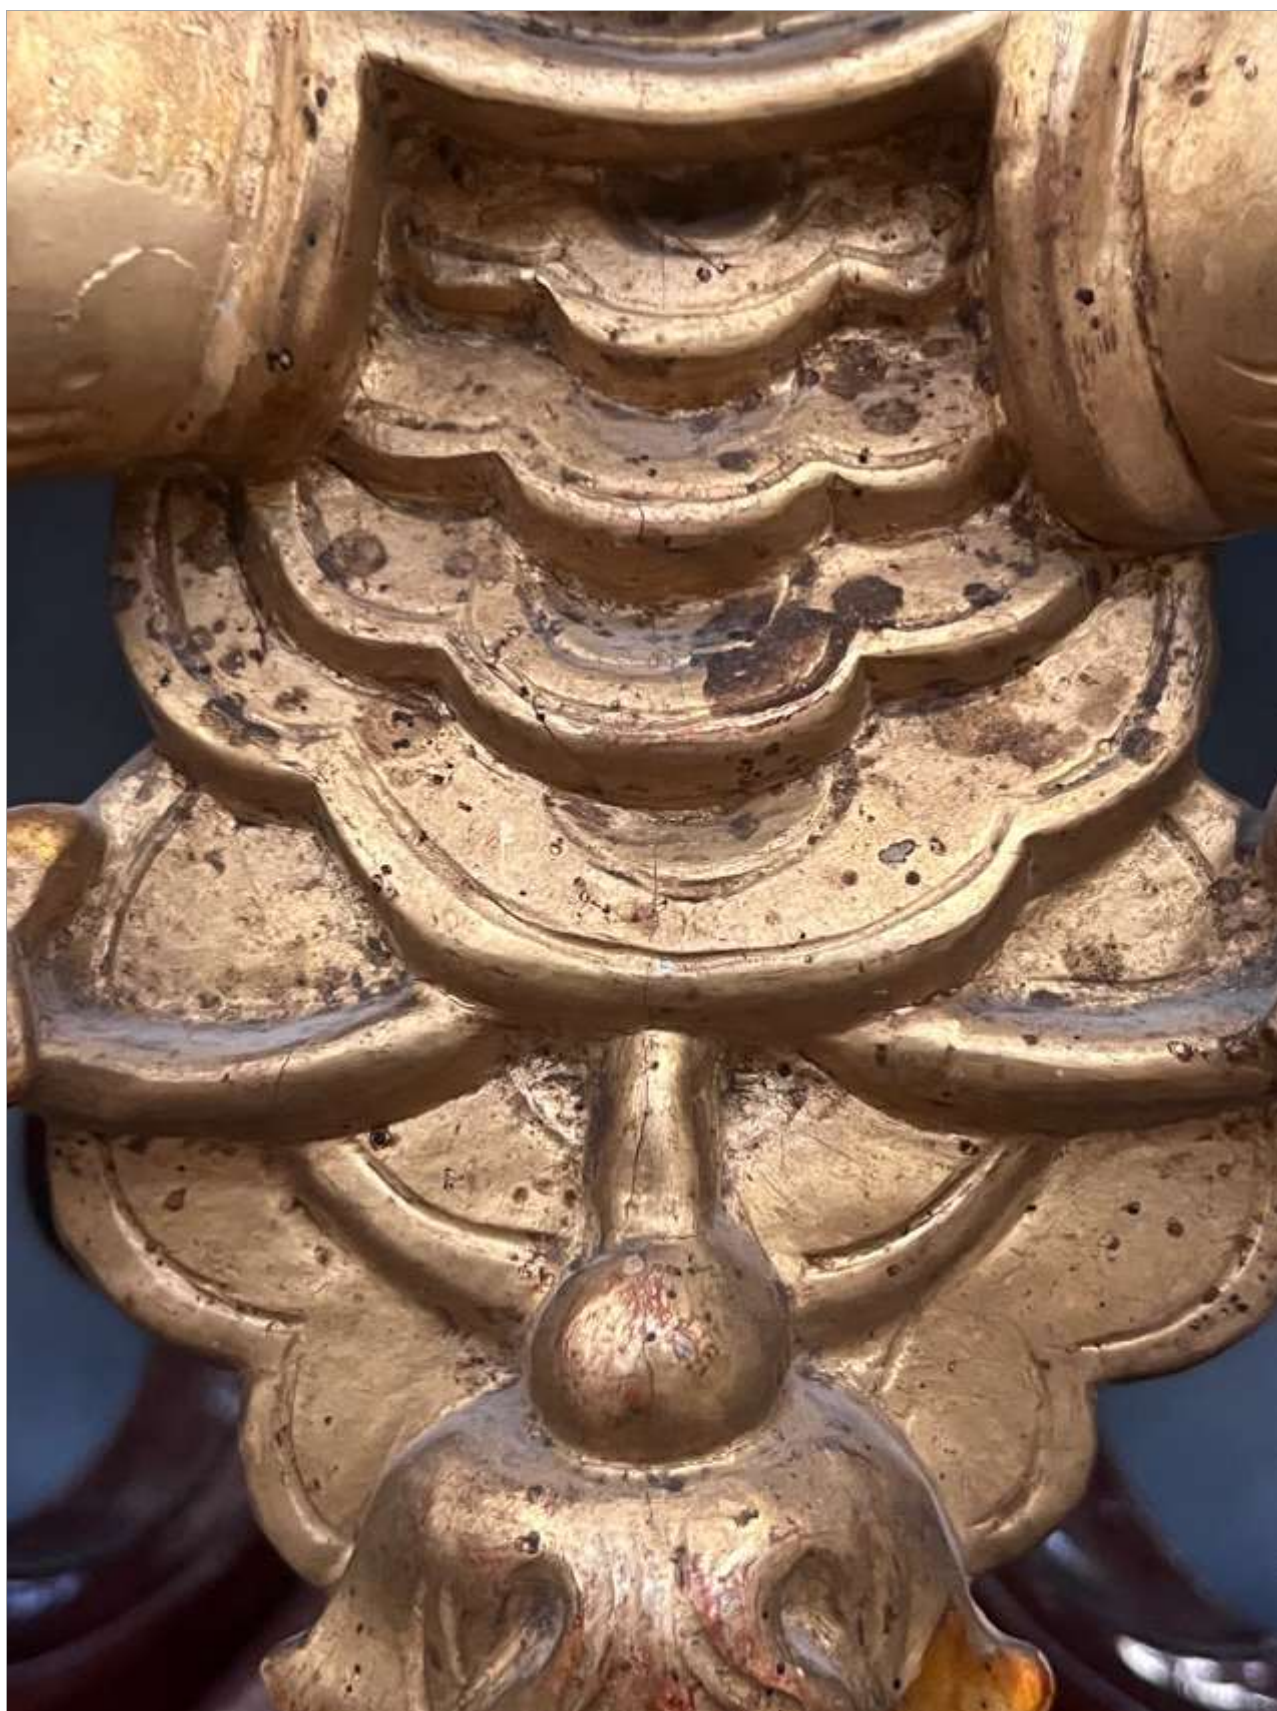
Figure 11 – Wax residues found on some of the frames

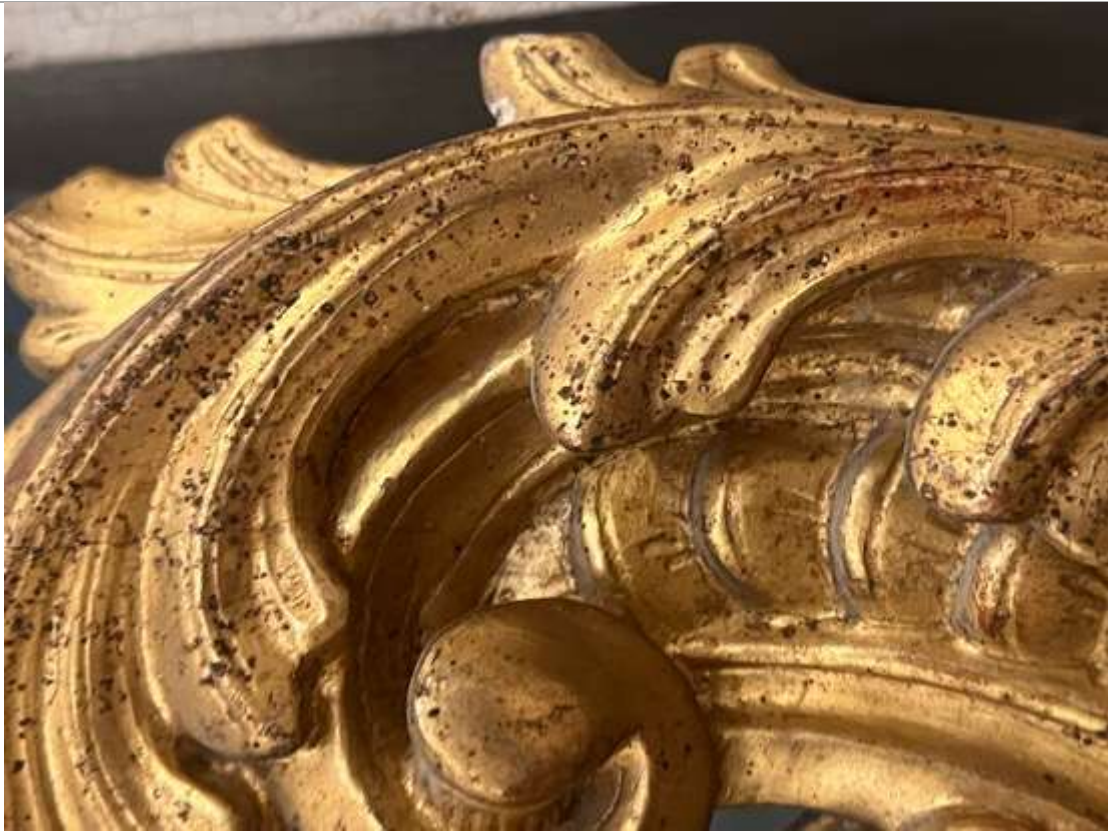
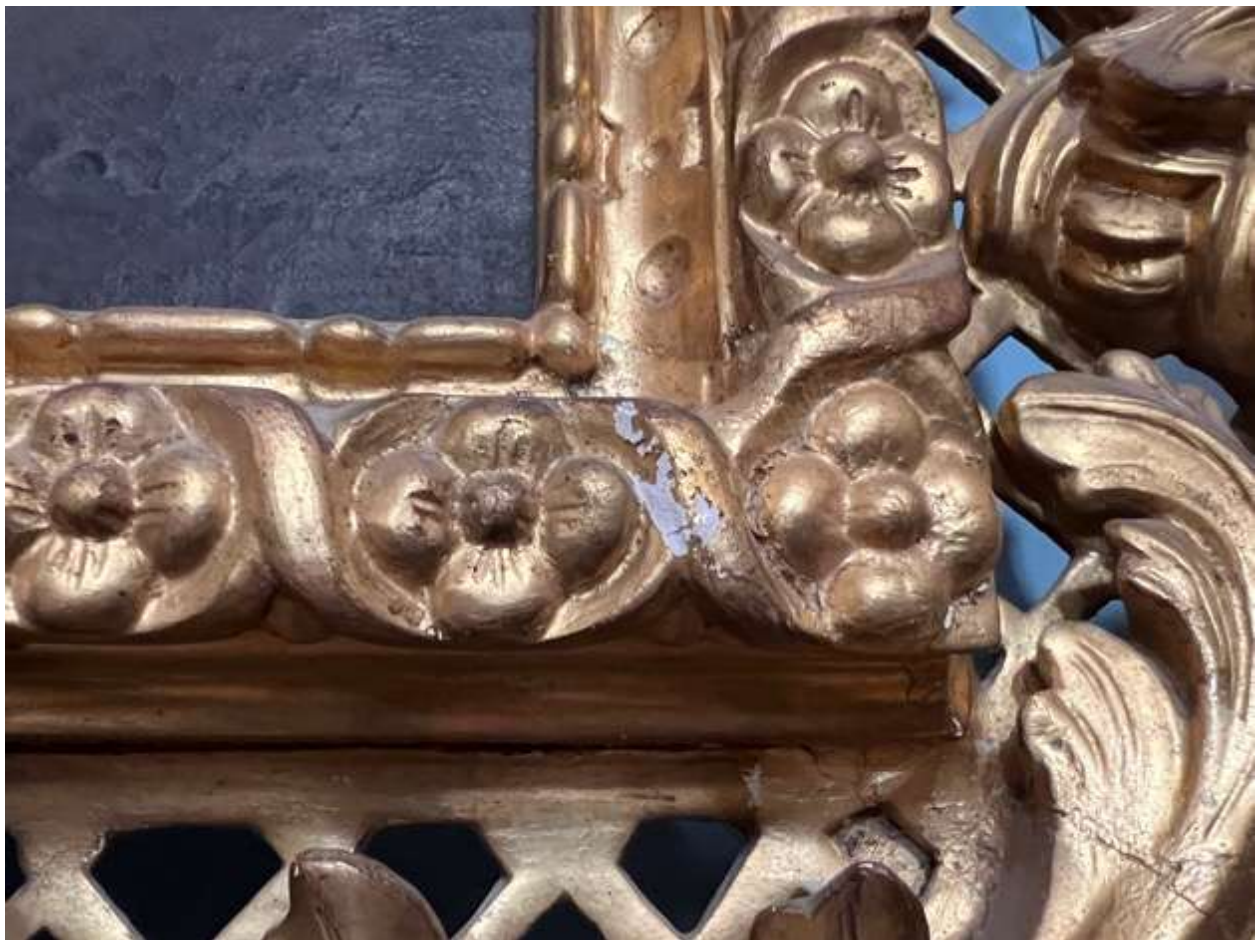
Figure 12 – Several flyspecks abraded the gilded surface due to their acidity

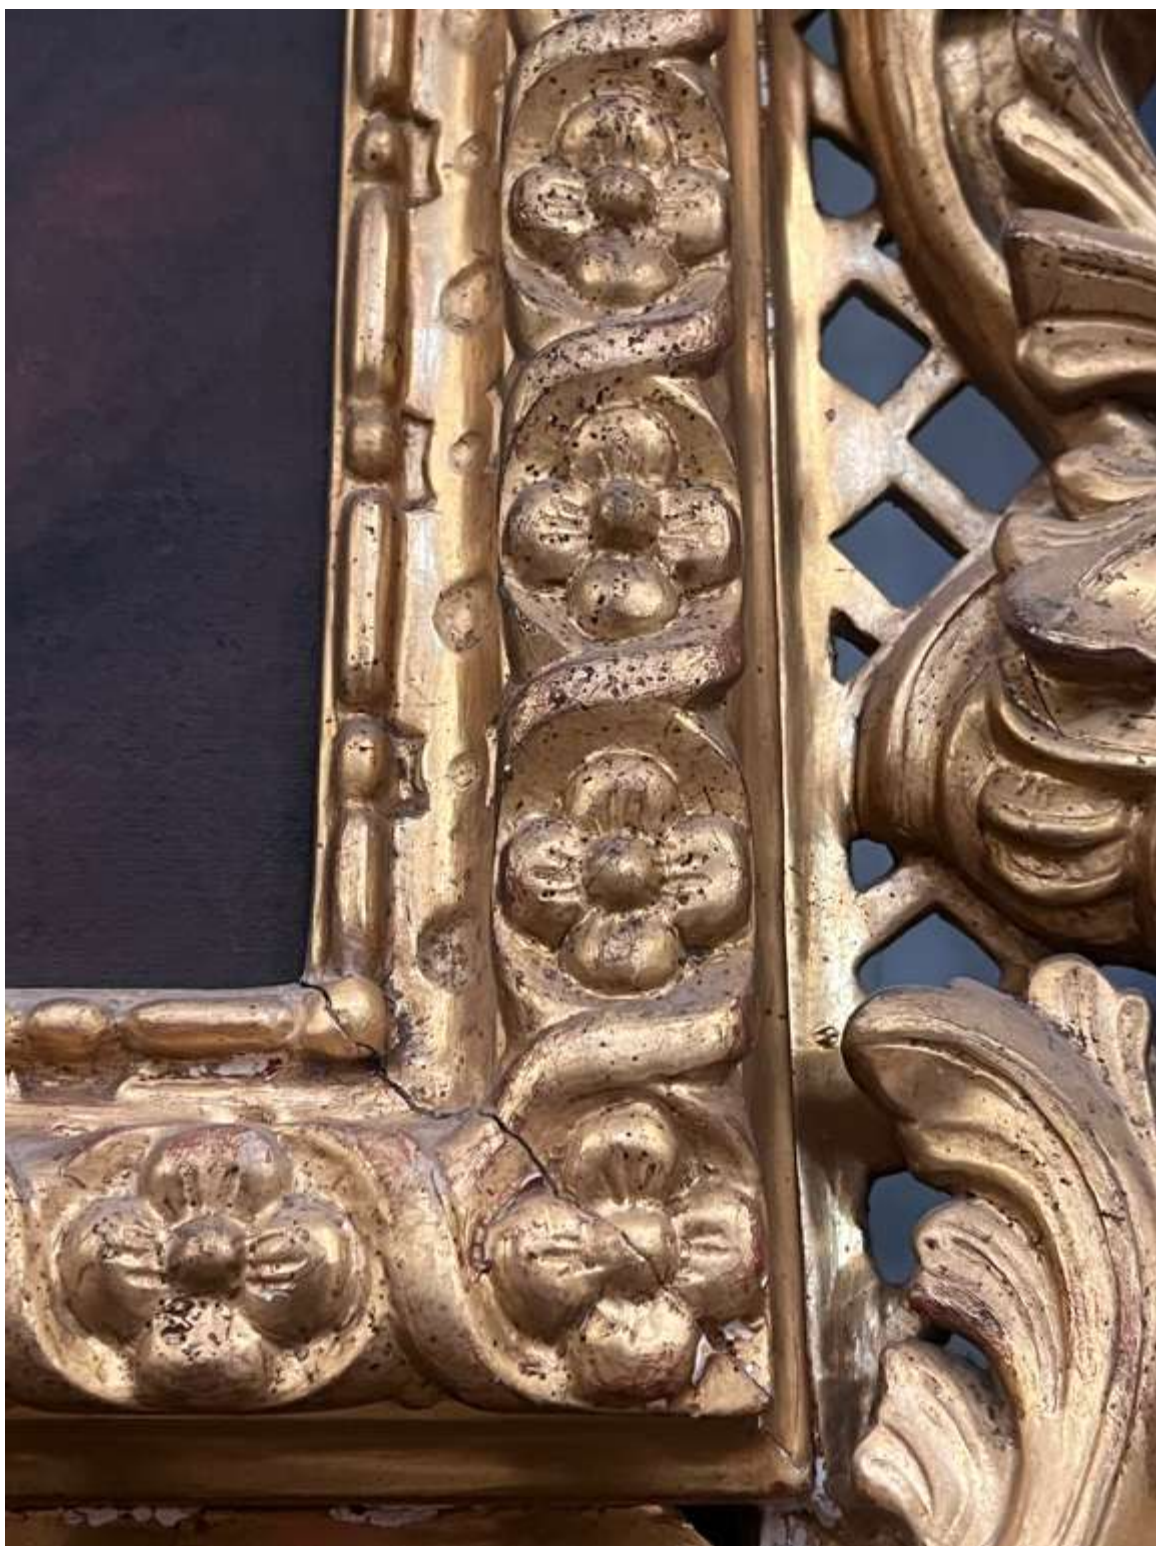
Figure 13 - Several flyspecks abraded the gilded surface due to their acidity

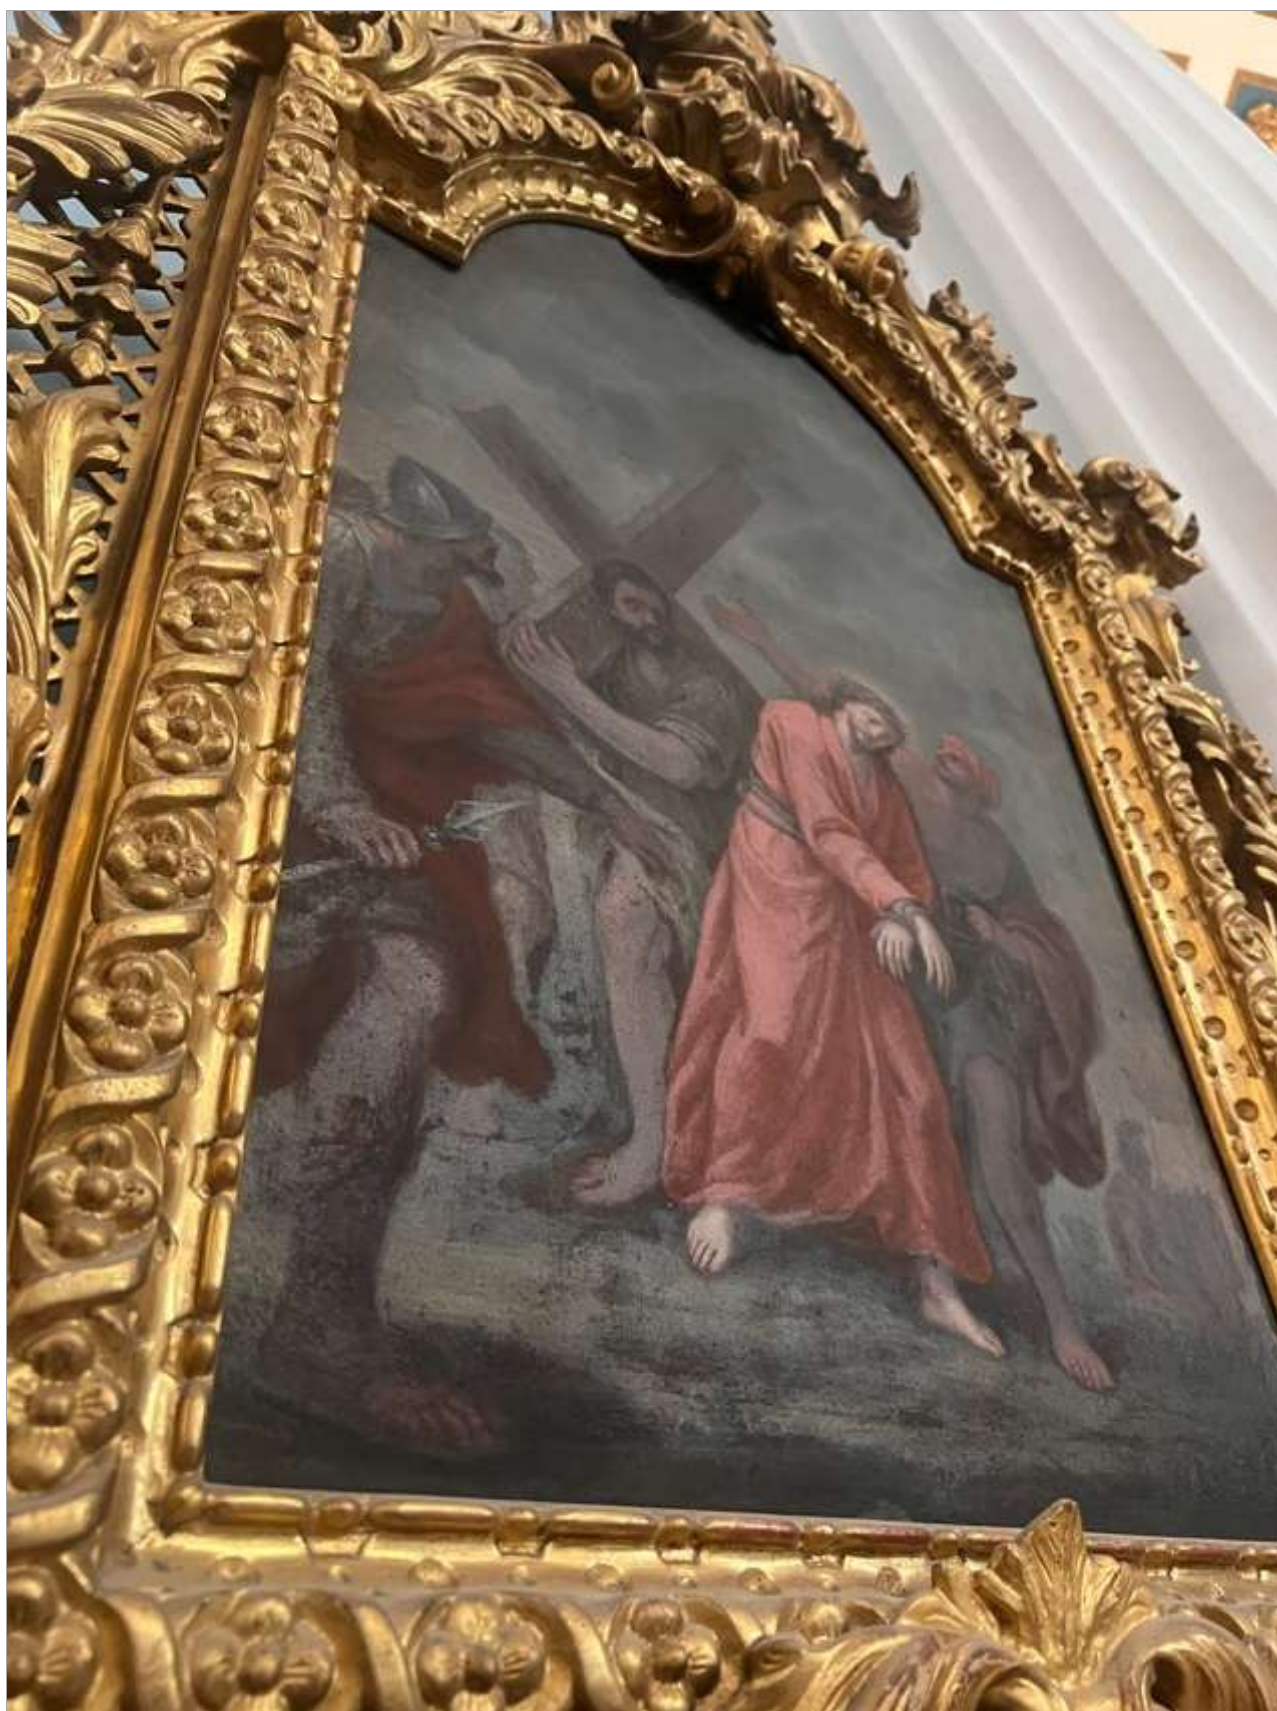
Figure 14 – A whitish layer is visible on this painting indicating blooming (trapped humidity on underneath the varnish)

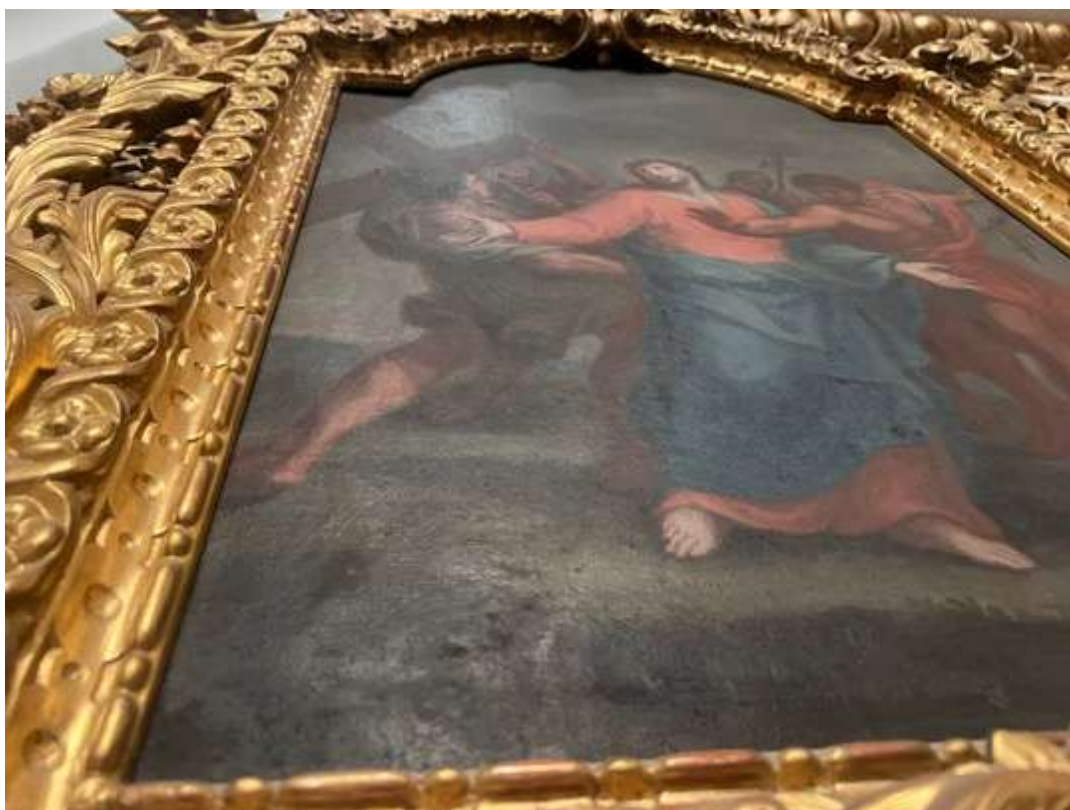
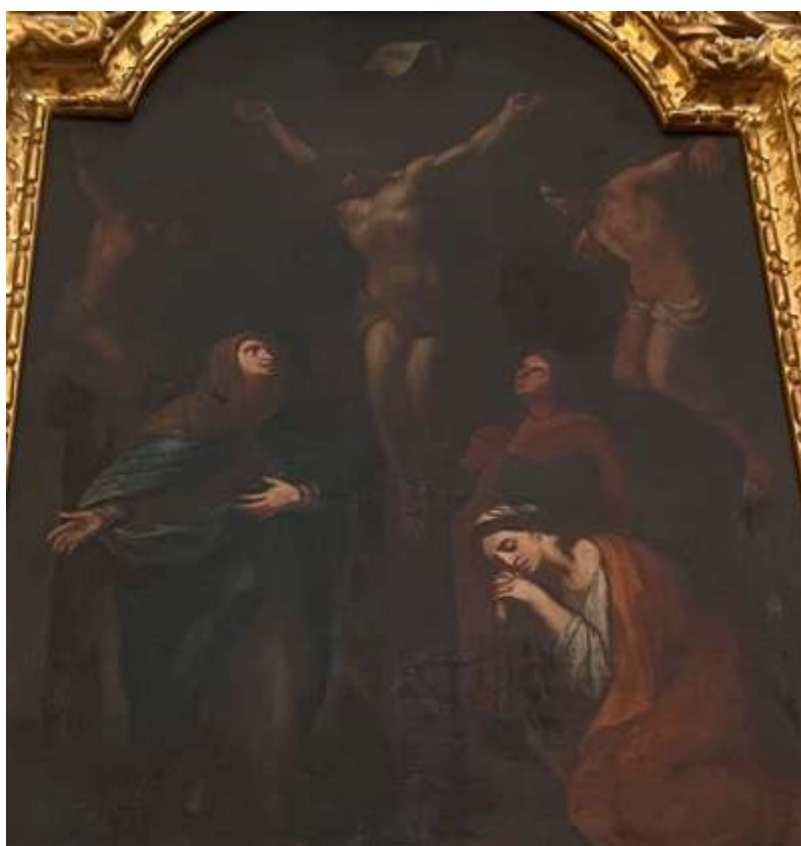
The varnish layer appears homogenous however it has oxidised in time and has therefore altered the original colours, resulting in an overall dark yellowish tone which hinders the full appreciation of the painting's intended tonality. Restoration intervention attempts seem to be present due to a number of overpaints observed in some of the paintings.

Figure 15 – General photos of two of the Stations showing a highly oxidized varnish

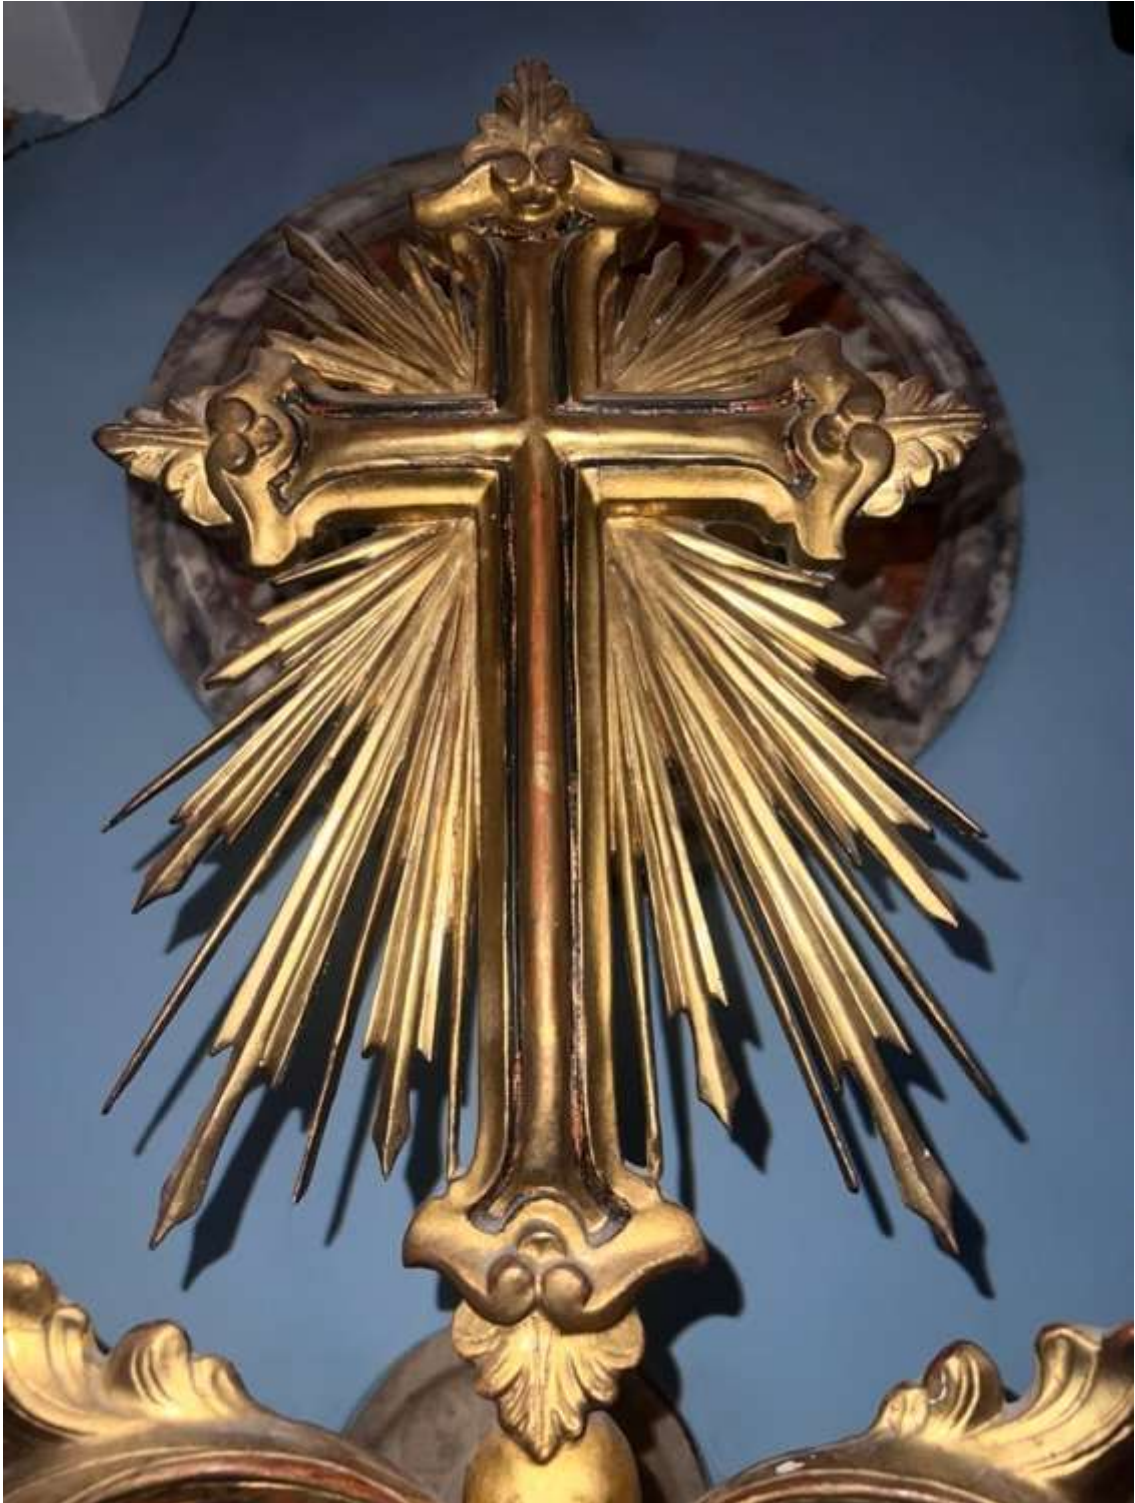
Figure 16 -the highly ornate cross found on top of the frames, having an abraded gilded surface exposing the red bolo.
