PREVARTI Laboratory

QUOTATION

Name: Church of St Albert (c/o Mr Godwin Dalli)

Title: Our Lady of Sorrows

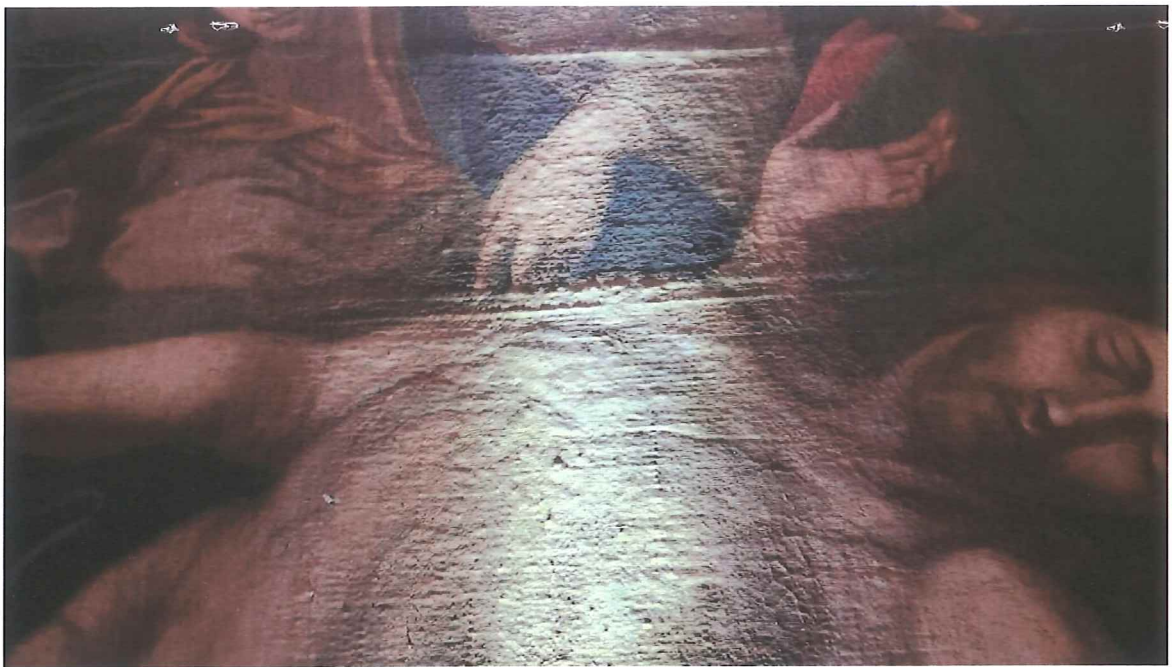
- The canvas is made up of three horizontal seams running across the painting. These seams are very visible and seem to protrude above the surface. This protruding effect has been caused by the relining process that pushes the seams out.

Detail from one of the protruding horizontal seams of the canvas.

- Removal of canvas from stretcher frame
- Removal of canvas deformations and lowering of seams protrusions face down on low-pressure table.
- Removal of Japanese paper that was used for the emergency consolidation of paint layer.

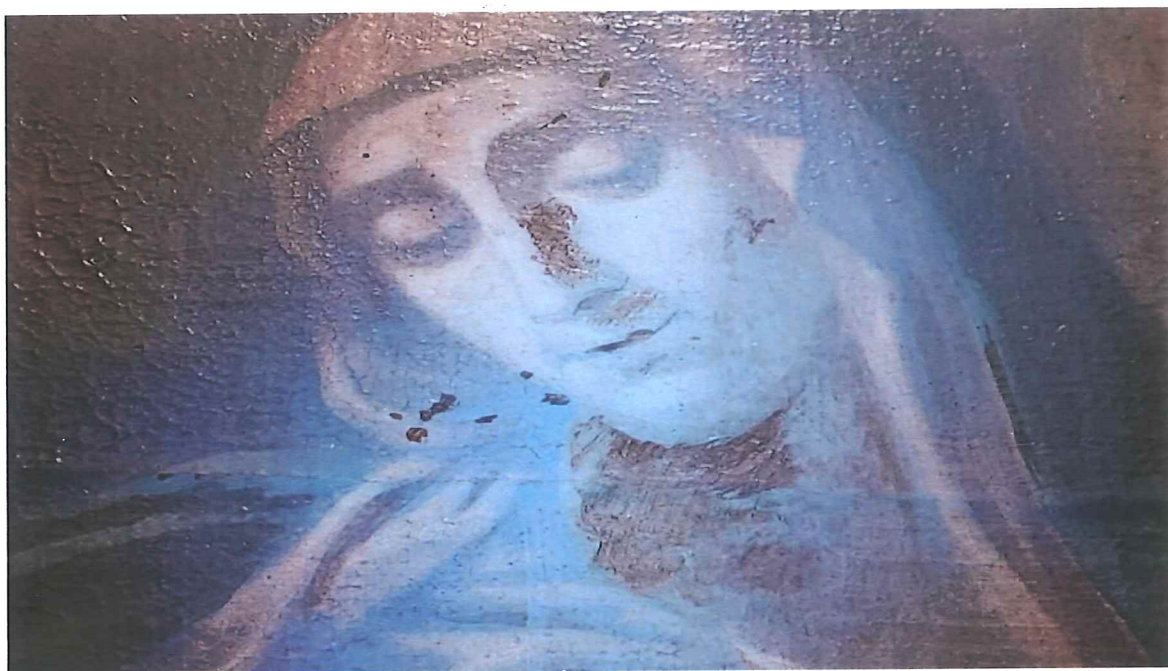
- Under UV light one can also notice a considerably amount of retouching especially around the faces of the Virgin, St John and Mary Magdalene.
- In at least two places the painting seems to have incurred damage where retouching was applied.

Detail under UV light of areas that have been previously retouched.

- Removal of surface dust, dirt.
- Removal of yellowed varnish.
- Removal of previous retouching and possible overpainting.
- Consolidating through facing of paint layer to protect it whilst working on back of the painting.

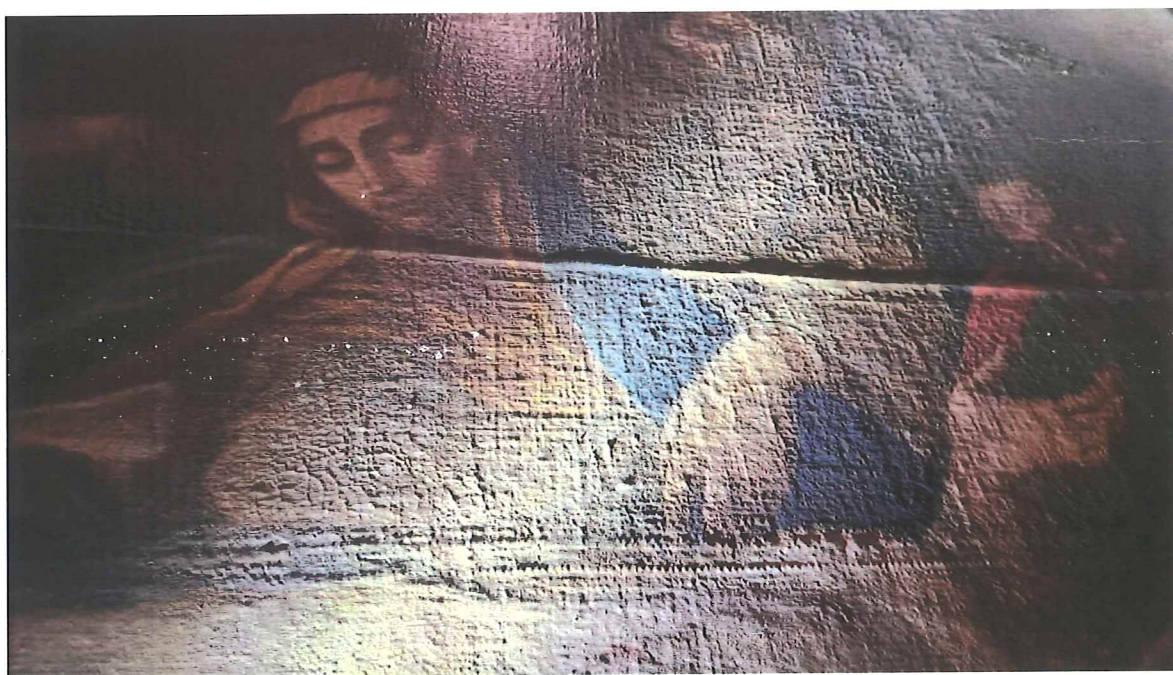
A further detail under raking light of the relining canvas pushing the seams out.

- Despite what has just been mentioned above, it is not suggested that the relining is removed due to possible damage that the painting may incur while the old adhesive is removed. It is suggested that a flattening using the low-pressure table is done instead.
