The Church of St. Agatha, Zurrieq  
Main Altar and Reredos

Restoration Method Statement

May 2025

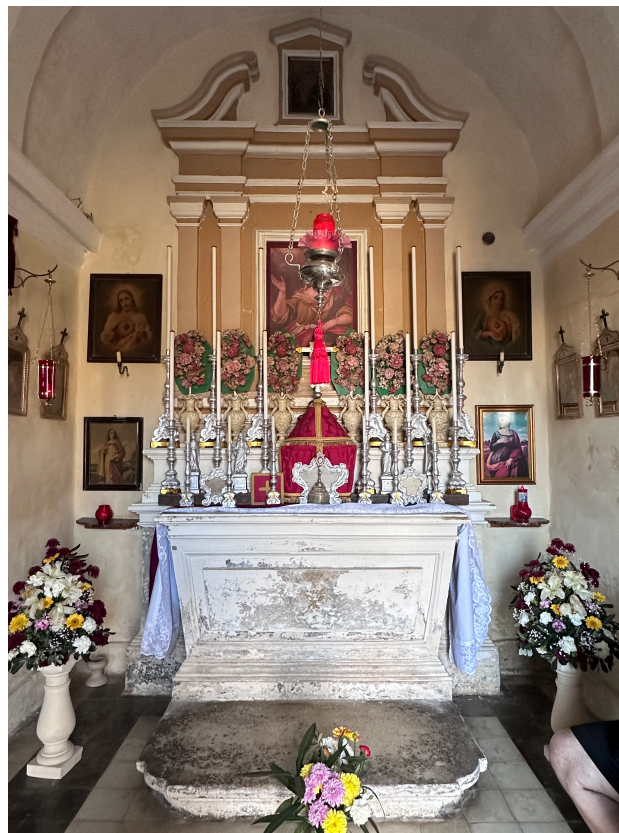
The stone support seems to be in a good condition, no major cracks or losses where noted. The altar and reredos are re painted with a commercial oil paint of a light cream colour (Figure 3.). Beneath this over paint one can notice an original *finto marmo* decoration (Figure 4.). This decoration is not entirely visible due to the repainted surface, and hence the actual condition of the underlying decoration needs to be investigated once cleaning tests can be carried out (Figure 5.).

Figure 3. General image of the Church of St. Agatha, Zurrieq. (Image, Restawr Arti, 2025)

The process will then move to the removal of the over painted paint. Cleaning tests are to be carried out to find the best possible solution and/ or gel to remove the re painted layer. Since the re painting is thought to be commercial oil paint, a polar solvent, or mixtures of polar solvents might be the best way for removing the unwanted re paint, while keeping the original 19th century *finto marmo*.

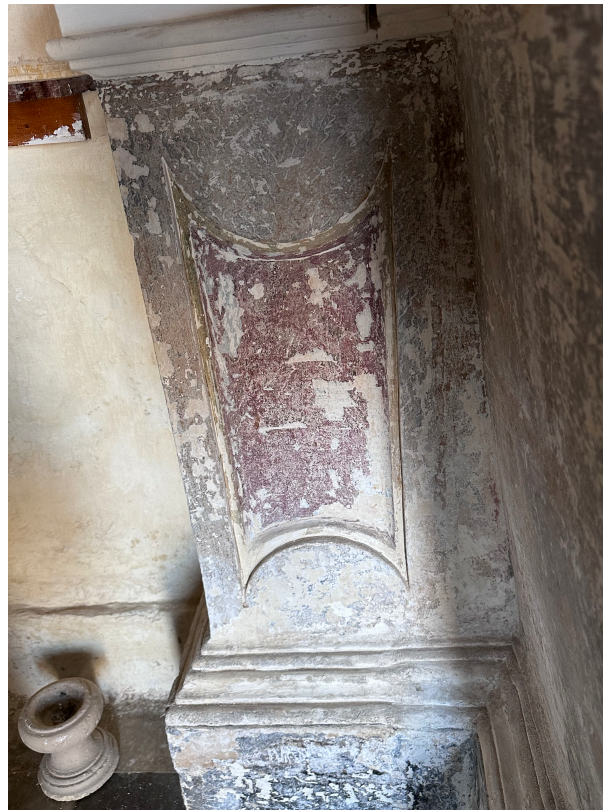
Figure 4. Original 19th century *finto marmo* exposed due to the natural deterioration of the re painted surface, and a previous restoration intervention. (Image, Restawr Arti, 2025)

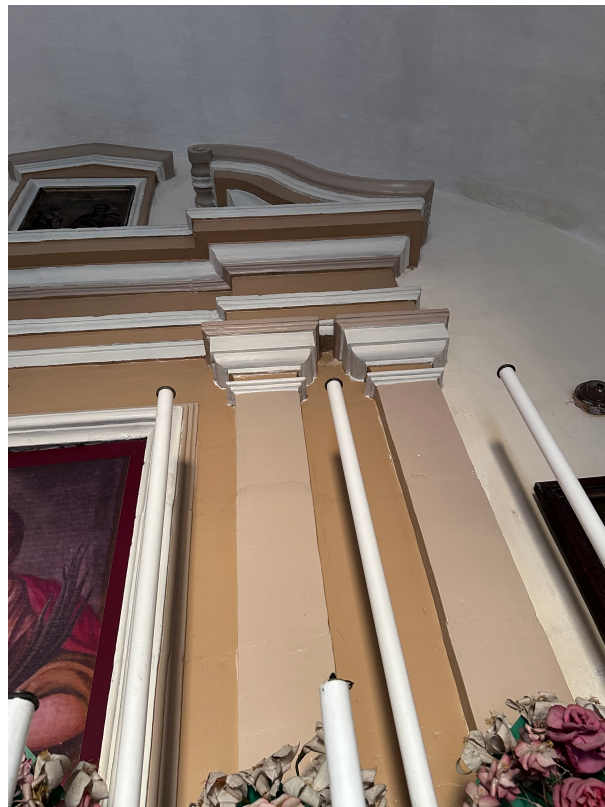
Figure 5. Re painted reredos. (Image, Restawr Arti, 2025)

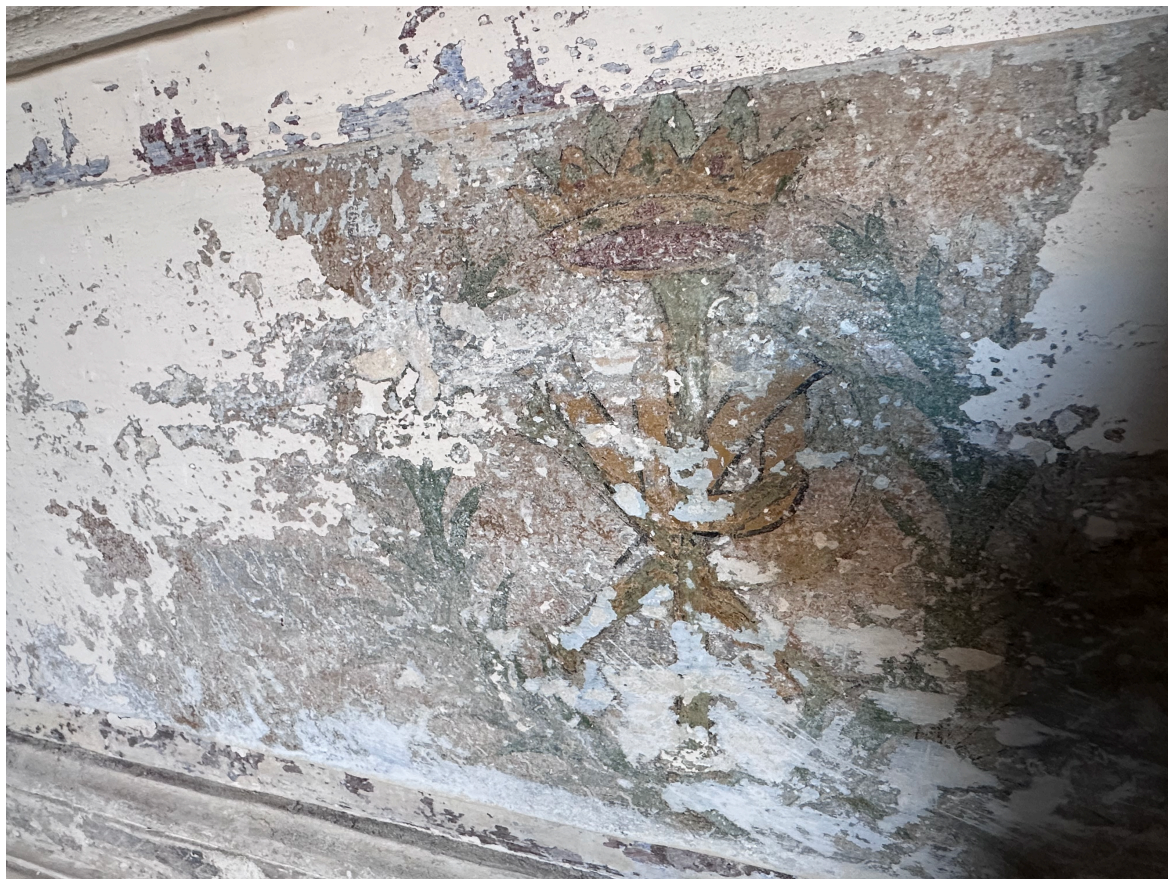
Additionally, due to the continuous rising damp and salt cycles, some areas of the repainting, mainly at the lower area of the altar, are flaking off, and exposing the original painted decoration. The colours at the lower area close to the ground are powdering and as a result seem to be faded (Figure 6.). Parts are entirely lost (Figure 7.). Lacunae in the paint layer are also exposing slight powdering, and salt efflorescence in the stone support (Figure 8.).

Figure 6. Powdering and faded oil colours. (Image, Restawr Arti, 2025)

Primarily, dust and dirt that has accumulated on the flat surfaces, will be dusted off using dry soft brushes and a vacuum cleaner. Additionally, a pre consolidation treatment will be applied in order to protect the powdering paint from getting affected during the coming steps. A low viscosity acrylic based consolidant diluted in water, such as PRIMAL CM300 or ACRIL ME, will be applied with a brush over a protective facing of Japanese paper. This method will ensure homogeneous application, without drippings, and eliminating the risk of pulling off powdered paint due to the use of brushes. The preferred consolidation strength will be tested as a first step through different test patches.

Once the surfaces are cleaned, a second treatment of consolidation will be applied on the deteriorating areas, hence those that are powdering or damaged. This stage will follow the same process of the pre consolidation treatment mentioned earlier in this section.

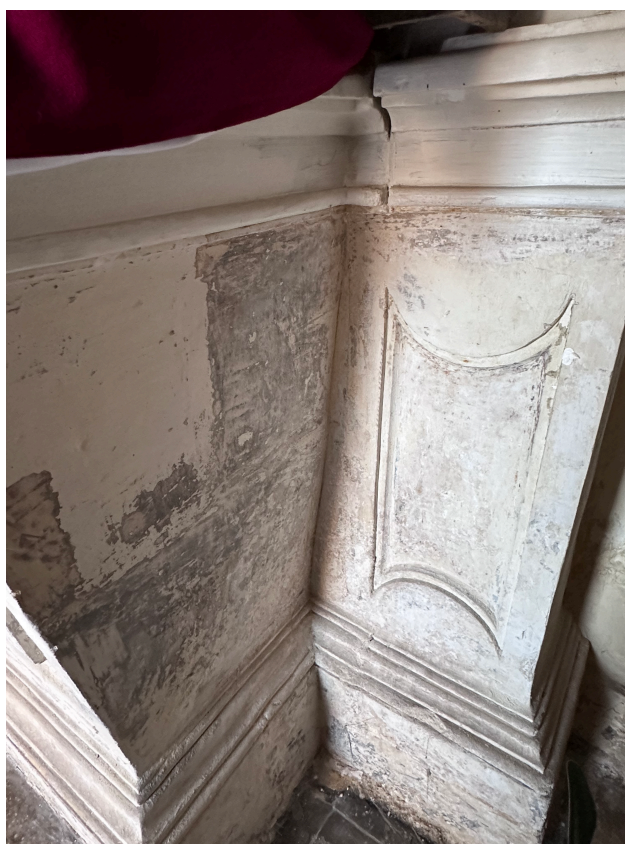
Figure 7. Lost painted decoration and exposed stone support. (Image, Restawr Arti, 2025)

The conservation process will continue with the mortar infills of losses and minor reconstructions. A non hydraulic lime, local sand, and Globigerina Limestone powder mix is proposed. Self designed mortars which cater for the requirements of the site understudy are preferred over ready made mortar mixes.

from the re- integrating restoration colours. The lacunae and newly applied mortar will be re integrated using an imitative technique and stable restoration varnish colours. As a final step, a final protective coating with a matte finish will be applied to protect both the original colours and also homogenise the final aesthetic of the painted surface. The varnish will be diluted as to not interfere with the porosity and breathability of the stone support. The final varnish will be sprayed over the entire surface.

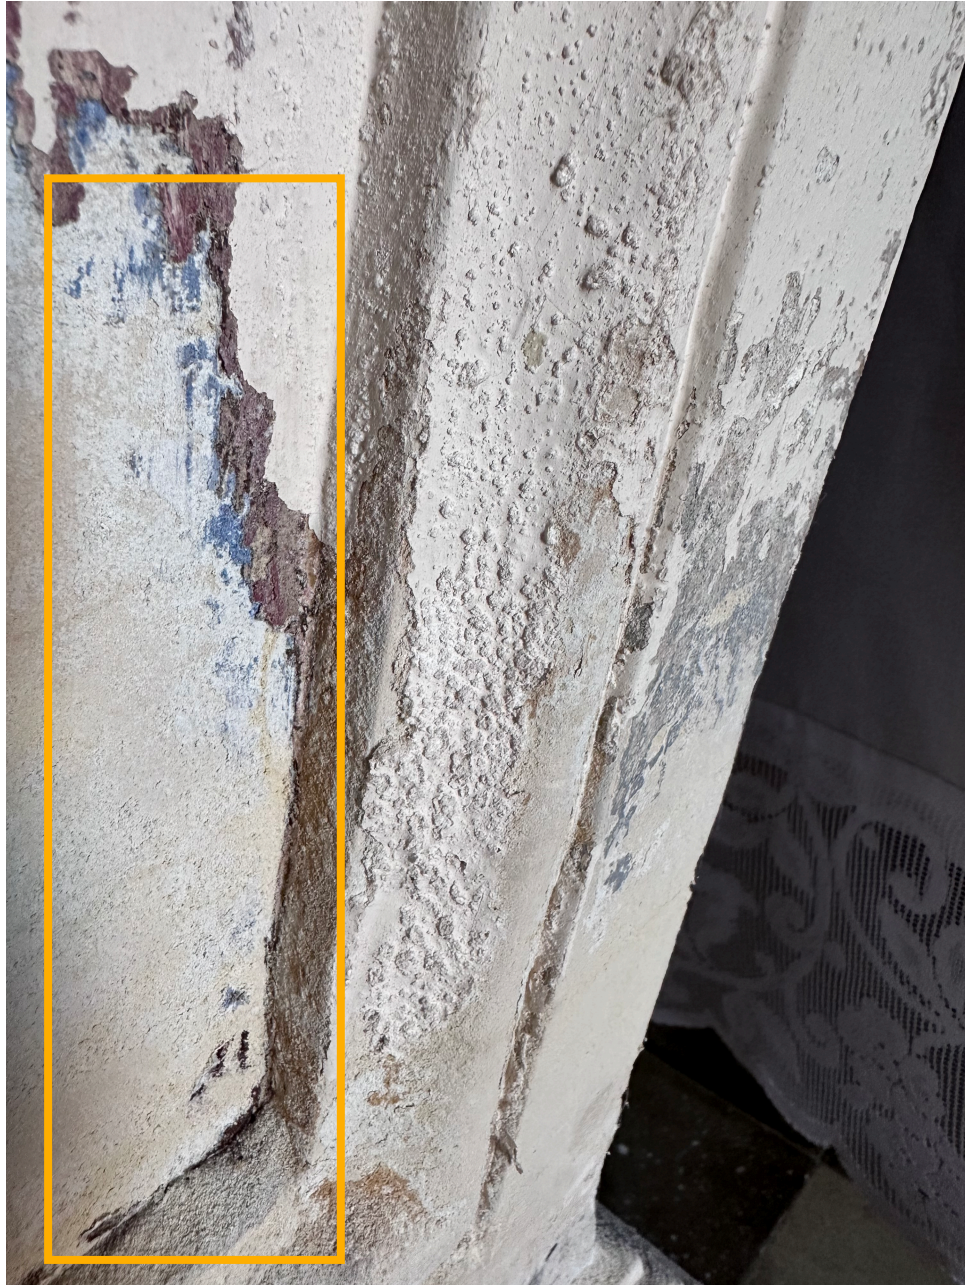
Figure 8. Stone powdering and salt efflorescence. (Image, Restawr Arti, 2025)

Eventually, a process of salt extraction will be carried out to those areas, essentially, at the lower areas of the altar. The process will involve the application of poultices by paper pulp and distilled water.
