METHOD STATEMENT FOR THE RESTORATION OF THE CUPOLA, DRUM AND LANTERN- ZABBAR PARISH CHURCH

The lantern, dome and drum

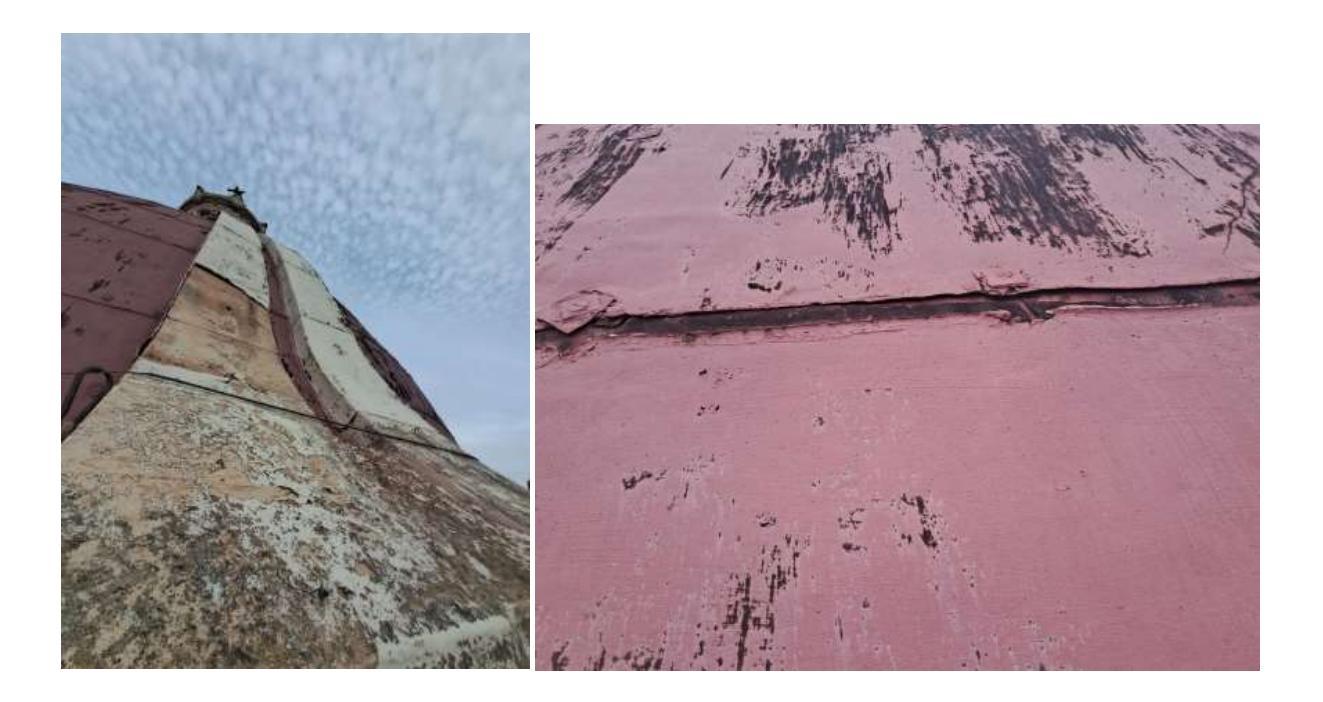
The current dome is waterproofed by sheet lead between the ribs and then painted over with a reddish paint. In one of the ribs, it is evident that the lowest section of the lead has become loose and is currently missing. Moreover, from close pictures it was also noted that the lead sheeting has exhibited some movement and in some areas the lead has torn.

The existing lead sheeting will be checked and the areas where it has become loose will be refixed adequately. Any highly cracked or loose areas will be replaced by means of lead sheeting in a similar manner.

The whole system will again be painted in a reddish colour to the RAL colour as approved by SCH officials.

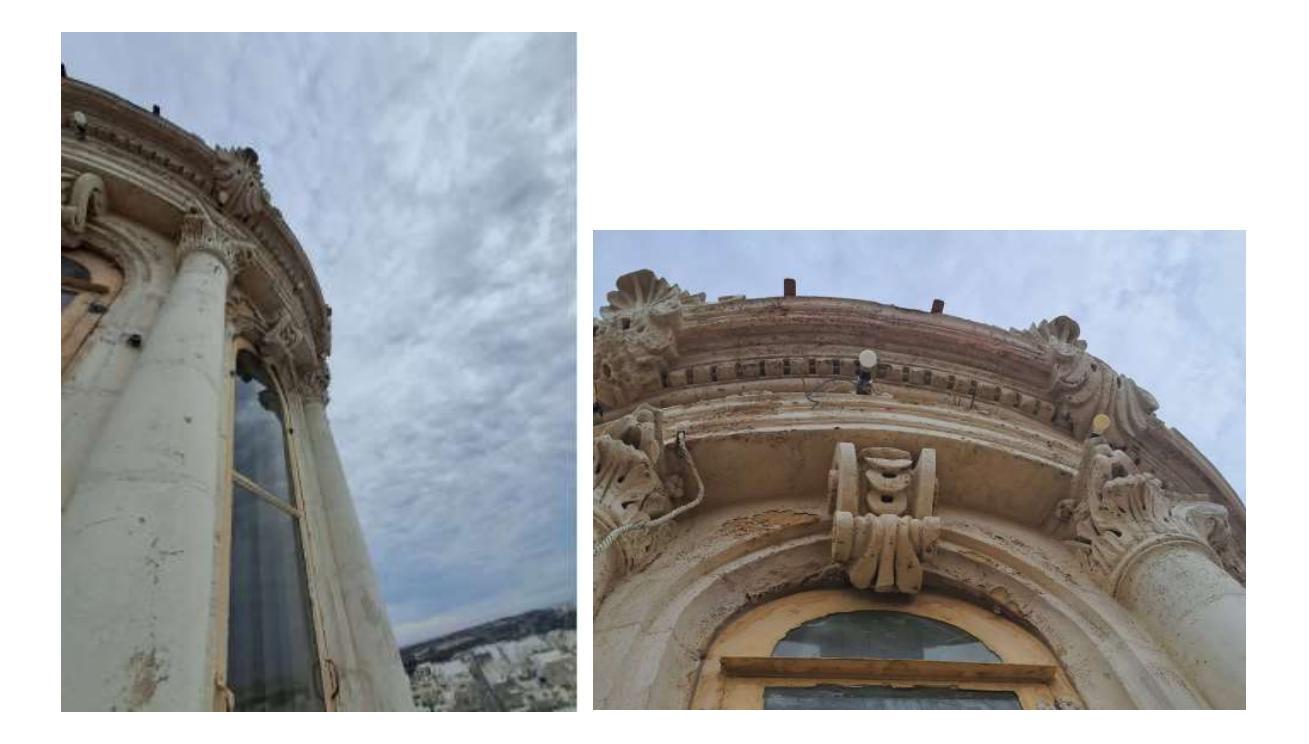
The lantern is currently painted over in a white paint directly over the masonry stone. The paint layer seems to be a silica based paint and is currently heavily flaking.

Moreover, the underlying stone in certain areas, shows signs of powdering and flaking. There is area also areas within the cornice above the lantern which have some missing elements.

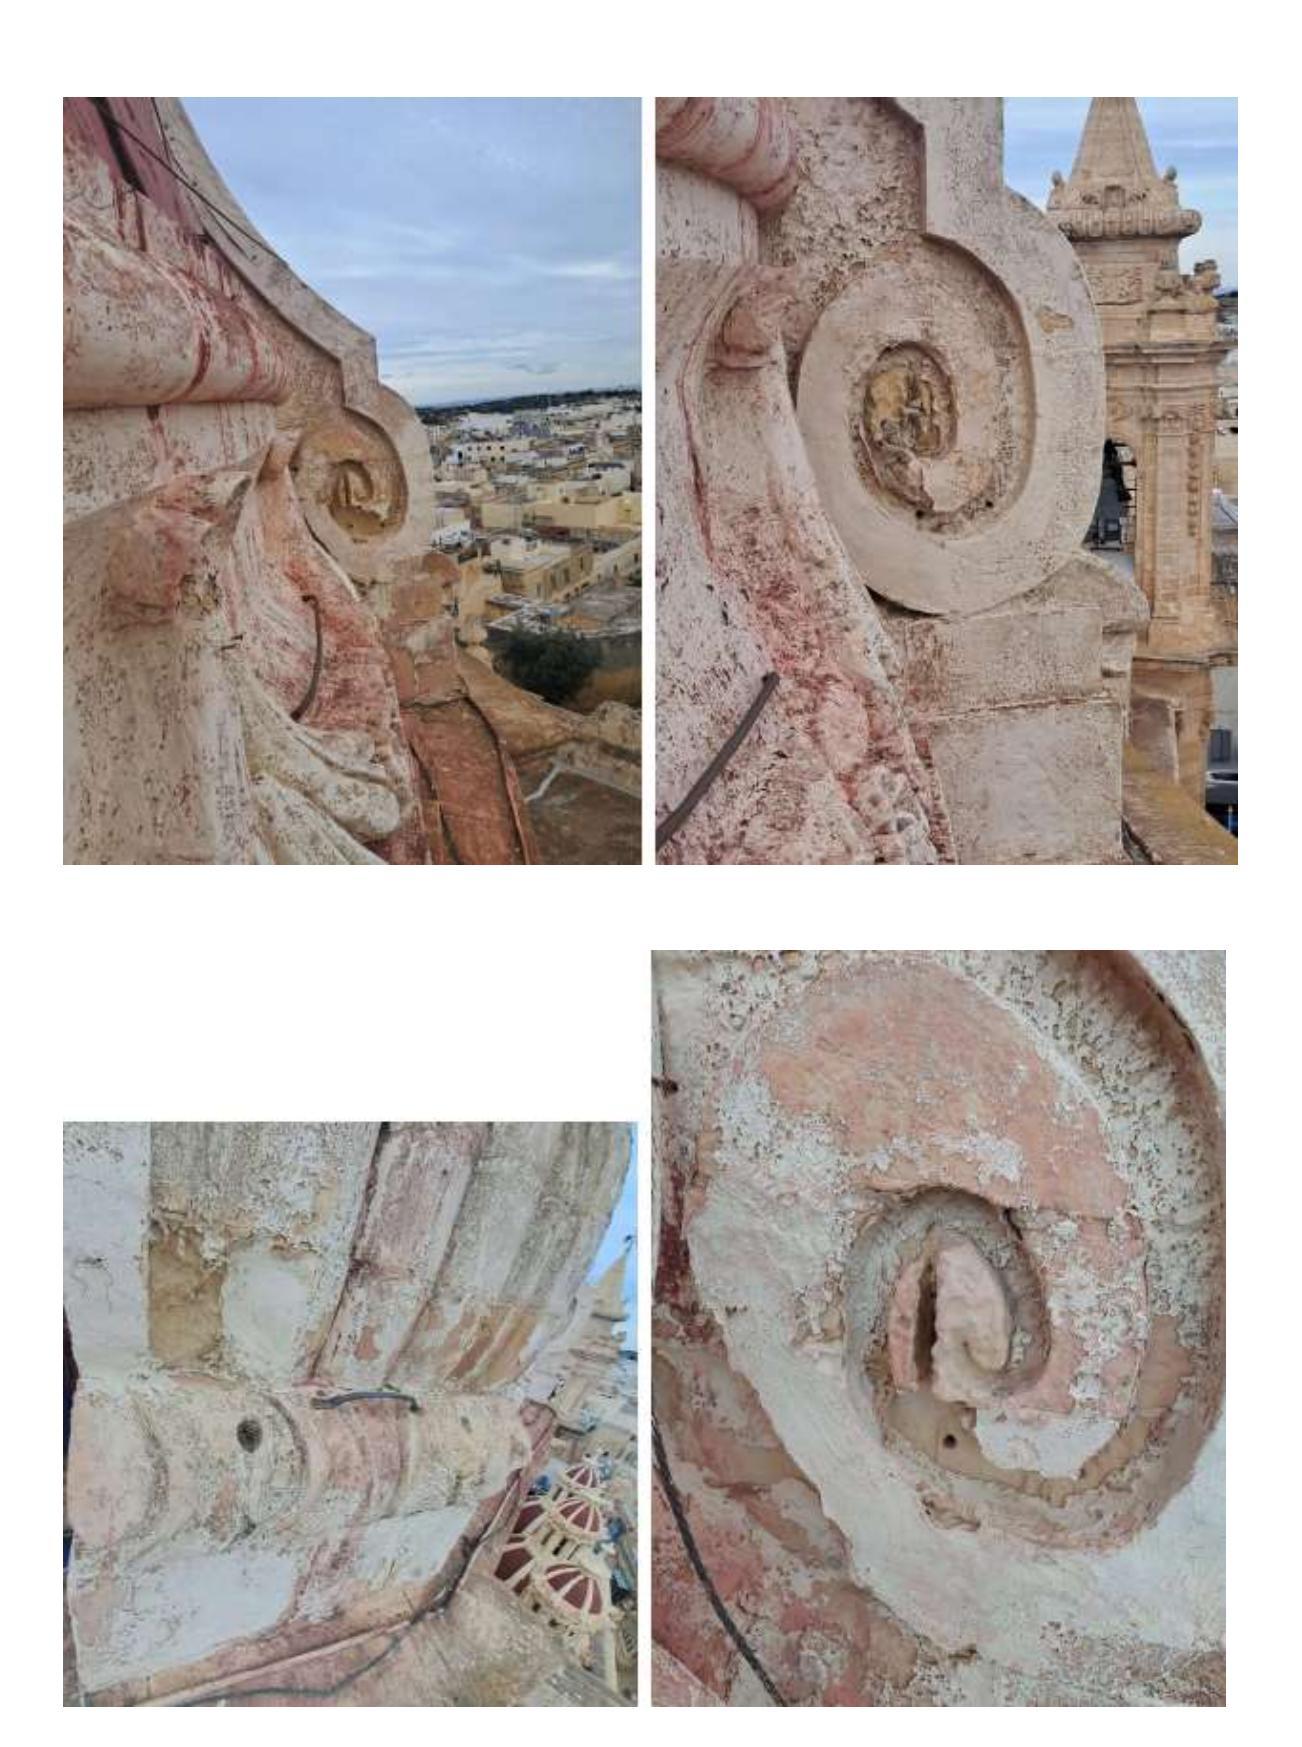
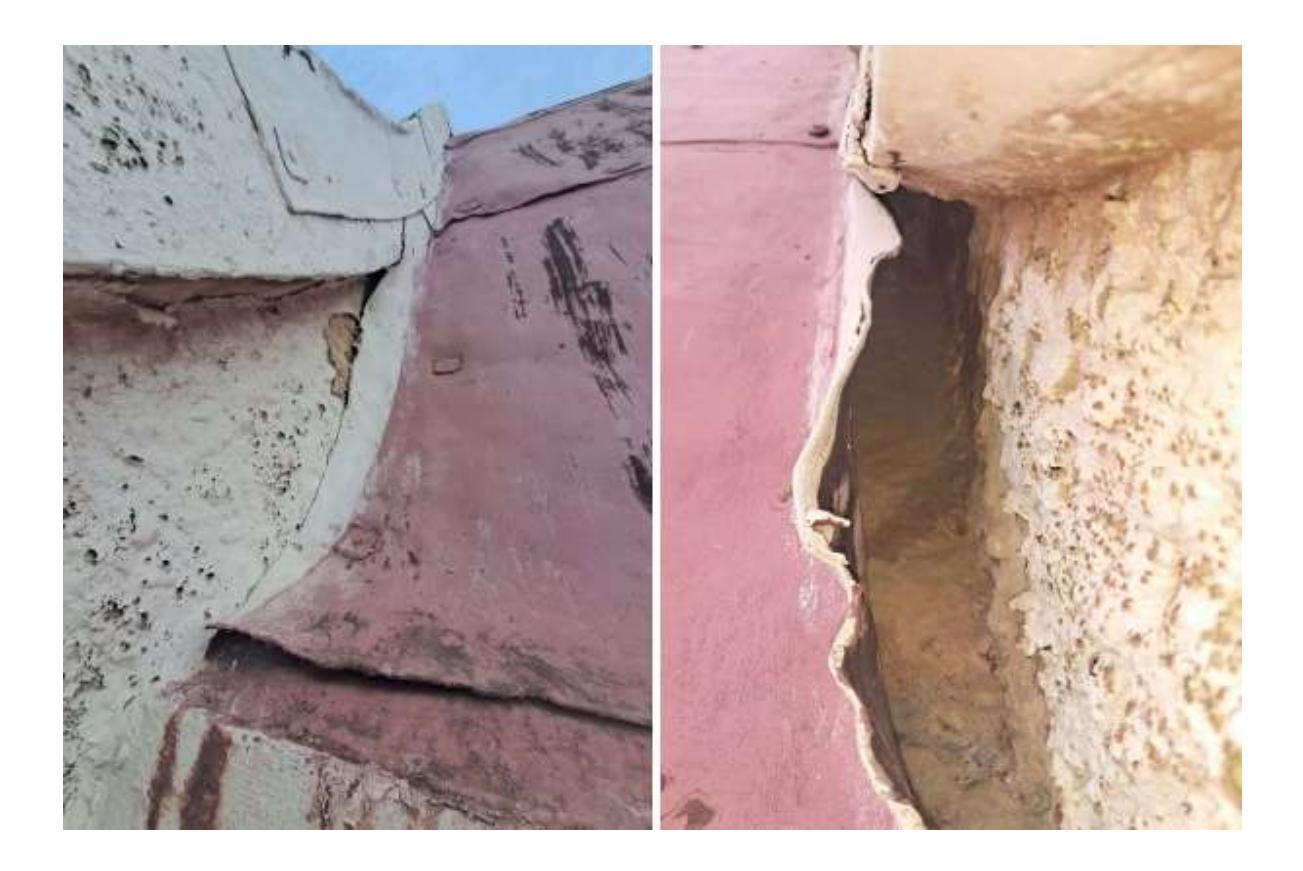
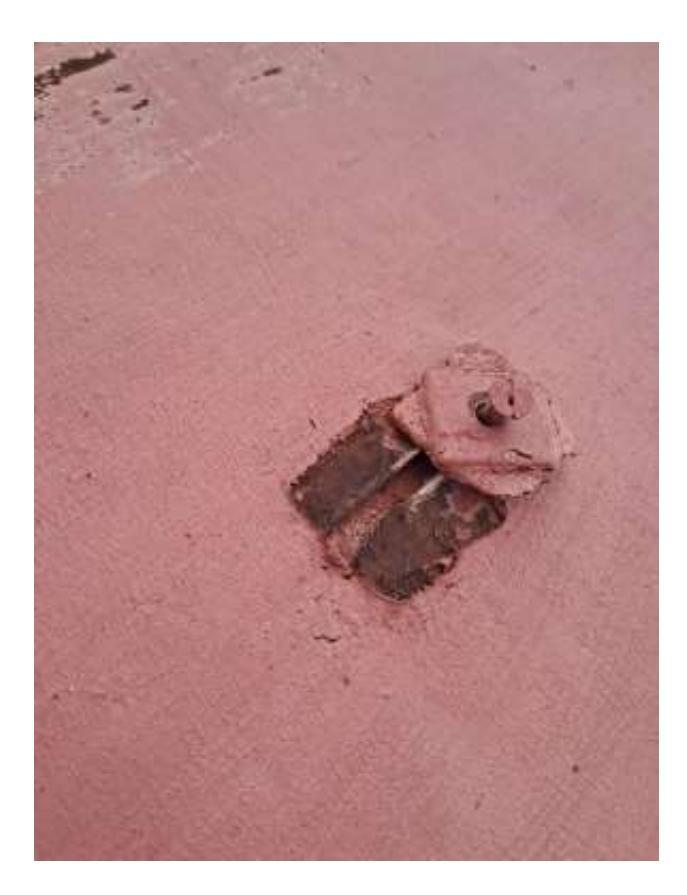
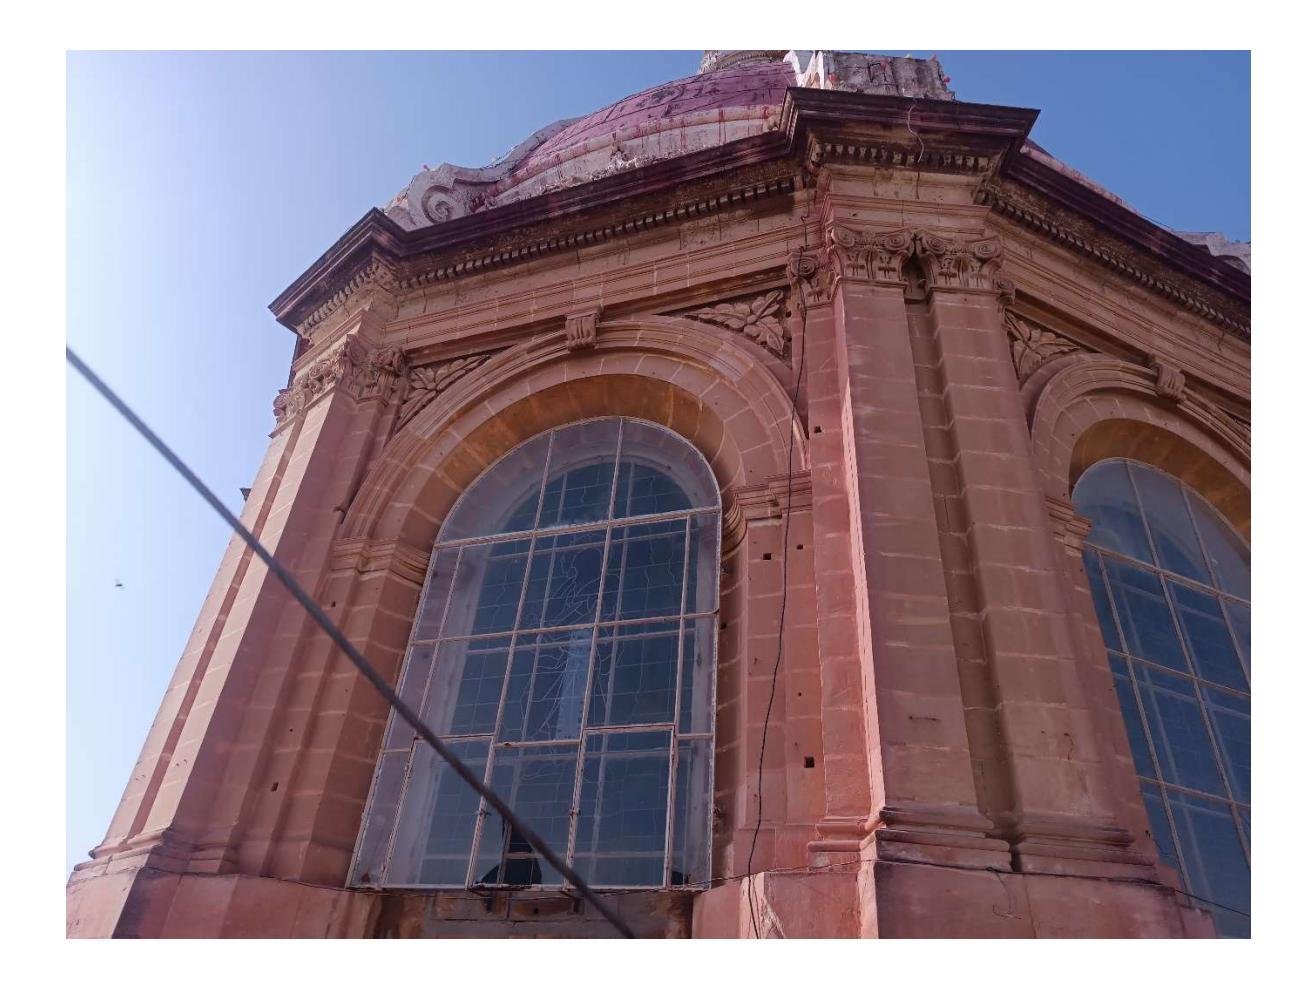
The underlying stonework seems to be in a fairly good condition with only some powdering showing in some areas.

The existing lead sheeting is showing some signs of movement especially on the South facing side of the church, since the areas where the sheeting was overlapping has become loose and also the perforations have become elongated due to the movement.

The reddish paint present on the lead sheeting has leeched and the south facing facades are highly stained in red due to the leeching of the paint.

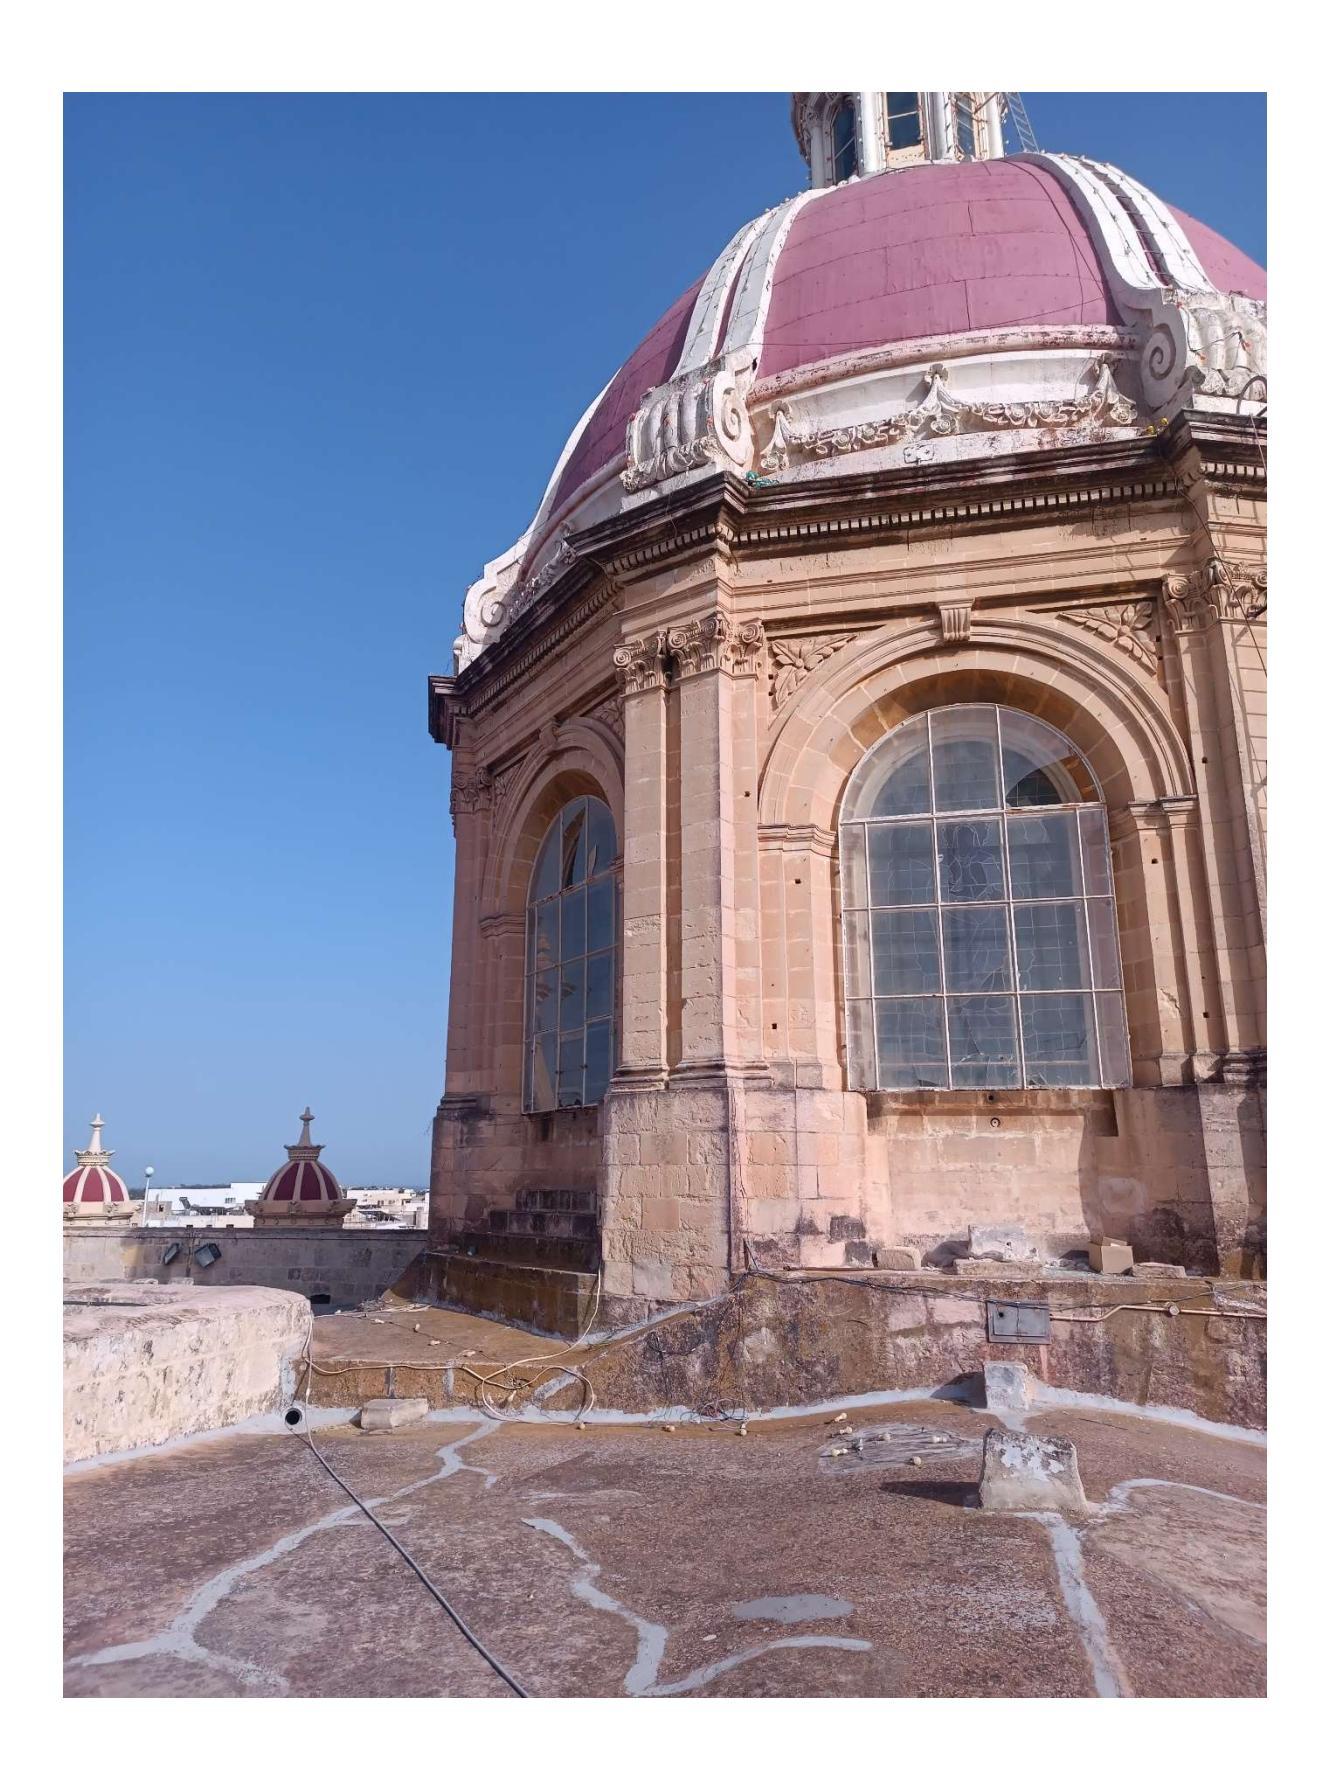
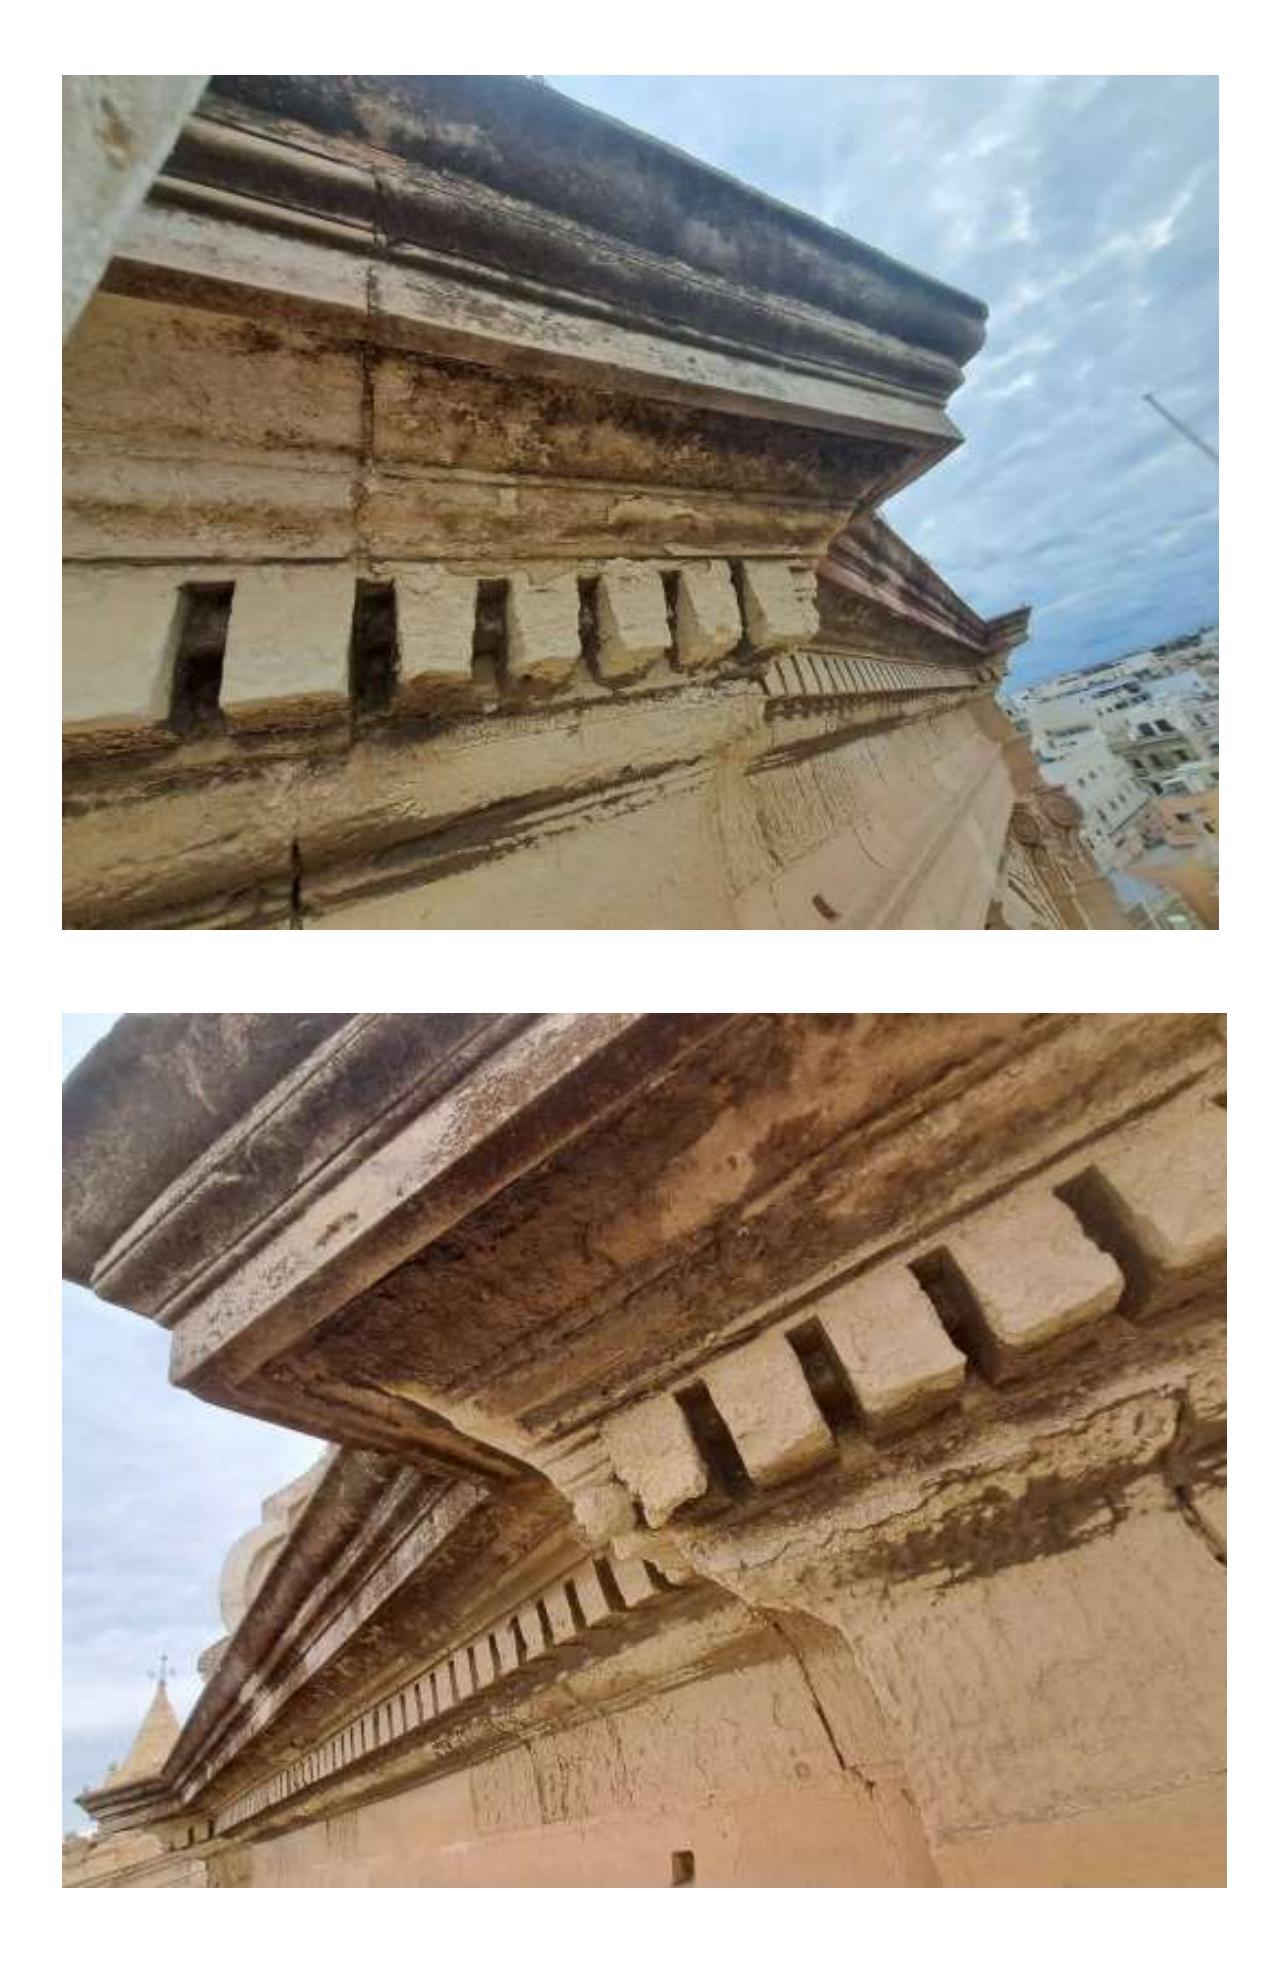
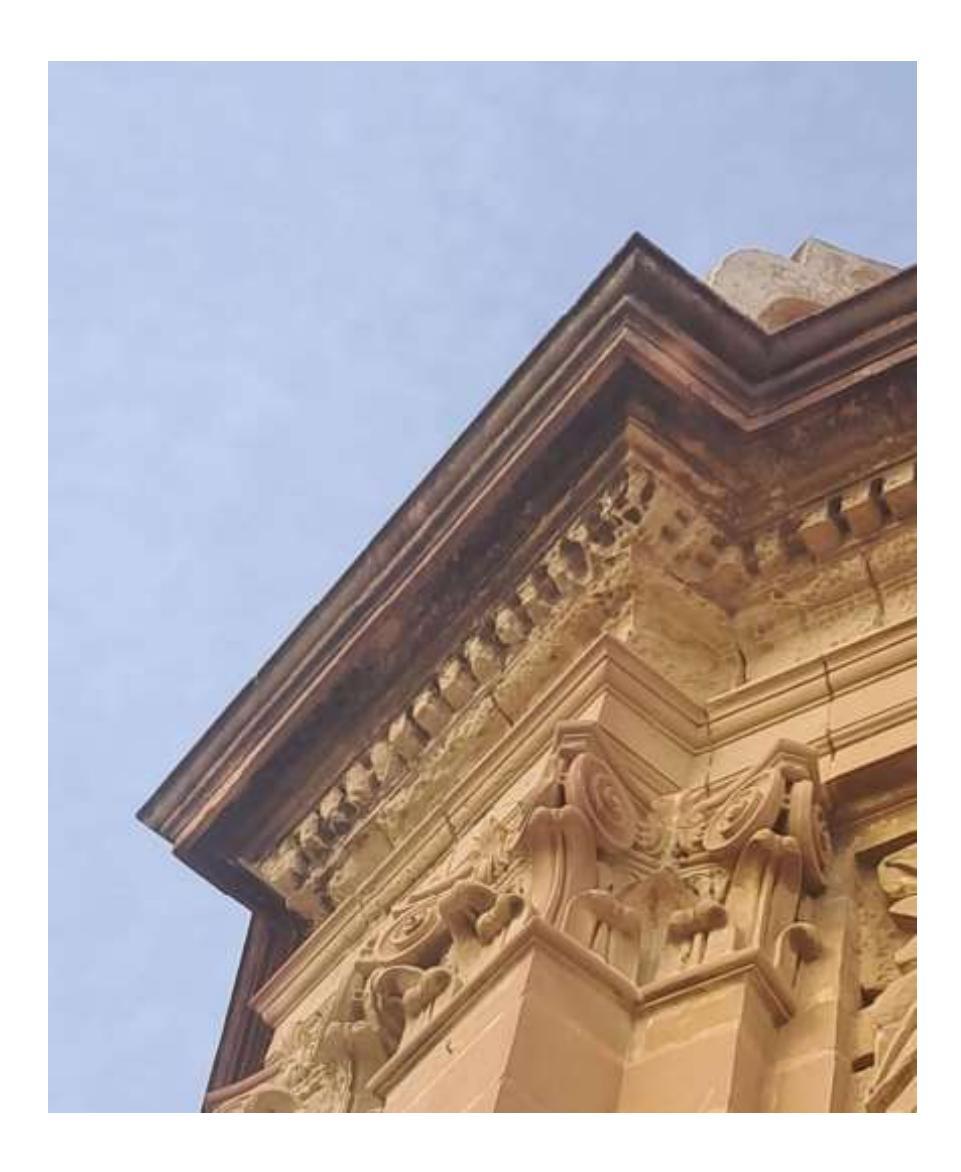
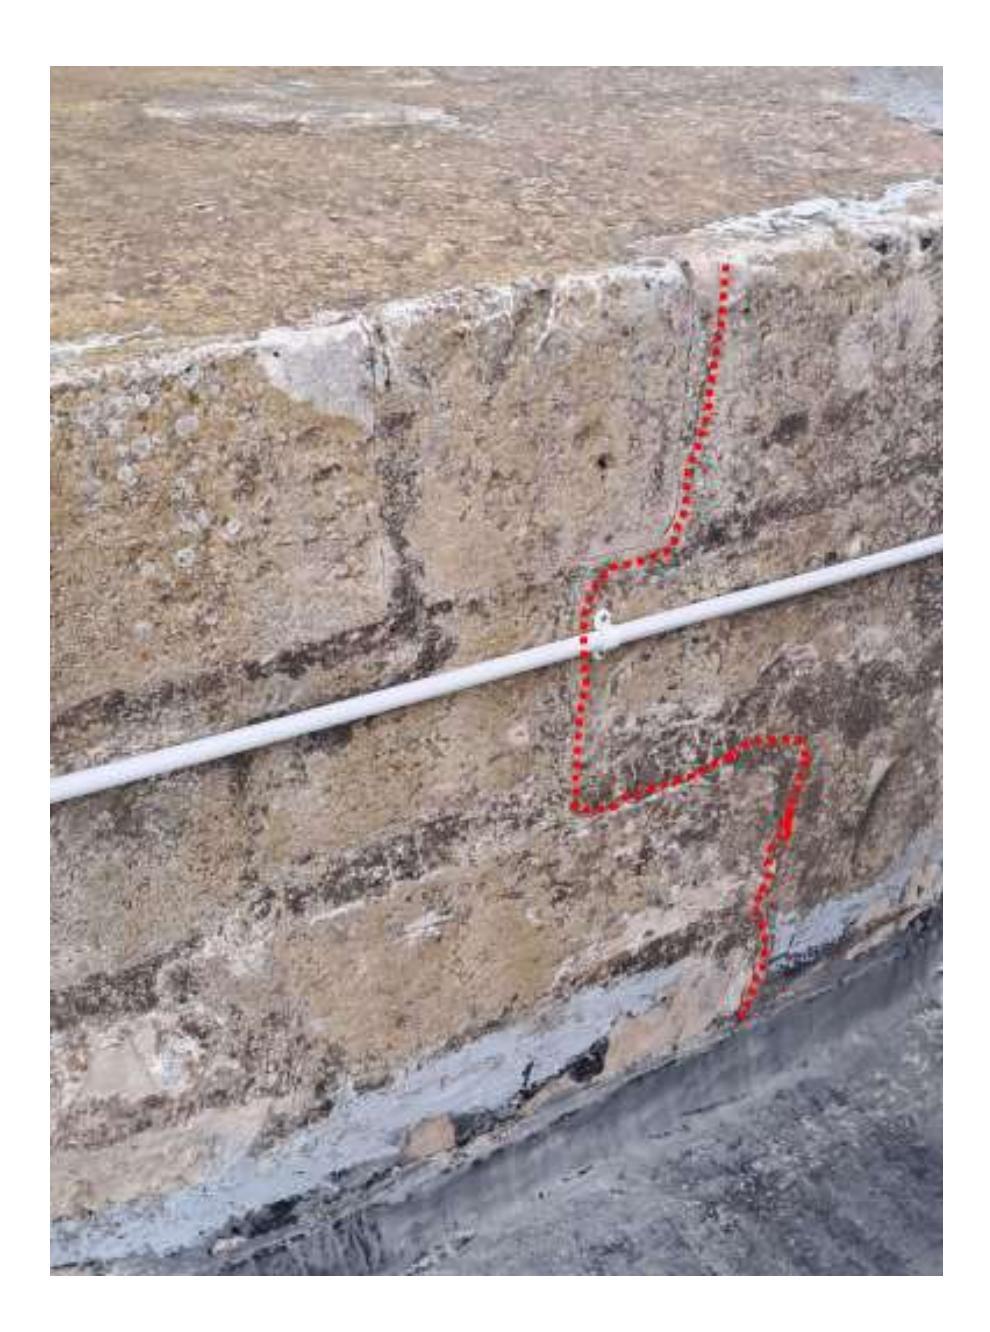
The stonework on the drum areas are still in a very good condition with very minimal areas showing signs of powdering.

The sheltered areas underneath the main cornice have black crusts and in certain areas where the black crusts is failing, it is clear that gypsum formation has happened underneath the crust with the result of leaving the stonework underneath powdered and more friable.

At the base of the drum there are areas showing some minor movement through cracking, which might also be related to the movement within the lead sheeting on the dome.

The areas where black crusts are evident and where these will not be removed with wet and dry brushing, a poultice with paper pulp will be applied in order to be able to soften down the crusts and in turn these are removed by means of surgical knives and brushes.

Stonework replacement will be limited to underneath the cornice.
