**Re: Manutenzjoni, Restawr u Installazzjani ta' Dawl Ġdid tal-Koppla tas-
Santwarju**

A Case for the Restoration of the Żabbar Parish Dome

Żabbar Parish Church, Sanctuary Street,
Żabbar, Malta.

Report no.: 1

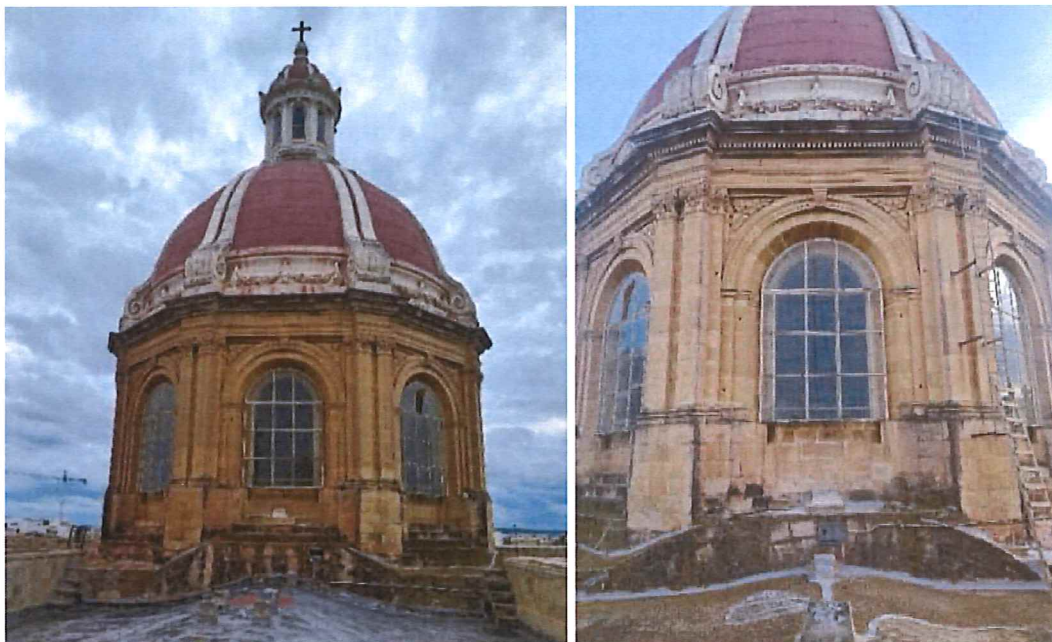
Figure 0-2 – (left) View from location 1 from the north-east, that is the dome's side facing towards Sanctuary Street, (right) View from location 2 from the north-west, that is the dome's side facing towards Mediatrix Square.

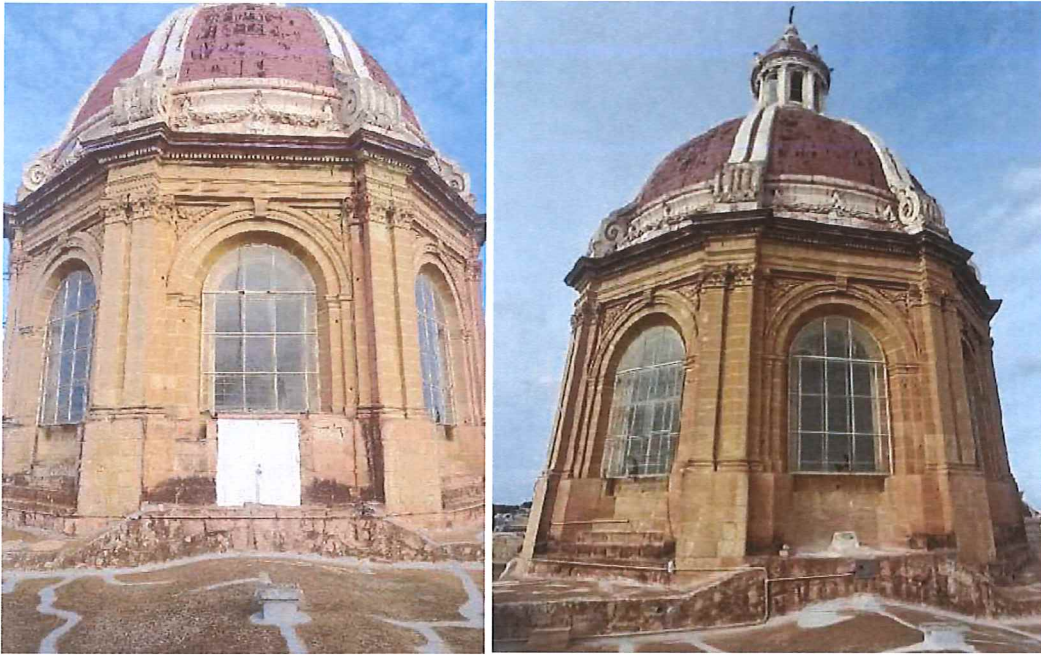
Figure 0-3 – (left) View from location 3 from the south-west, that is the dome's side facing towards Fgura, (right) View from location 4 from the south-east, that is the dome's side facing towards Żejtun and Marsascala.

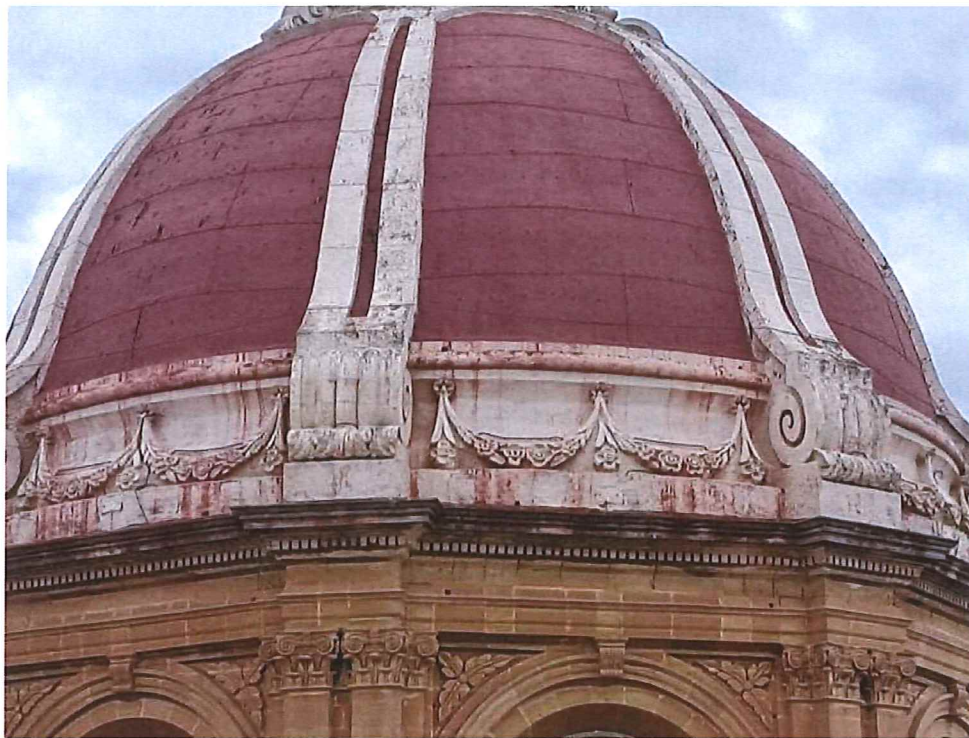
Figure 0-4 – Close view of the dome
