St Peter,
Oil and gilding on panel, 16th Century
Naxxar Parish Museum

Restoration Method Statement

Semira Gayle Bugeja (M.Sc., B.A. (Hons) (Melit.))

January 2025

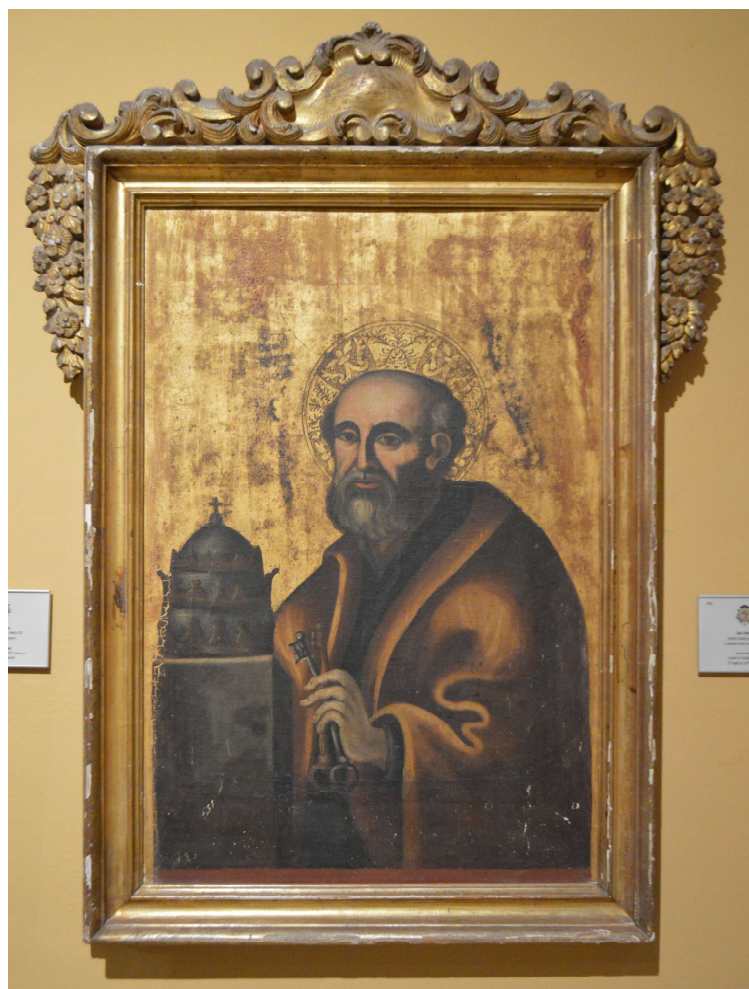
The following report carried out by Restawr Arti provides a description of the required conservation and restoration treatments for the 16th Century Icon of St. Peter and it's Baroque style decorative frame at the Naxxar Parish Museum (Figure1.). All knowledge gathered regarding the present condition of the work of art understudy is based on a visual inspection. The proposed required conservation - restoration treatments are based both on professional experience, and published research, and may require slight changes in the process or methodology once the conservator/s carries out a close and thorough visual inspection.

The work of art in discussion is an 16th Century panel painting representing St. Peter (Figure 1.). The structure consists of 2 vertical wood panels, held by 2 cross bars to hold the panels in place (Figure 2.). Canvas is adhered to the panel support, and is minimally exposed due to the damages and losses. This was probably carried out to support and close off the joint openings between the different panels and also to prepare a flat and homogeneous surface for the artist.
