STATE OF CONSERVATION AND TREATMENT PROPOSAL
FOR THE IMPORTANT PAINTINGS AND FRAMES DEPICTING
THE VIA SAGRA LOCATED INSIDE THE BASILICA OF MOSTA
DEDICATED TO THE ASSUMPTION OF THE VIRGIN MARY

10th January 2025

ATELIER DEL RESTAURO
CONSERVATION & SCIENTIFIC ANALYSIS OF WORKS OF ART

QUOTATION

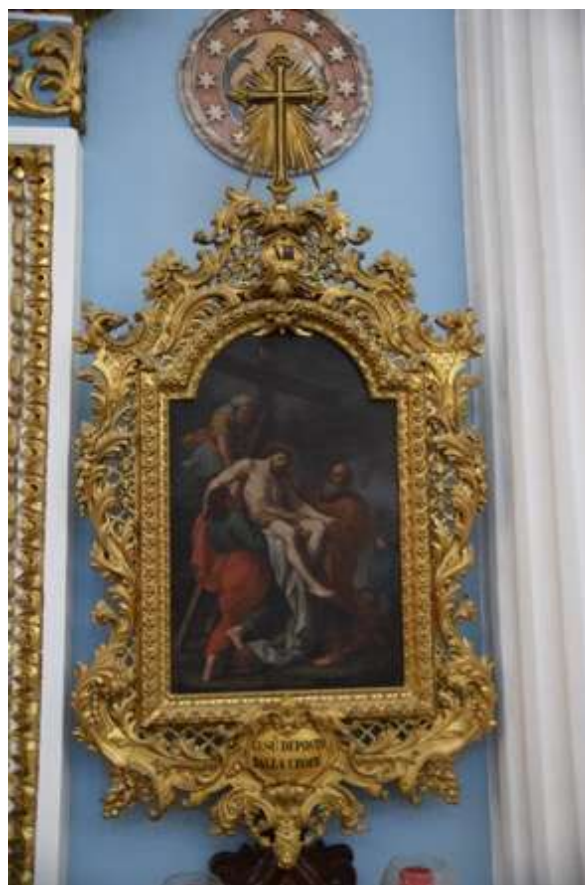
Figure 3 – General image of the 13th Station of the Cross

The paintings in general were found in a stable state of conservation. Some exhibit a craquelure pattern. This pattern is present throughout the painting due to the repeated expansion and contraction of the canvas support. This movement most probably happened because the painting absorbed humidity present in the air. Due to the expansion and contraction of the canvas support with changes in temperatures and humidity stresses are created on the paint layer and by time a loss in the painting's elastic properties takes place.

The varnish layer appears homogenous however it has oxidised in time and has therefore altered the original colours, resulting in an overall dark yellowish tone which hinders the full appreciation of the painting's intended tonality. Restoration intervention attempts seem to be present due to a number of overpaints observed in some of the paintings.

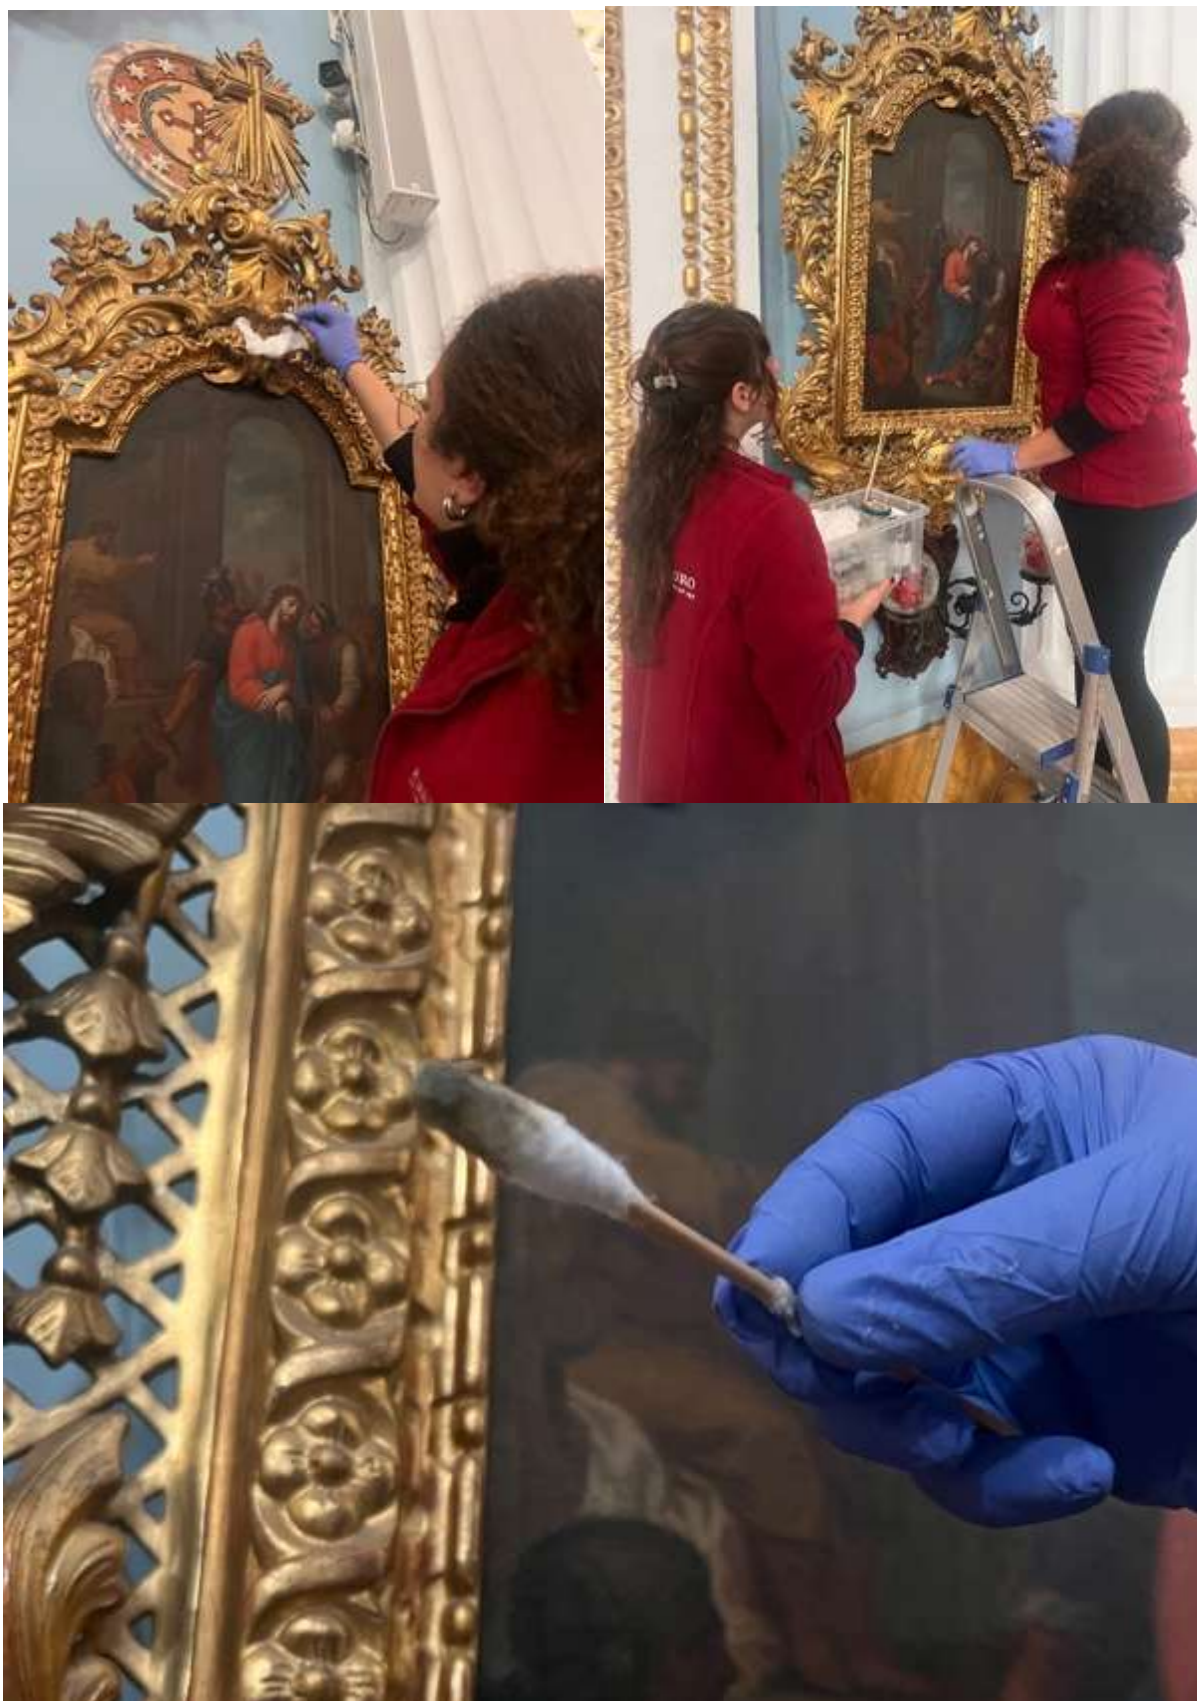
For the purpose of this project specialised conservators in the conservation of wooden and gilded surface did a site- visit to carry out cleaning tests.

Figure 4 - During the cleaning tests carried out on the frames
