PREVARTI Laboratory

QUOTATION

Name: Church of St Albert (c/o Mr Godwin Dalli)

Title: Our Lady of Sorrows

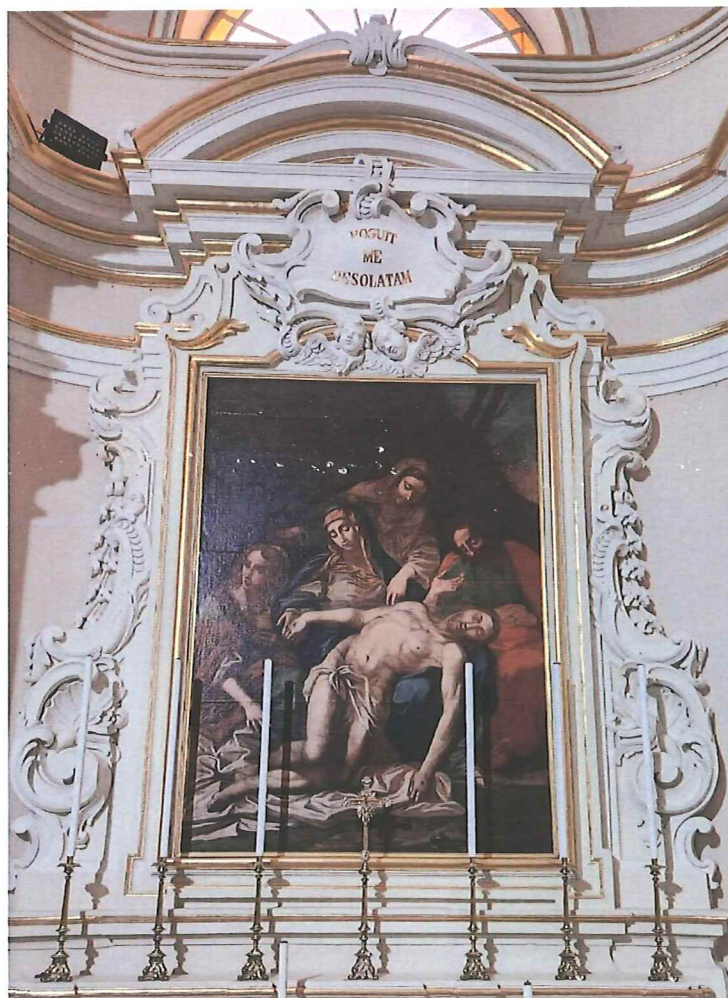
- This painting was previously relined around the end of the 1980's. An organic kind of adhesive was used for relining and the canvas feels very hard and rigid to the touch.

- The canvas is made up of three horizontal seams running across the painting. These seams are very visible and seem to protrude above the surface. This protruding effect has been caused by the relining process that pushes the seams out.

- The canvas does not exhibit any deformations and seems to be stretched well. This gives an indication that the auxiliary frame is in a fair state of conservation even though it could not be observed directly from the back.

- The varnish that was applied to the painting has already yellowed.
- Under UV light one can notice how in the restoration process done in the past not all areas of the painting were properly cleaned.

- Under UV light one can also notice a considerably amount of retouching especially around the faces of the Virgin, St John and Mary Magdalene.
- In at least two places the painting seems to have incurred damage where retouching was applied.

- There is some cupping in the paint layer but the paint does not seem to be unstable or in risk of flaking.

- Despite what has just been mentioned above, it is not suggested that the relining is removed due to possible damage that the painting may incur while the old adhesive is removed. It is suggested that a flattening using the low-pressure table is done instead.

- Dismantling, wrapping and transportation to Prevarti Lab.
- Documentation under normal light, UV light, Infra-Red imagery and raking light.
- Cleaning tests to determine the proper solvents for the cleaning process.

- Removal of surface dust, dirt.
- Removal of yellowed varnish.
- Removal of previous retouching and possible overpainting.
- Consolidating through facing of paint layer to protect it whilst working on back of the painting.

- Removal of canvas from stretcher frame
- Removal of canvas deformations and lowering of seams protrusions face down on low-pressure table.
- Removal of Japanese paper that was used for the emergency consolidation of paint layer.

- Removal of any old infilling and application of new one where necessary, and levelling.
- Retouching and application of protective varnish.

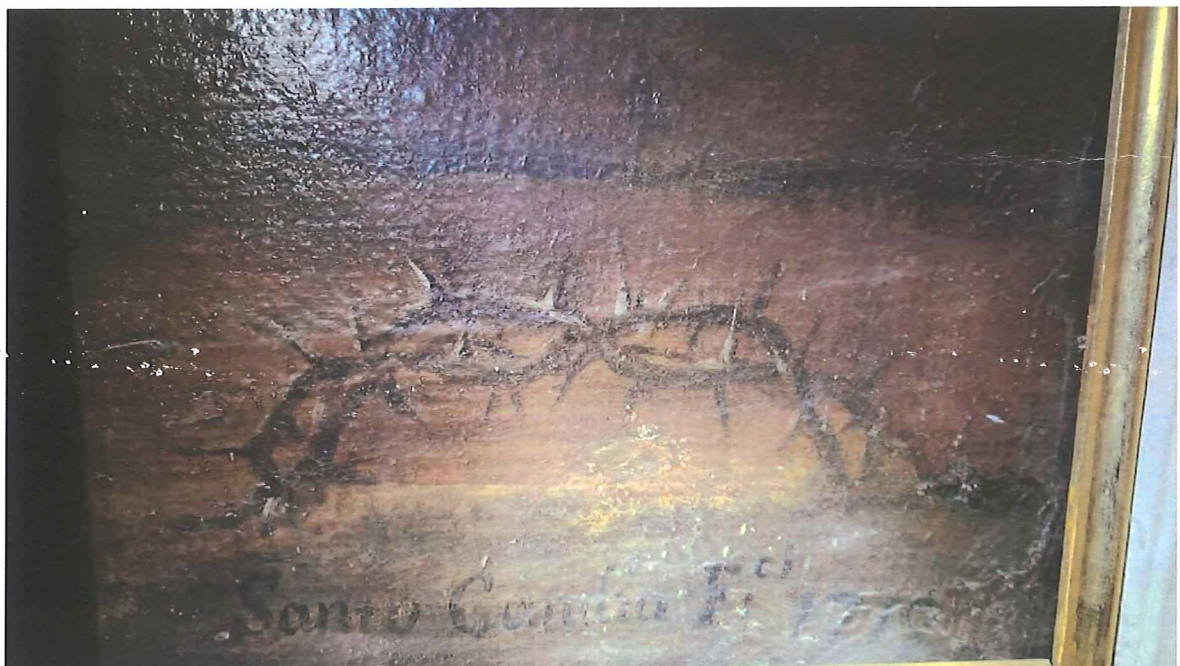
Detail of the signature and dating in the bottom left corner of the painting.
